Pro 8200s/8210s/8220s Pro 8210/8220

Operating Instructions Troubleshooting: TCRU/ORU

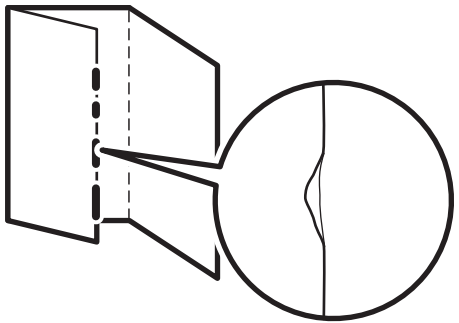
CEZ592

Edges of letter fold bent

When letter folding is applied, the edge of the inner flap may become bent.

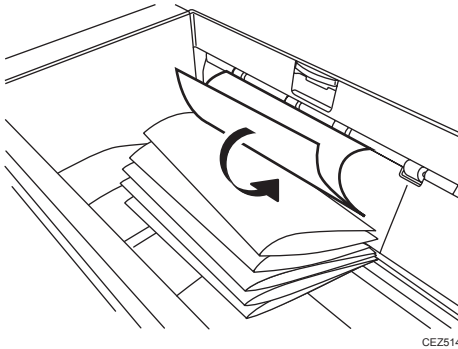
- Thick, relatively stiff paper is used.

As a bundle is delivered, its folded edge may droop and catch on the stacked bundles, causing the delivered bundle to flip over.

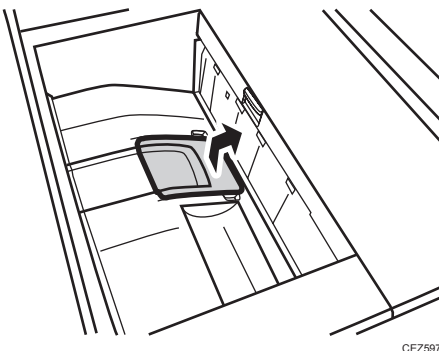
Use the Z-fold support tray for multi-folding unit.

This will reduce the angle of stacked bundles and prevent bundles flipping over as they are delivered.

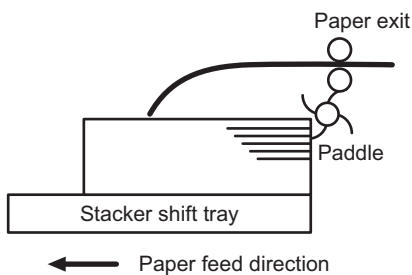
1. Downward curled paper is delivered to the stacker tray.

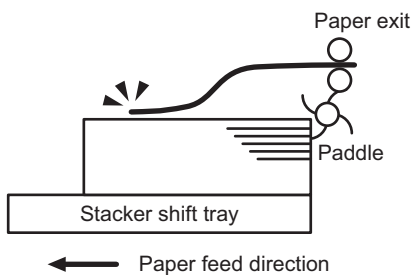
2. The leading edge of the sheet, while delivered, causes strong paper-to-paper friction against the top sheet of the stack. As there is no air gap between the sheets, and the delivered sheet becomes stuck.

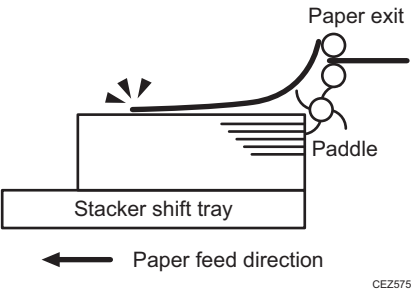
3. The trailing edge of the sheet, while delivered, is left in the paper exit.

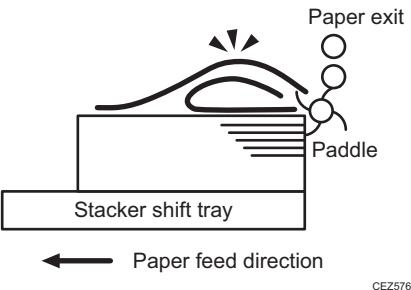
4. The next sheet to be delivered slips under the sheet still in the paper exit and bends back.

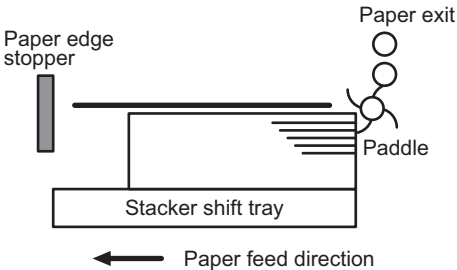
1. An uncurled sheet is delivered to the stacker shift tray.

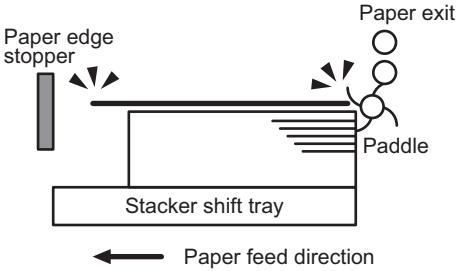
2. Strong friction occurs on the trailing edge so that the paddle cannot pull the sheet back and align the edges of the sheet with those of the stack.

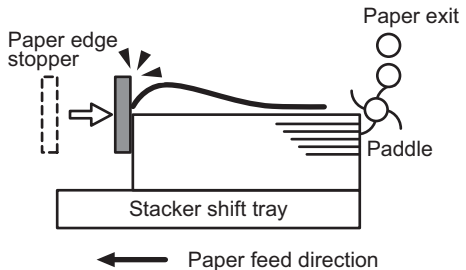
3. The paper edge stopper fails to push back the protruding leading edge and align the sheet as required.

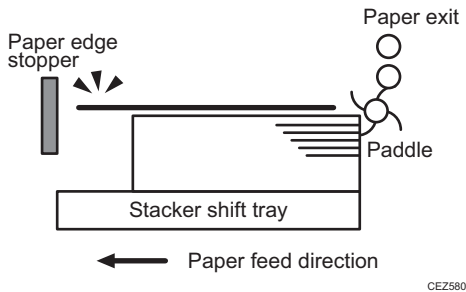
4. Stacked sheets are not aligned properly.

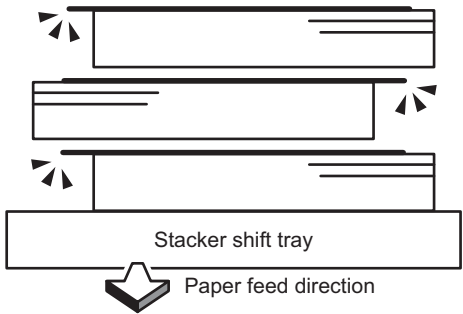
CEZ605

- The top sheet of each offset bundle of delivered sheets may protrude above the rest of the bundle by about 7 mm.
