Model Ta-C2/P2 Machine Code: D194/D195/D203/D204 M195/M196/M207/M208

Troubleshooting

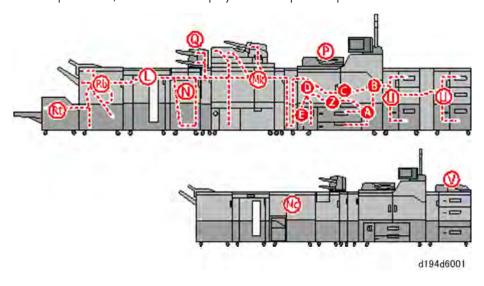
Jam Displays

When a jam occurs, the location is displayed on the operation panel.

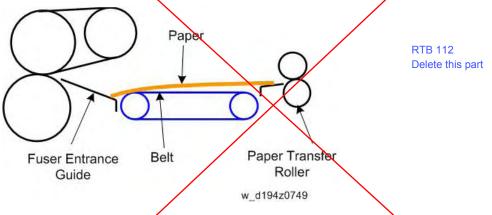
Poor paper transporting due to less adhesion between belt and paper: It occurs particularly in a paper that its leading edge reaches at the Fuser Entrance Guide when its trailing edge goes through the Paper Transfer Roller.

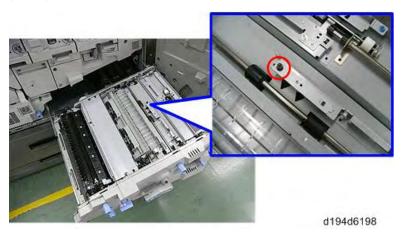
Pull out the right drawer and remove the bracket of the double-feed sensor 2 (receptor) (\$\mathbb{O}^2 \times 1\$).

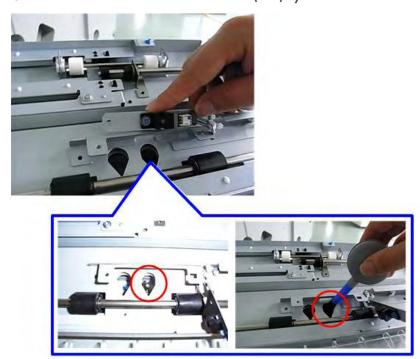
d194d6200

3. Clean the lens of the double-feed sensor 1 (LED) by a blower brush.

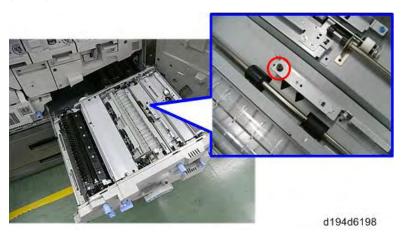
4. Re-attach the bracket of the double-feed sensor 2 (receptor) and close the right drawer (\$\mathbb{O}^* \times 1\$).

• Be careful not to pinch the harness when attaching the bracket.

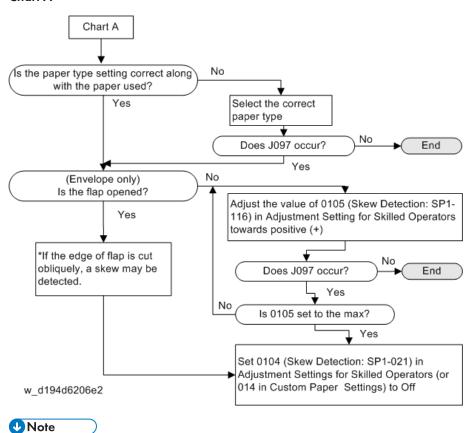
Chart A

· Skew may occur in output paper because the skew detection level is mitigated or skew detection is disabled. Adjust the registration gate position if the skew level is poor. See page 636 "Adjusting the Registration Gate Position".

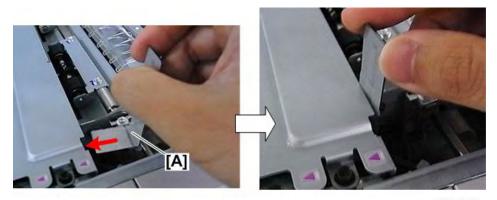
d194d3116

• Slide the cleaning part [A] of the CIS cleaning tool into the paper transporting path.

3. Clean the sensor part of CIS by sliding the tool toward the main scan direction.

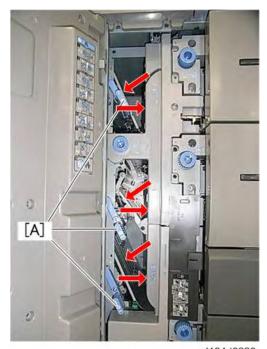
d194d6226

- 5. If tray 2 and tray 3 are applicable, do the step 1-4 in this procedure for them.
- 6. Open and clean the vertical transport guide plate [A].

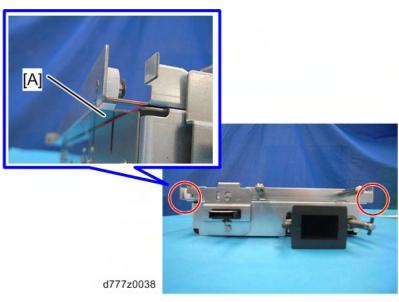
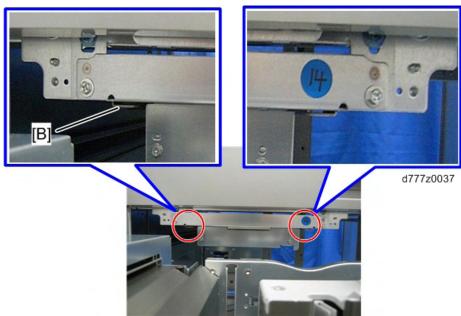
d194d6705

- The paper feed belt unit must be pulled out horizontally relative to the paper tray, to ensure that the paper feed belt is not damaged by getting caught in the side fences or other parts.
- To prevent damaging the paper feed belt when you return the paper feed belt unit to its original position, align the right and left guides [A] with the rail [B] on the paper tray side and raise them slightly before replacing the unit.

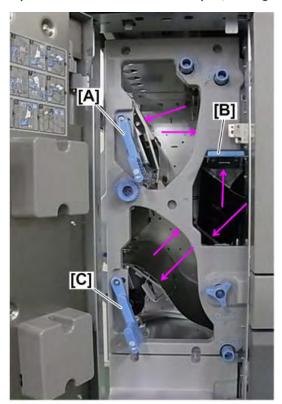
d194d6277

6. Open and clean the front door, Open/close guide plates [A], [B].

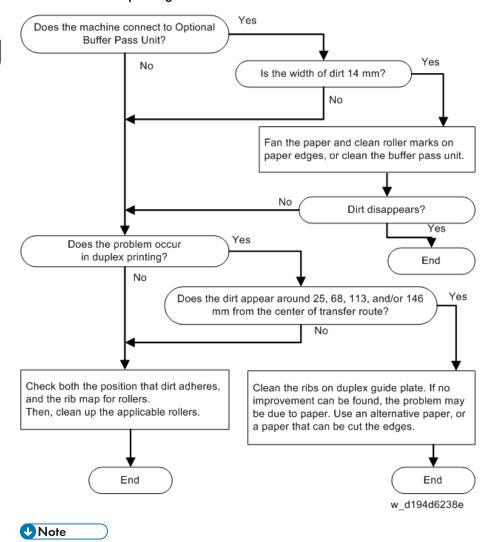
Roller Marks on Paper Edges due to the dirt on transfer roller

- · Fanning the paper, and Cleaning the roller marks
- Put your finger on the roller marks, and fan the paper. Then remove the dirt with a dry cloth.

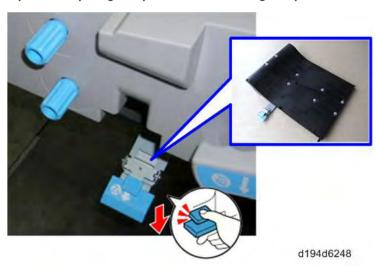
- 1. Pull out the left drawer.
- 2. Open the duplex guide plate, and clean the guide plate.

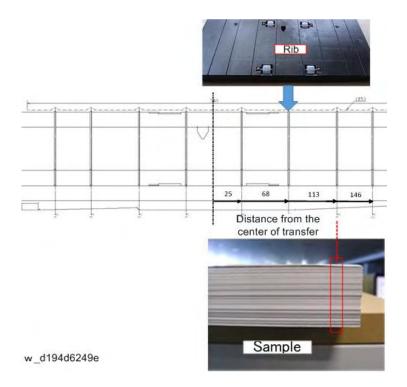
• Guide Plate Rib Location

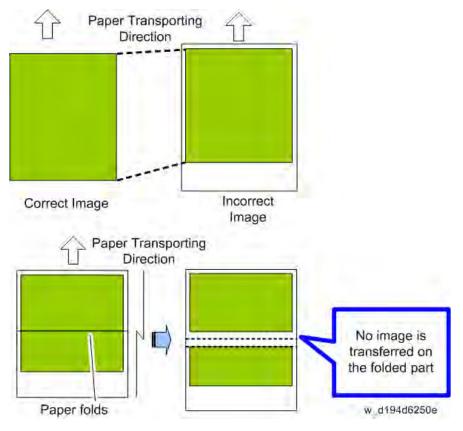
Paper folds unexpectedly, and/or no image is transferred in the folded part.

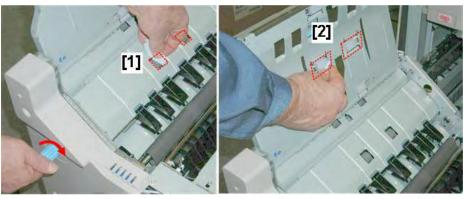
d074t548

• Wipe the roller surface, while rotating the knob with pressing the cloth to the roller.

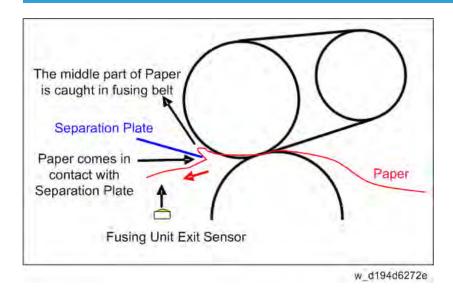
Fusing Jam When Printing with High Coverage (J033/J034/J083)

In printing solid image, paper is delivered with slightly sticking to the fusing belt in separating the paper at the paper separating part of the fusing nip outlet.

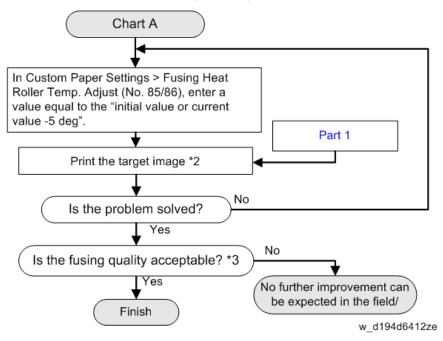
Chart A: Flowchart for Decreasing Set Temperature

- *2: A4/LT LEF more than 50 sheets.
- *3: Guidelines for Fusing Quality
 - No image peeling.
 - No toner peeling even when rubbing the image gently with fingernails.
 - No toner peeling even when rubbing the image with the optical cloth.

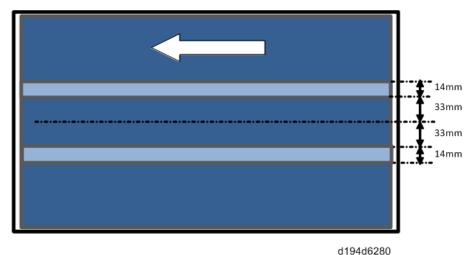
RTB 112 Modified In printing a solid image with high coverage, two 14mm-width bands are generated at 33 mm away from the center of transfer on the 2nd side in duplex printing or on the side where image transferred in simplex face-down.

Temperature on the surface of toner differs between the contact area of Paper transport roller and the image, and other non-contact area. Pressure force of rollers also changes the surface property of toner, leading to produce a difference of glossiness.

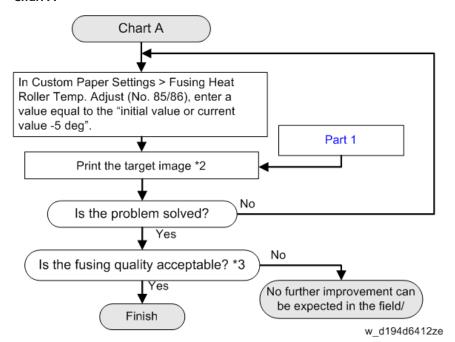
Chart A

- *2: A4/LT LEF more than 10 sheets.
- *3: Guidelines for Fusing Quality
 - No image peeling.

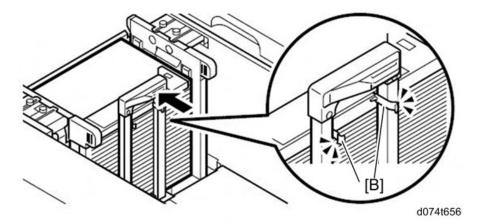
3. Slide the end fence against the paper so that the tab sheet holder's clips [B] pass through the fence and click into place.

- You can use the tab sheet holder for paper of the following sizes:
- Paper with a width of 288.0–330.2 mm (11.34–13.00 inches) and a length of 182.0–487.7 mm (7.17–19.20 inches).
- Paper with a width of 139.7–287.9 mm (5.50–11.33 inches) and a length of 335.5–487.7 mm (13.21–19.20 inches).

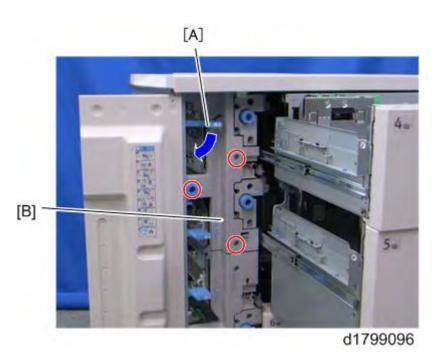
When removing the 1st or 2nd paper feed unit, lower the lever [A] and remove the inner
upper cover [B] (\$\widethat{\text{\$\pi}}\$x3, knob x1).

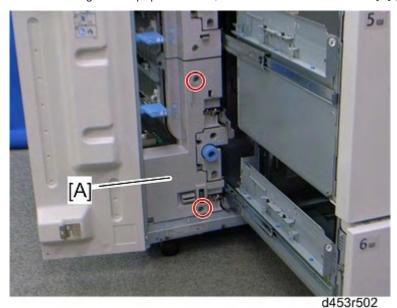
• When removing the 3rd paper feed unit, remove the inner lower cover [A] (@x2).

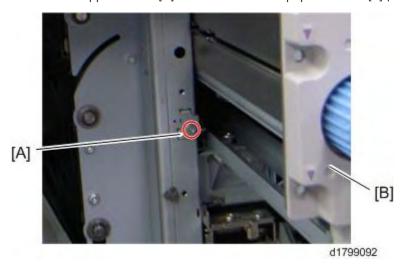
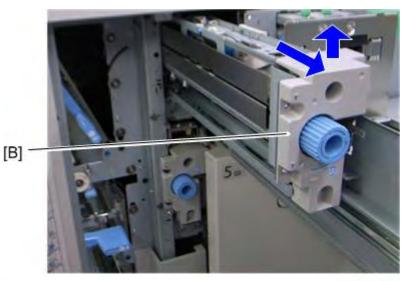
d1799093

5. Remove the stopper bracket [A] and then remove the paper feed unit [B] ($\mathfrak{G}^{*}x1$).

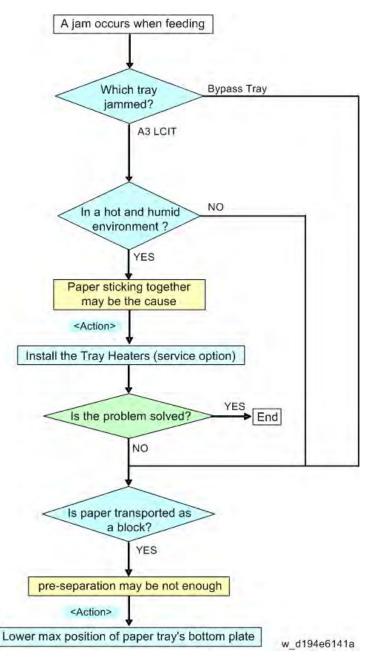
Follow the flowchart below.

- For details about Tray Heaters (service option) Installation Procedure, refer to Main Chapters>
 Chapter 2. LCIT RT 5090 (D732) > Tray Heaters (service option) for installation procedure
- page 707 "Adjusting the Upper Limit Position (A3 LCIT)"

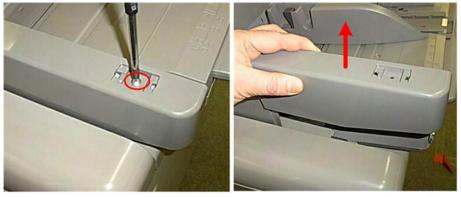
d517r803

2. Remove the right front cover ($\Im x1$).

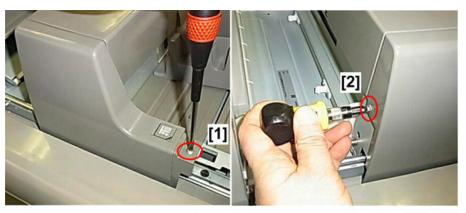
d517r804

3. Disconnect the right [1] and left side [2]

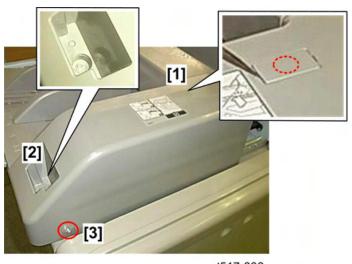
d517r806

- 5. Remove the screws.
 - [1] Covered screw (@x1)
 - [2] Rear screw (©x1)
 - [3] Well screw (@x1)

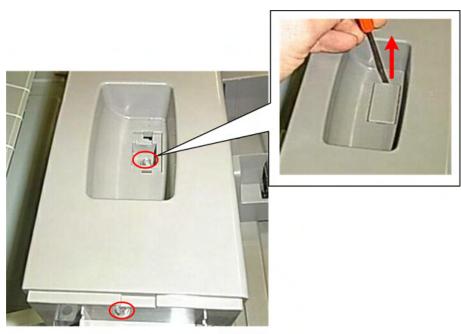
d517r808

7. Remove the top cover ($\Im x3$).

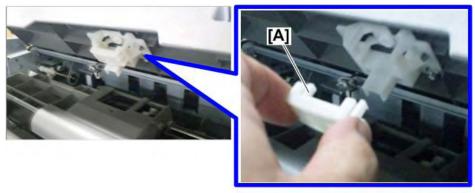
d194d6144

1. Open the tray cover and remove the plastic part [A] on the inside of the cover.

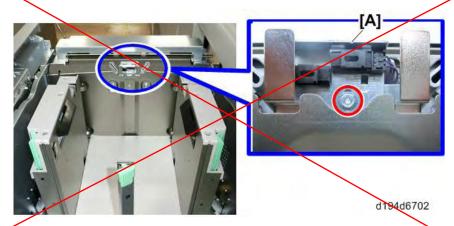
1. Loosen the screw on the sensor bracket [A].

RTB 112 Deleted Use the scale shown in the diagram below as a guideline to adjust the sensor bracket by bliding up and down.

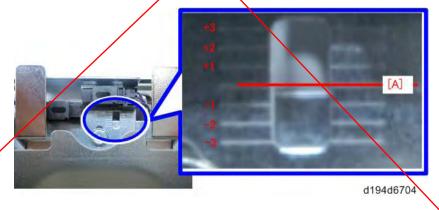
Adjust by sliding in increments of 1 mm from the reference position [A].

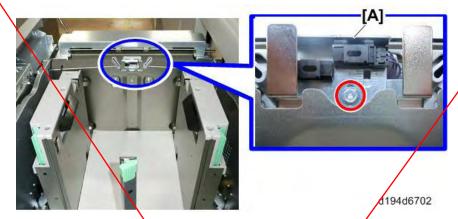
1. Loosen the screw on the sensor bracket [A].

2. Use the scale shown in the diagram below as a guideline to adjust the sensor bracket by sliding up and down.

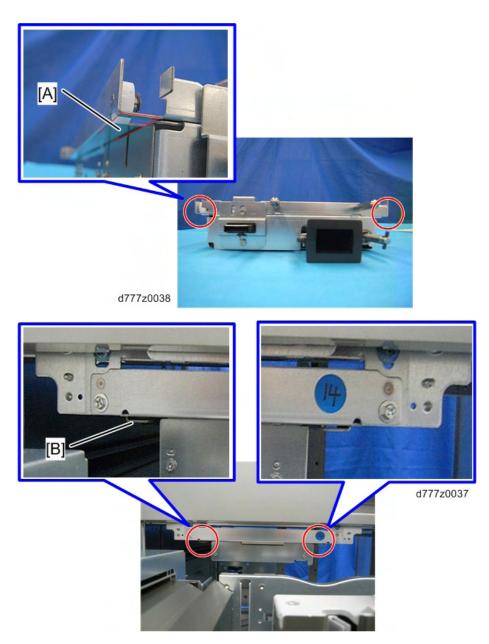
Therefore, be sure to pull the paper feed belt unit out horizontally relative to the paper tray.
- In order to avoid damaging the paper feed belt when returning the paper feed belt unit to its original position, align the right/left guides [A] with the rails [B] of the paper tray and lift up it slightly when setting.

. Turn the paper feed belt unit over and wipe the paper feed belt [A] with a damp cloth.

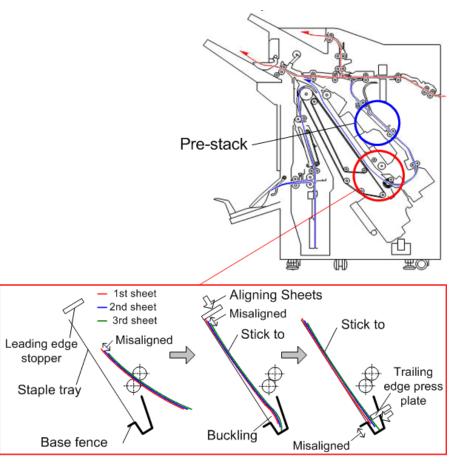
w d194e6170a

If there is a lot of friction between sheets of paper, as happens with coated paper, during pre-stacking, the alignment of leading edge stopper fails to correct the misalignment of paper, so it is not stapled neatly.

The paper is discharged to the staple tray and its leading edge is pressed against the leading edge stopper, the paper is then aligned by the base fence pressing against the trailing edge; however, when there is a great deal of friction between sheets, as happens with coated paper, the aligning effect of the leading edge stopper fails to correct the misalignment.

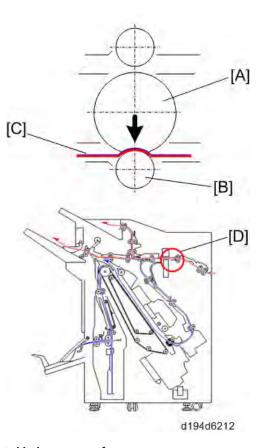
When the back curl correction (straightening paper which is curled face down) is enabled, nip the paper with sponge roller (upper) [A] and metal roller (lower) [B]. Pressing deflection of sponge roller corrects the curl.

If printed side faces up [C], toner becomes easy to come off from paper because the printed side is pressed by the sponge roller to correct the curl. When this paper is transported to the finisher, the anti-static brush [D] on the upstream of the punch unit catches the toner, and then toner is transferred to the leading edges of paper.

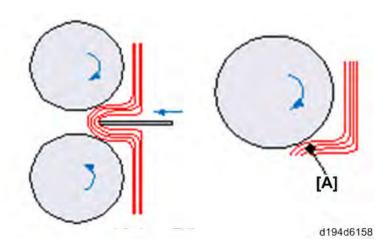
However, if the print density of an image is high, such as with a solid image, it lowers the friction coefficient between sheets of paper [A], which can result in slipping during the folding process of paper other than the cover as the transport pressure drops; in such case, only the cover is discharged and other paper is left behind in the saddle stitch process tray, resulting in a paper remaining jam error (JAM129).

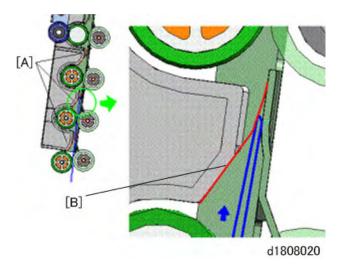
When the folded paper is transported to the fold crease unit, the leading edge (creased edge) enters the fold nip prepared level for the press guide [B], and then is pressed by the on the paper transport guide. The press guide is provided with three press rollers [A]. The friction between the press guide and press guide plate as the paper is fed can scratch or mark the matte finish of the paper.

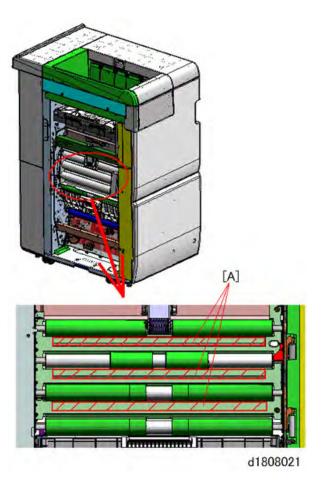
1. Open the guide plate and clean the metal plate at [A] with an alcohol dampened cloth.

- Cleaning the surface of the metal guide plate and buffing it with a piece of paper reduces the occurrence of marks on the paper.
- The present condition of the guide plate at the affected area depends on the amount of usage of
 the folding unit, but buffing the surface of the plate with paper 20 to 50 times should reduce friction
 during paper feed.

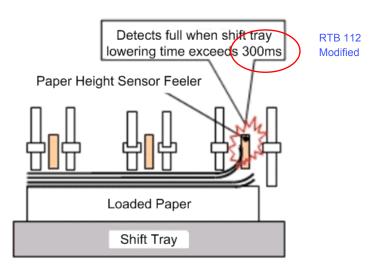
w_d194e6186a

When paper that is about as wide as the paper height sensor feeler is discharged to the shift tray, if it has side face curl, the edge of the paper may fail to go under the paper height sensor feeler and ride up on the feeler; alternatively, by coming in contact with the paper height sensor feeler, it may ride up and press against the feeler and the load from this may hinder the movement of the feeler. In this case, even if the shift tray lowers down, the paper height sensor feeler fails to turn OFF, and the lowering time of the shift tray ends up exceeding 300ms, and the unit ends up sensing it is full.

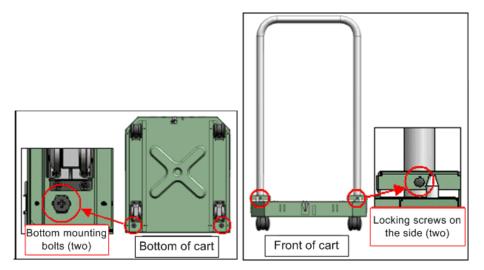
w d194e6191a

If the cart's handle starts to rattle, or if the paper holder fails to be effective because of loosening, re-tighten the mounting bolt on the bottom of the handle.

Also, if the locking screws on the side of the handle get loose, re-tighten them.

The torque on the mounting bolt of the handle on the bottom of the cart is too low, so when the cart is loaded with paper and it is pushed/pulled repeatedly, the mounting bolt may get loose.

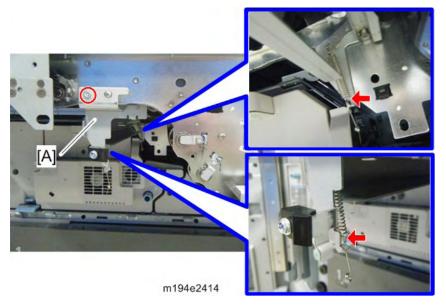
- Do not remove these springs. Let them hang free. They will not fall off.
- 6. Remove the screw of the belt tension roller assembly [A] (\$\mathbb{O}^{\text{x}} \mathbb{1}\$)

- 7. Slowly lower the belt tension roller assembly [A], while you support the other end of the roller with your other hand [B] under the ITB unit.
- 8. Remove the tension roller assembly [C] and tension roller.

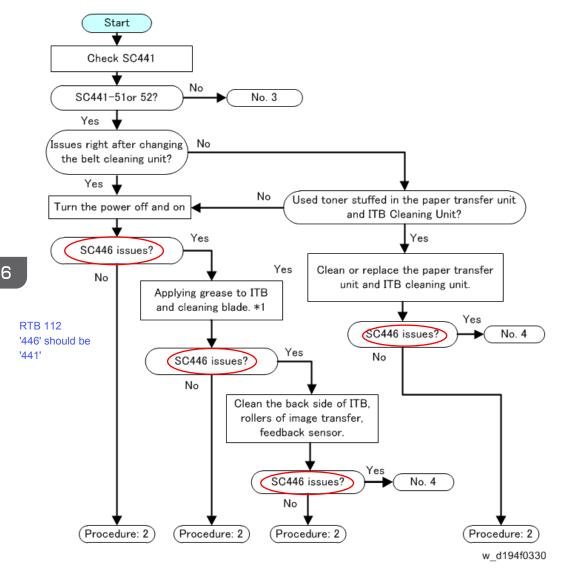
SC441: ITB Drive Motor Error Measure Flow

Procedure: 1

^{*1} For applying grease, refer to the main chapter (Chapter 4: Replacement and Adjustment).

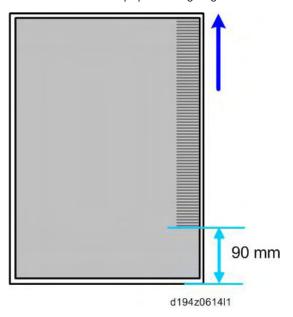
Horizontal Black Streaks (Image Edge)

Uneven density occurs at 11mm interval on the right edge in the paper feed direction. It does not occur within 90mm from the paper trailing edge.

If the rotation speed of the paper transfer roller is faster than the rotation speed of the transfer timing roller, paper is pulled between the both rollers. This causes uneven density because a sheet of paper is in contact and non-contact with the intermediate transfer belt at the nip of the paper transfer rollers.

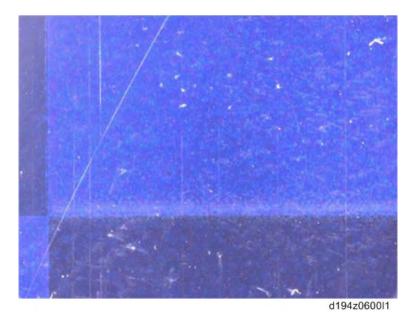
Whiter at the Trailing Edge

When looking through the transparent film, horizontal white streaks of about 1mm appear at the trailing edge of the white toner layer on the image in which white toner and CMYK toner overlap.

White toner tends to gather at the 1 mm width from the trailing edge of the white toner layer. As a result, 1 mm width from the trailing edge of the white toner layer appears as a white streak due to the insufficient fusing.

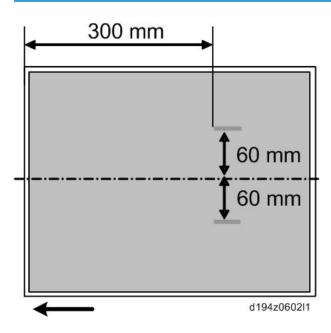
Vertical Black Streaks

The line speed of the feed belt is faster than the line speed of the fuser unit. This results in bending of paper at the fusing entrance and then cause the toner scattering in an unfixed image on a paper surface due to the frictional charging between the PTB unit and a sheet of paper.

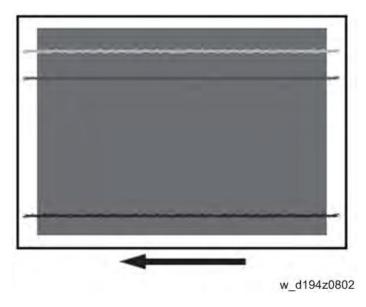
Vertical Black (color) Streaks (2)

Extended, blurred colored streaks parallel to the paper feed direction appear. The streaks also appear randomly in the margins.

If the temperature or humidity is low, remaining toner might be missed by the cleaning blade of the ITB cleaning unit or paper transfer unit, causing streaks to appear sporadically.

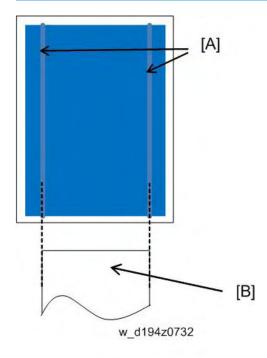
Glossy Lines at the Edge of the Paper

[A]: Glossy Streaks

[B]: A sheet of paper which is previously fed through and causes scratching on the fuser belt

In some cases, burrs on the sheet edge of paper cause the fuser belt surface to become scratched horizontally in the paper feed direction. These scratching areas cause the glossy streaks for solid images or density difference for halftone images.

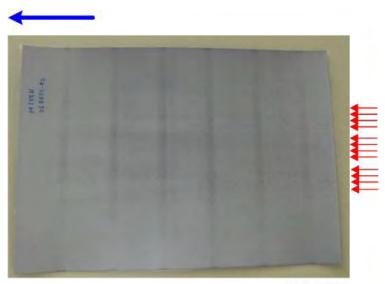
w_d194z0739

Vertical White Bands

When feeding 188 gsm transparent film from the Vacuum Feed LCIT, vertical streaks may occur for solid images.

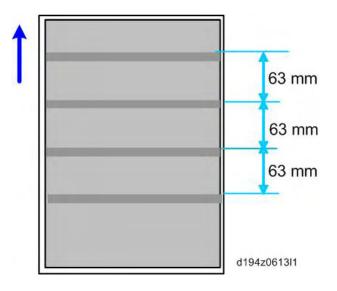
Banding (63 mm intervals)

Uneven density occurs at 63 mm interval.

If the rotation speed of the paper transfer roller is faster than the rotation speed of the transfer timing roller, paper is pulled between the both rollers. This causes uneven density because a sheet of paper is in contact and non-contact with the intermediate transfer belt at the nip of the paper transfer rollers.

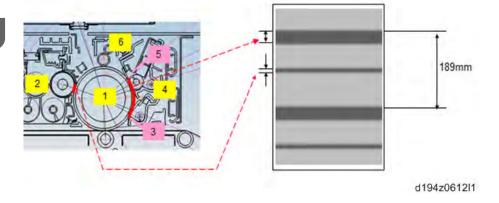
[1]: Drum	[4]: Drum Cleaning Unit
[2]: Development Unit	[5]: Lubrication Blade
[3]: Drum Cleaning Entrance Seal	[6]:Charge Unit

Uneven density occurs at the contact area where the opening of the development unit contacts the drum, and at the closed area where the drum cleaning unit contacts the drum.

When drastic environmental changes or prolonged disuse occurs after stopping the machine, moisture is absorbed only to areas contacting the development unit and drum cleaning unit on drum. This makes uniform charging of the drum impossible and causes uneven density.

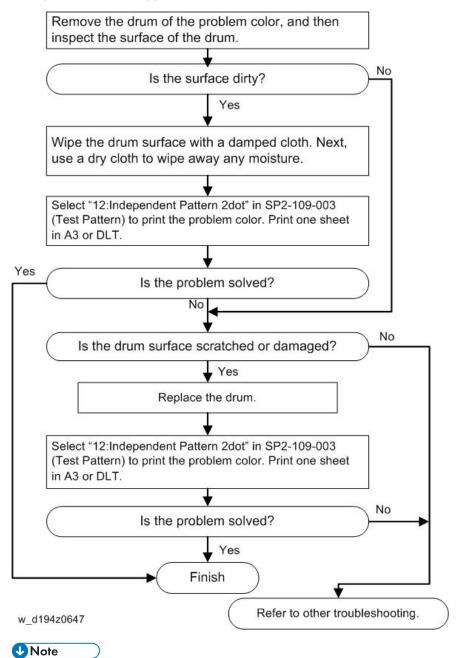
[A]: Spots Interval for Approx. 189mm

- Do not use ethanol or other organic solvents when wiping the drum. Using such solvents may damage the drum.
- Follow the specified procedures when attaching the drum to the machine after cleaning or replacement. Refer to the procedures in Chapter 4 "Replacement and Adjustment" of the field service manual.

- If black spots occur at 189mm interval, this problem is caused by a damaged or dirty drum.
- If black spots occur at 40mm interval, this problem is caused by a damaged or dirty charge roller.

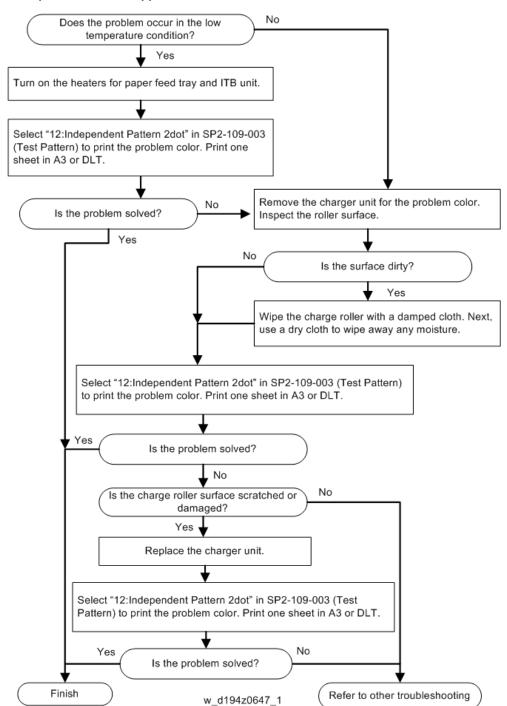
[B]: Spots Interval for Approx. 40mm

- For the replacement procedures of the charge roller or charger unit, refer to Chapter 4 "Replacement and Adjustment" in the field service manual.
- Do not use ethanol or other organic solvents when wiping the charge roller. Using such solvents may damage the roller.

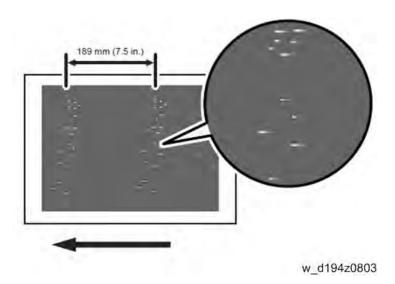
Medaka (White Spots)

White sports or short streaks occur at 189 mm interval in the paper feed direction.

Dirty drum (photoconductor unit)

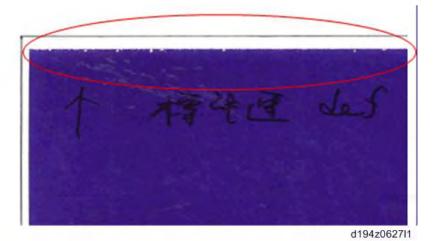
Patchy Image at the Leading Edge

Unprinted areas like worm holes appear in the leading edge of the image.

When the shock jitter canceller widens the gap between the paper transfer roller and the ITB, discharge occurs at the paper leading edge.

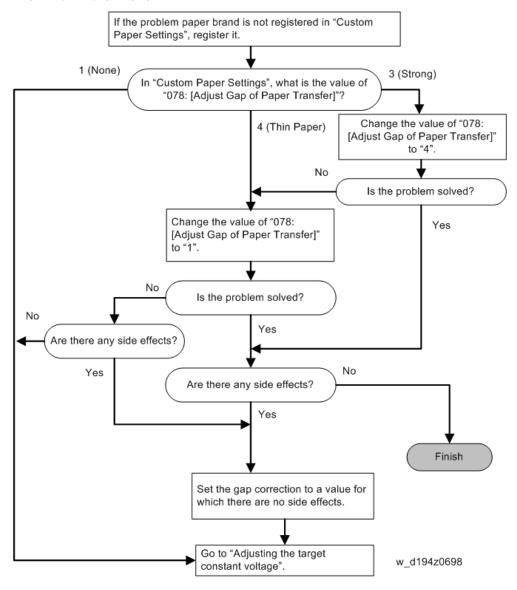
Adjusting the gap of paper transfer

- This measure only works when the thickness of the paper is equivalent to paper weight 4 or higher.
 Do not try this as a measure when using paper with a thickness equivalent to paper weight 3 or lower, as it may cause paper misfeeding.
- Execute commands in the following order: "Adjusting the gap of paper transfer" → "Adjusting the target constant voltage".

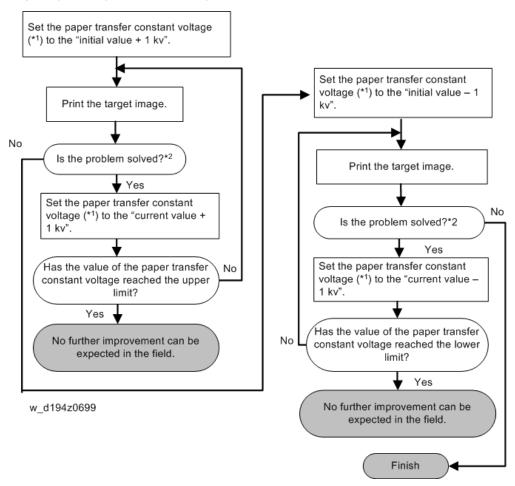
Adjusting the target constant voltage

* 1 Settings to adjust for the paper transfer constant voltage

*2 Excessive increase or decrease of the paper transfer constant voltage may increase the unprinted area on the leading edge. In such cases, gradually return toward the original value by steps of 0.5kV and adjust to a value which does not cause increased unprinted area.

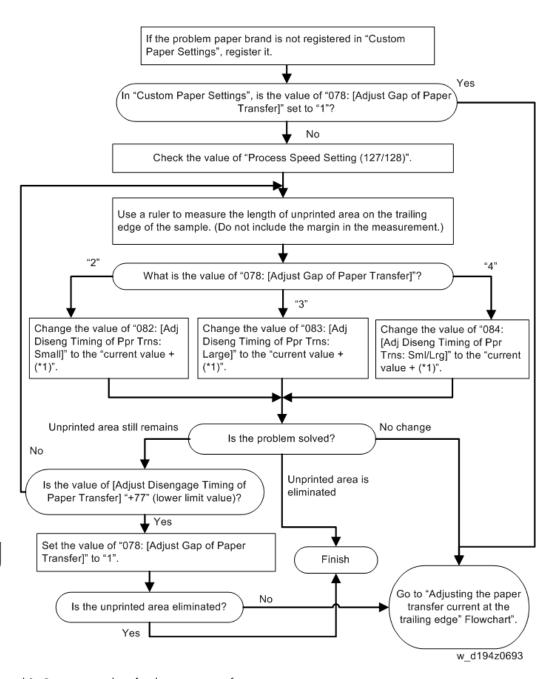
Adjusting the disengage timing of paper transfer

As a side effect, shock jitter may increase when the paper is disengaged.

* 1: Correction values for the paper transfer

Set the setting of Adjust Disengage Timing of Paper Transfer (No.83/ No.84/ No.85)" to the lower limit if the setting value of these is below the lower limit (+77) after this calculation (current value + each correction value shown above).

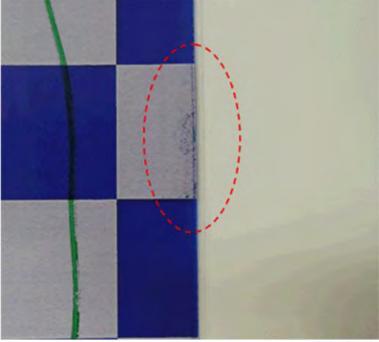
d194z0630I1

Unprinted: When Using a Transparent Film

White spots appear at the trailing edge when printing on a transparent film.

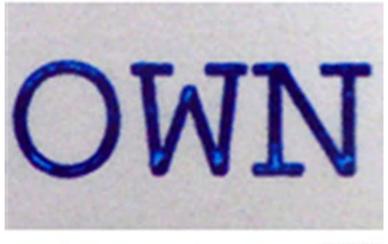
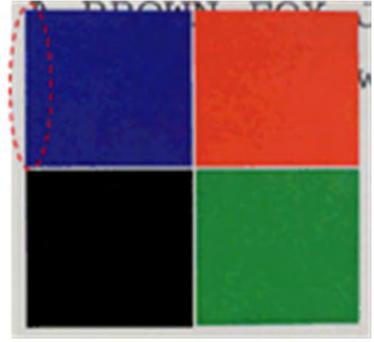
Worm Holes: Text or Edge of an Image

Dropouts (character voids) occur when characters or lines are printed in color mode.

This problem occurs when pressure during transfer causes toner to contract at color texts where toner deposits partially increase, or at the edge of solid images.

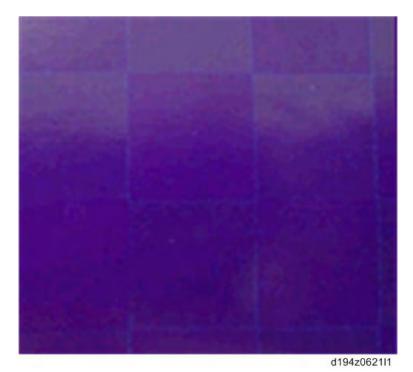
Worm Holes: When Using the Clear Toner

When printing using the clear toner, patchy images appear where the clear toner overlaps.

When superposing toner, the pressure during transfer causes toner to contract, thus causing worm holes.

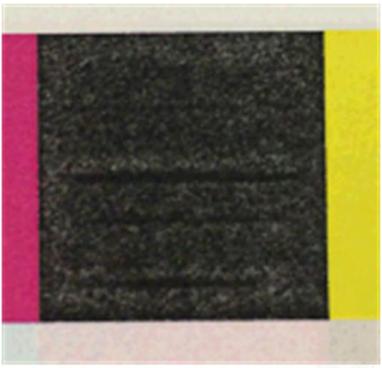
d194z0610l1

Low Image Density of Black Area

Compared to color toner, Bk toner has a lower transfer charge. Therefore, low image density is caused by excessive transfer at the PTR unit.

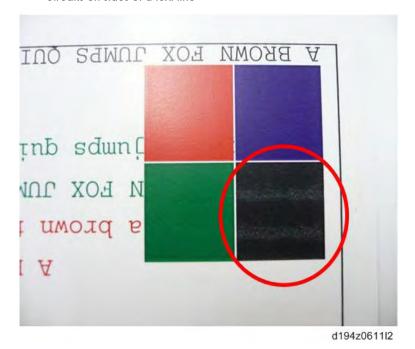
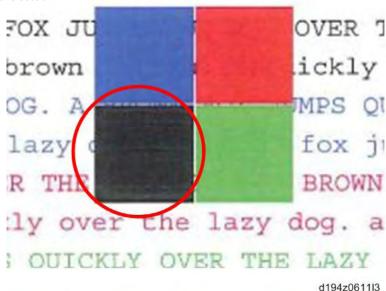
The following unexpected images occur when printing a Bk image area in the FC mode.

- Low image density on a entire page
- · Low density on sides of a text line
- Streaks on sides of a text line

The paper transfer rate of low-charged Bk toner is often decreased due to excessive paper transfer bias in FC mode because the paper transfer bias in the FC mode is higher than the paper transfer bias in the BW mode. In particular, if a text line in the main scanning direction is located close to the edge of Bk solid images, the density of a Bk solid image area often becomes lower along the text.

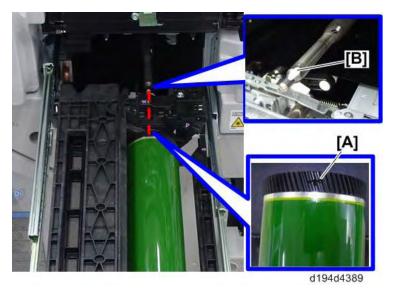
- Execute [DEMS] in "0201 [Adjust Image Density/DEMS]" (SP3-040-001), and then check
 the output image.
- 2. Align the drum shaft * 1.
- 3. Execute [DEMS] again, and then check the output image.
 - * 1: Align the direction of the white marking position [B] on the drum shaft with the notch mark [A] on the top of the drum gear.

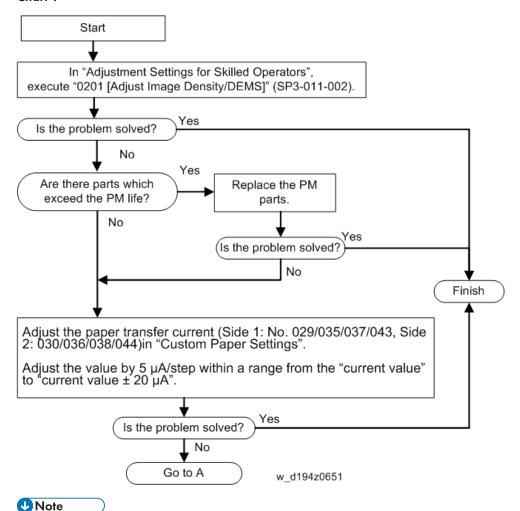
Chart 1

When using clear toner, the mottled effect can be improved by applying another layer of clear
toner to the mottled area. However, a larger M/A (mass per unit area) of clear toner results in
more glossiness, and then causes color tone changing.

Adjustments of Paper Transfer Current may cause the following side effects.
 Decreasing the paper transfer current (ex: -82ua → -92uA): White spots is getting worse in the low temperature and low humidity condition or Bk image in the full color mode is getting lighter in the high temperature and high humidity condition.

Increasing the paper transfer current (ex: $-82ua \rightarrow -72uA$): Mottled effect is getting worse in the low temperature and low humidity condition.

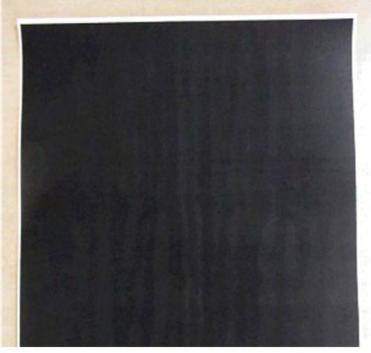
d194z0609l1

Worm Track

River marks are caused when an image on paper touches the fuser belt due to waves of the transparent film at the entrance or exit of the fusing nip.

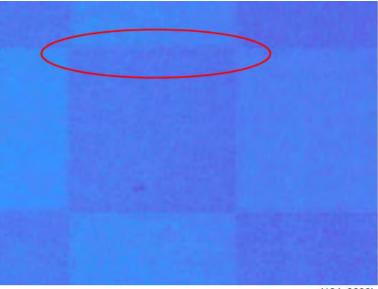
d194z0606l

Blurred Image: Around a Clear Image

Blurring occurs around a clear image.

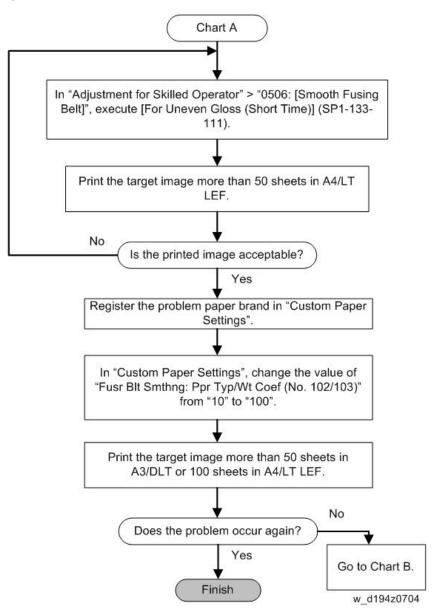
Chart A

"Chart B" is greater effective for the improvement and it is also the permanent measure. However, productivity is decreased. Use either "Chart A" or "Chart B" depending on a customer's demand.

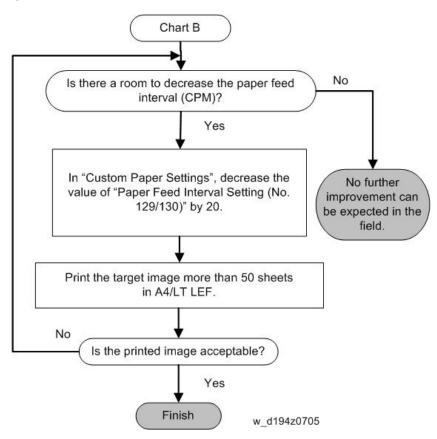
Chart B

If [Fusr Blt Smthng: Ppr Typ/Wt Coef] (No.102/103) is set to "100", the belt smoothing interval function becomes shorter (See table below as A4/LT LEF.)

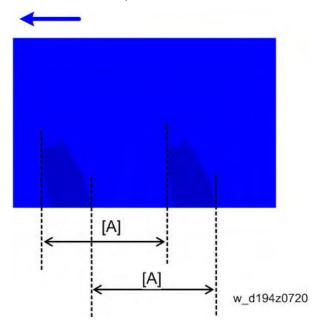
Wax or other substance adhering to certain spots of the fuser belt causes an increase in the rotation amount of wax at the point of adherence. This results in localized uneven gloss.

[A]: One round of the fuser belt (approx. 251mm)

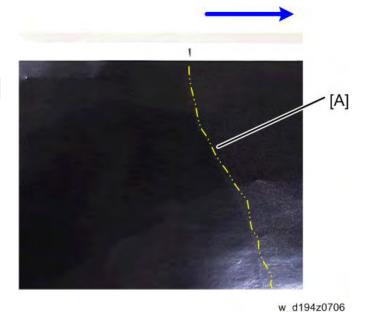
Uneven gloss waves sometimes occur on the 1st side of paper when printing on thin coated paper in the duplex mode.

[A]: Uneven gloss occurs from the line shown above.

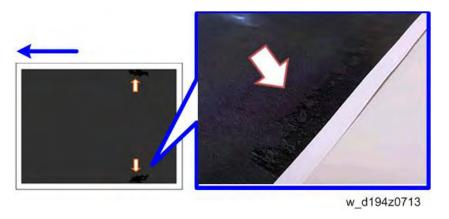
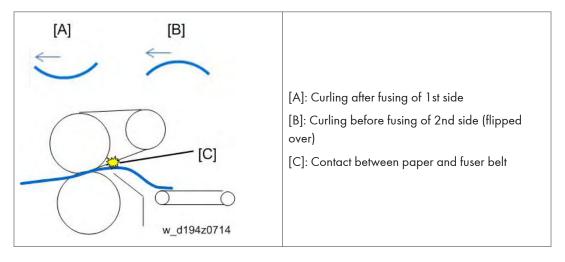
During fusing of the 2nd side for duplex printing, when paper enters the fusing nip, the paper rises up slightly due to curling *1 which occurred during feeding of the 1st side. This causes the paper trailing edge to contact the fuser belt and results in uneven gloss.

*1 In the case of paper for which face curling occurred during fusing of the 1st side, a back curl occurs when the backside of the paper is flipped over for duplex printing. The paper enters the fuser unit with this back curl.

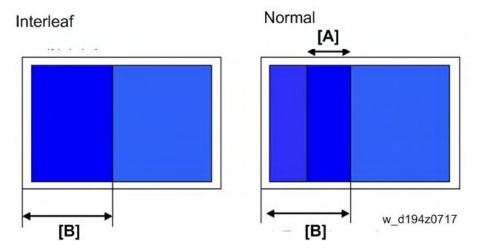
1st side of image during duplex printing

The re-melt temperature of toner for the 1st side of the image is differs at one round (204mm) of the pressure roller and at subsequent areas. Therefore, uneven gloss occurs at 204mm within the image leading edge and at other areas of the image.

[A]: Pressure roller for interleaf (high temperatures result in a particularly high level of glossiness)

[B]: High level of glossiness at one round (204mm) of the pressure roller

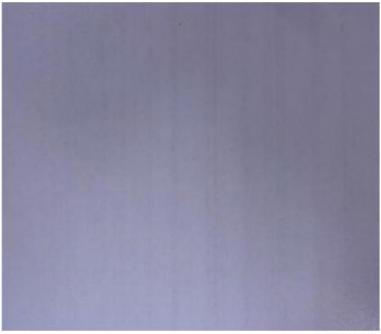
d194z0619I1

The charging of developer decreases, thus causing toner residue like streaks or scattered dots on the background.

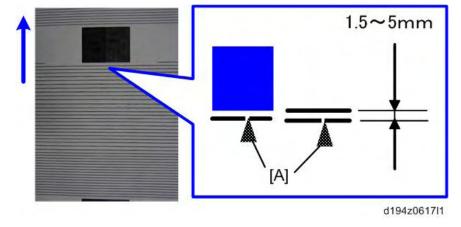
Toner scattering occurs for a portion of lines.

This may occur in a line that is 5 mm or less from the leading edge, or in a line that is 1.5 to 5 mm from the trailing edge of an image.

[A]: Toner Scattering

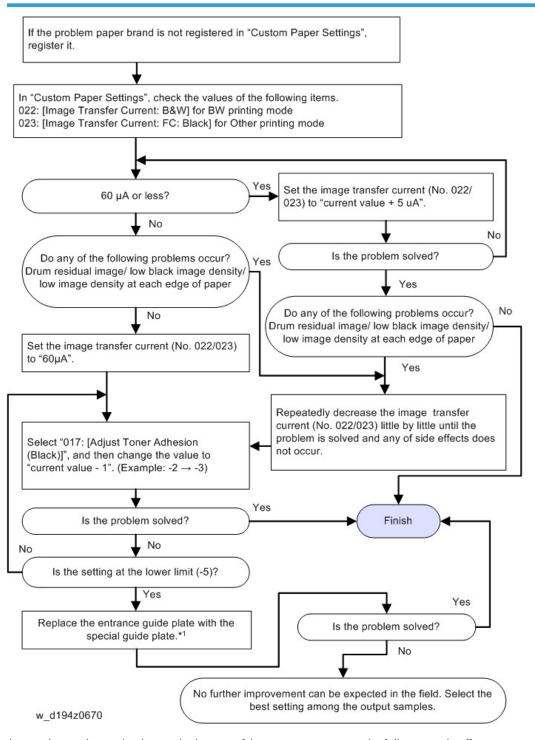
^{* 1:} Replacing the guide plate at the bottom of the ITB unit may cause the following side effects.

- High image density within approx. 10mm of the paper trailing edge
- Scattering for a portion of lines or letters (See page 940 "Toner Scattering: Trailing Edge")

For details about replacing the guide plate [A], refer to the Field Service Manual ("Transfer Belt Removal" under "Intermediate Transfer Belt Replacement" in the chapter "Replacement and Adjustment").

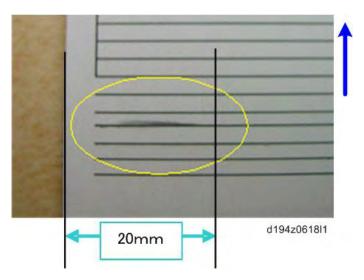
Toner Scattering: Trailing Edge

Toner scattering occurs for a portion of lines or letters. This may occur in a line or letters that is 8 to 13 mm (0.3" to 0.5") from the trailing edge, and 20 mm (0.8") or less from the left edge in the paper feed direction.

A shock occurs when the trailing edge of the paper leaves the paper transport guide during the paper transfer, and then causes toner scattering.

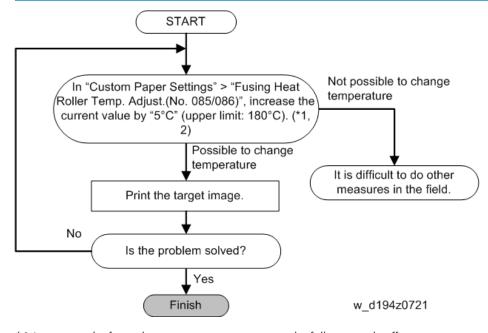
Solution (Adjusting the fusing temperature)

- * 1 Increasing the fusing heat temperature may cause the following side effects.
 - Increased curling (causes jamming).
 - Increased glossy streaks.

- Bubble-shaped white spots on coated paper.
- Decreased glossiness.
- *2 If side effects occur, set the temperature to a level (initial value to 180 deg) where side effects do not occur.

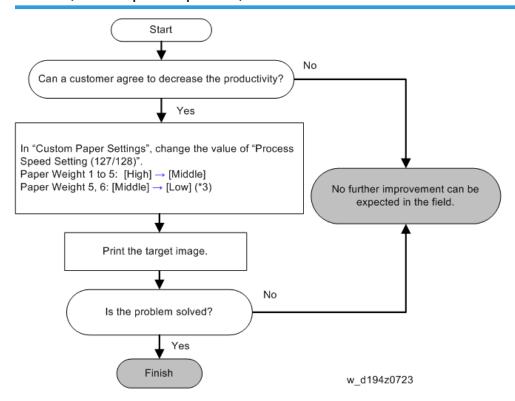
Solution (Process Speed Adjustment)

- *3: The productivity of the machine is decreased.
 - [High] (75 ppm) → [Middle] (52.5 ppm)
 - [Middle] (52.5 ppm) → [Low] (37.5 ppm)

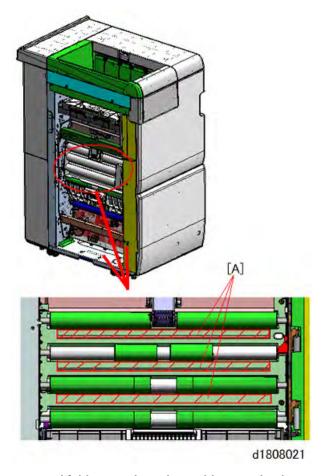
1. Open the guide plate and clean the metal plate at [A] with an alcohol dampened cloth.

- Cleaning the surface of the metal guide plate and buffing it with a piece of paper reduces the
 occurrence of marks on the paper.
- The present condition of the guide plate at the affected area depends on the amount of usage of
 the folding unit, but buffing the surface of the plate with paper 20 to 50 times should reduce friction
 during paper feed.

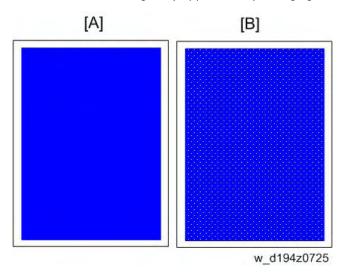
Unlike FC mode, the image may appear cloudy if image gloss is low in FCS (clear) mode.

[A]: Normal image

[B]: Cloudy image

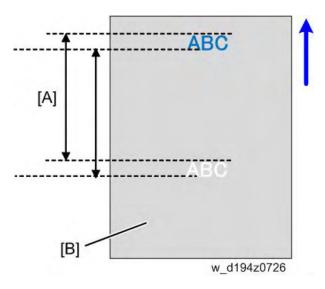
When the transparent film is exposed to a large amount of heat by the fixing nip, the transparent film surface is reformed and a very small amount of unevenness is transferred to the fuser belt surface. This creates a cloudy appearance.

Furthermore, when drag wax of the toner image for the fuser belt used 1 lap ago adheres to the cloudy area, this area is smoothed and becomes a transparent residual image.

[A]: A residual image occurs after the fuser belt circumference (approximately 251mm).

[B]: Clouding occurs for the entire blank surface.

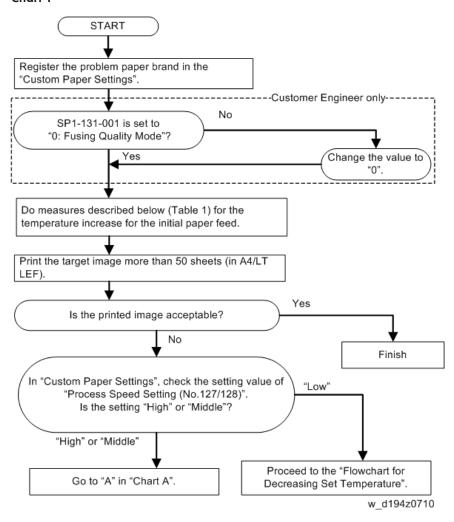
Chart 1

Table 1
Change all of the 5 setting items shown below.

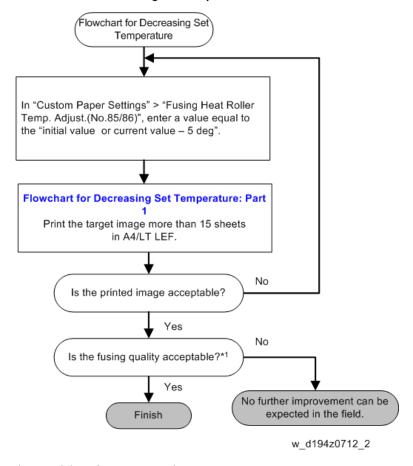
Flowchart for Decreasing Set Temperature

- * 1: Guidelines for Fusing Quality
 - No image peeling.
 - No toner peeling even when rubbing the image gently with fingernails.
 - No toner peeling even when rubbing the image with the optical cloth.

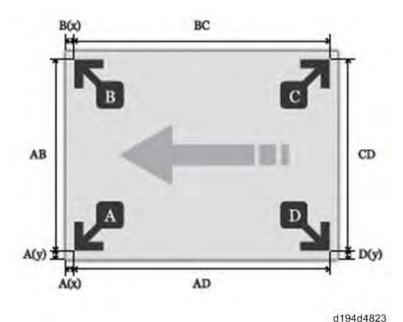
Use the same method to measure 16 points on side 1 and side 2 of the paper. Write the measured dimensions in the template.

AB: The length from the peak of one arrow to the peak of another arrow A(y/x): The length from the corner of the paper to the peak of the arrow

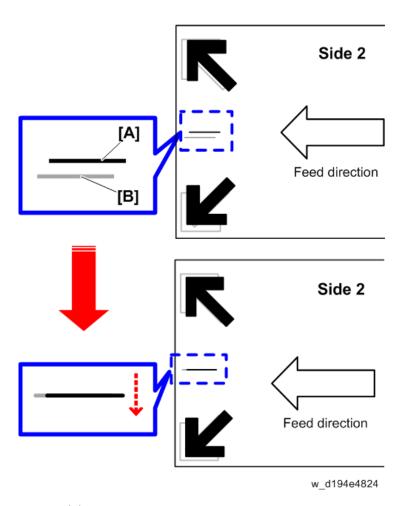
Adjust [Adj Image Position of Side 2 With Feed] so that the Side 2 center line [A] is aligned with the Side 1 center line [B].

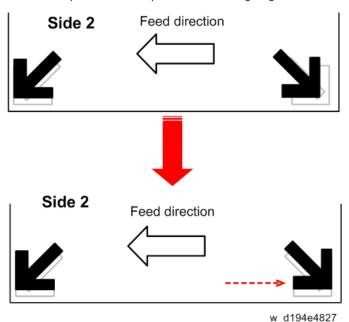
• The adjusted value is update to the trailing edge.

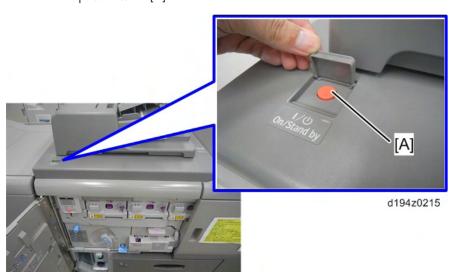
1. Turn the main power switch [A] OFF.

- 2. Insert the SD card into the Service Slot Board.
- 3. Turn the main power switch ON.
- 4. Log capture starts automatically.

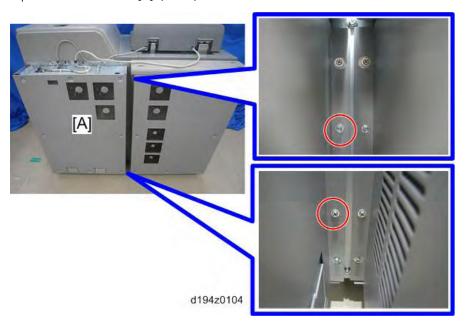
- 1. Confirm that the main power switch is OFF and the power cord is disconnected.
- 2. Open the controller box [A]. (@x2).

3. Connect the Debug Cable to the relay connector (on top of IOB) for capturing the Engine Debug Log.

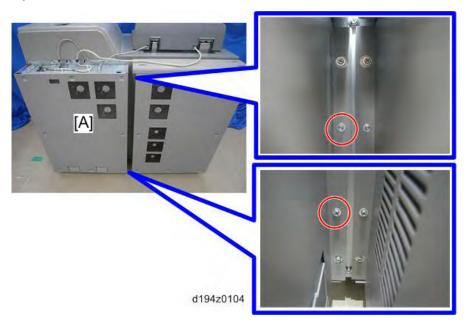
- 1. Confirm that the main power switch is OFF and the power cord is disconnected.
- 2. Open the controller box [A]. (\$\mathbb{O}^c x2).

- 3. Connect the Debug Cable to the CN383 on the TDCU.
- 4. Connect the other end of the Debug Cable to the PC via the serial cable or RC232C-USB conversion cable.

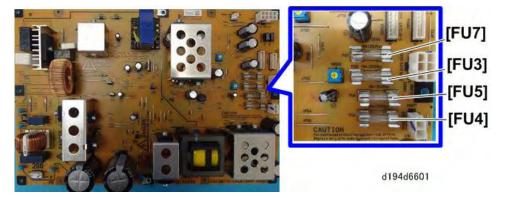
- PSU2 to PSU5 use the same type of fuse.
- PSU1 fuses cannot be replaced.

Fuse	Power To	Rating	If Fuse Blows at Power On
FU3	TDCU	250Vac 10A	SC202-01
FU4	IOB	250Vac 10A	SC685-02
FU5	None	250Vac 10A	-
FU7	None	250Vac 10A	-

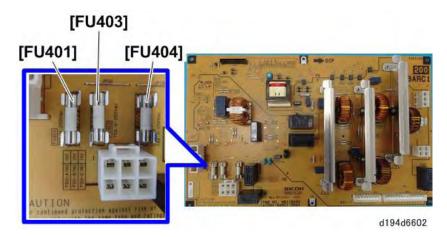
AC Drive

Fuse	Power To	Rating	If Fuse Blows at Power On
FU401	None	250Vac 5A	-
FU403	None	250Vac 5A	-
FU404	None	250Vac 8A	-
