Troubleshooting: TCRU

Model Name:

Pro C651EX/Pro C751EX/Pro C751

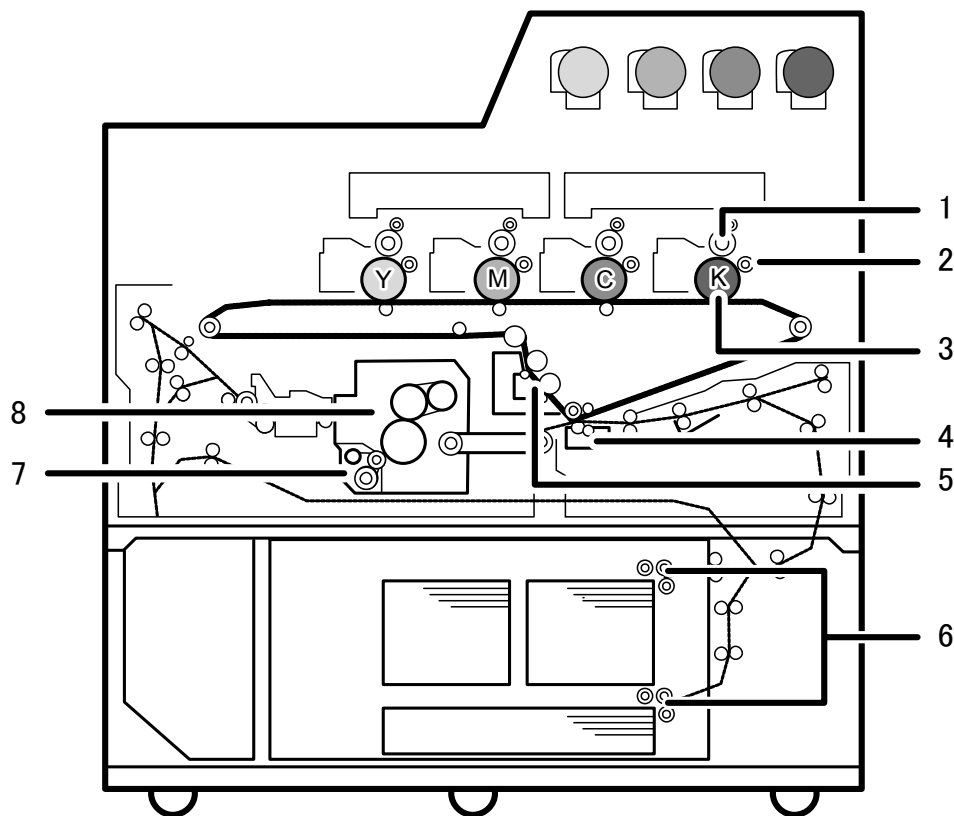
CEZ591

This section introduces the names of the components.

Refer to the following diagrams when replacing units or troubleshooting.

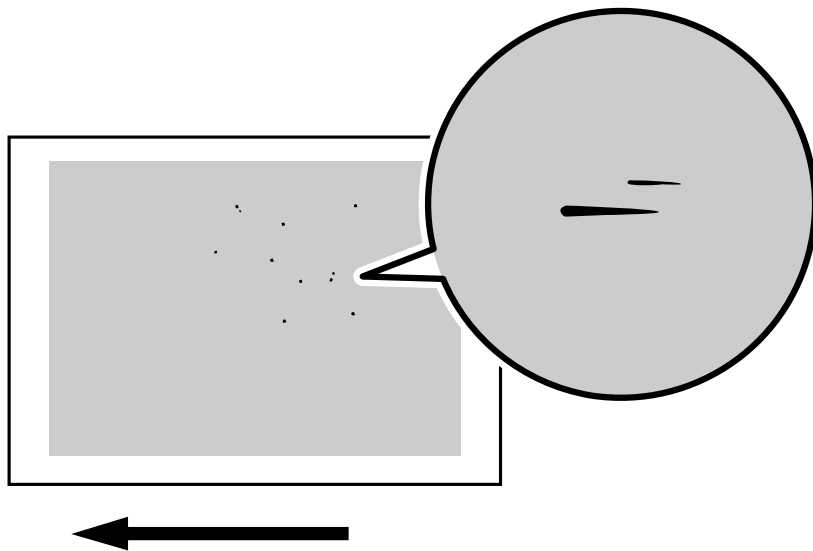
CEZ538

3.1.1 Paper Is Spotted with Toner

Paper is soiled with toner spots of 0.5–1 mm (0.02–0.04 inches) in diameter.

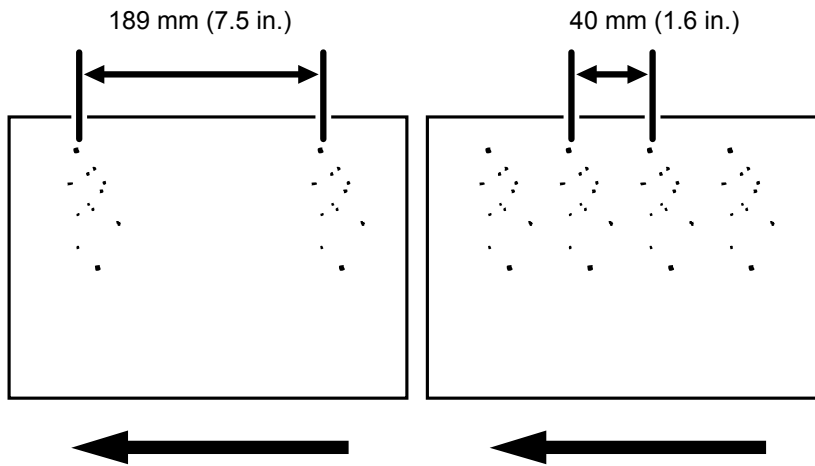
CEZ539

3.1.2 Colored Spots

Colored spots appear at 189 mm or 40 mm (7.5 inches or 1.6 inches) intervals.

- (a) Colored spots appear at 189 mm (7.5 inches) intervals
The drum unit is scratched or stained.
- (b) Colored spots appear at 40 mm (1.6 inches) intervals
The charge roller is scratched or stained.

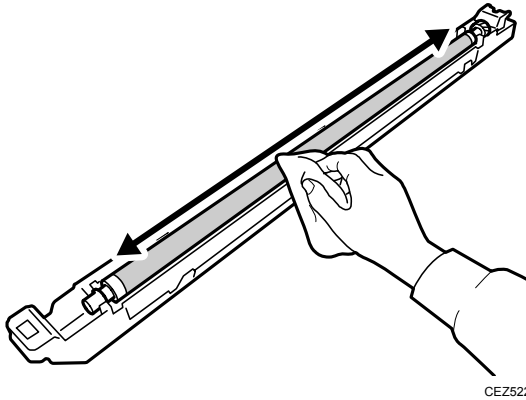
No Wipe the charge roller surface with a well-wrung-out damp cloth, wipe it with a dry rag until no moisture remains, and then reattach the roller.

- Do not use ethanol or any other organic solvent to clean the charge roller. Otherwise it may cause damage to the charge roller.

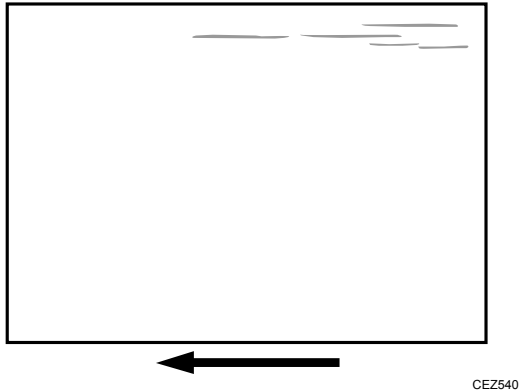
3.1.3 Colored Streaks (1)

Colored streaks parallel to the paper feed direction appear.

- The charge roller is stained.
- The cleaning unit for PCU has worn out.
- The drum unit surface is scratched.

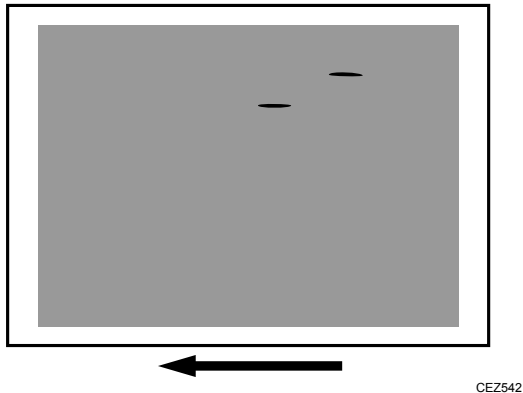
3.1.5 Colored Streaks (3)

Colored streaks appear in solid-filled areas.

If the toner contains small clumps, they disintegrate in the development unit, producing colored streaks.

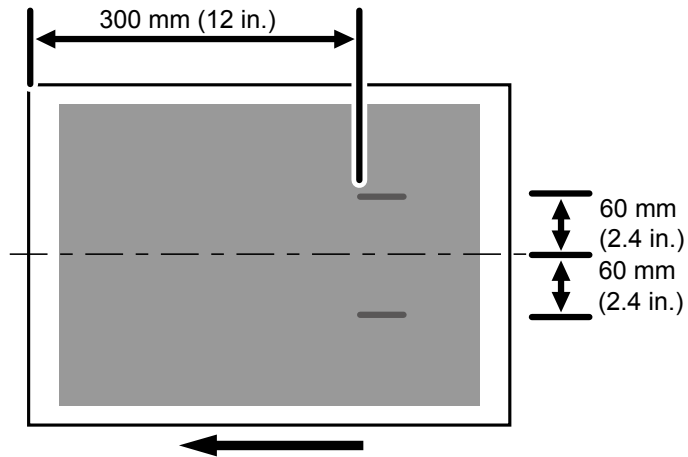
3.1.6 Black Streaks

Short black streaks appear on a black halftone image.

A sheet is bent at the entrance to the fusing unit and comes into contact with the edge of the paper delivery tank, where static electricity builds up on the sheet through friction. This causes scattering of unfixed toner on the paper surface.

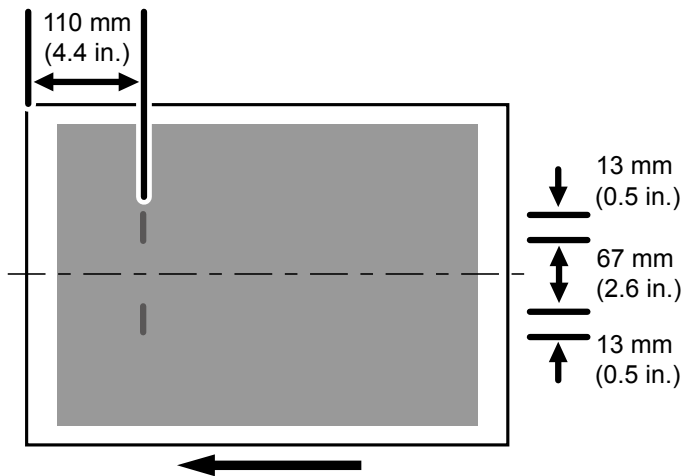
CNT005

3.1.7 Two 13-mm Long Vertical Streaks

Two 13-mm long vertical streaks appear within 110 mm (4.4 inches) from the leading edge.

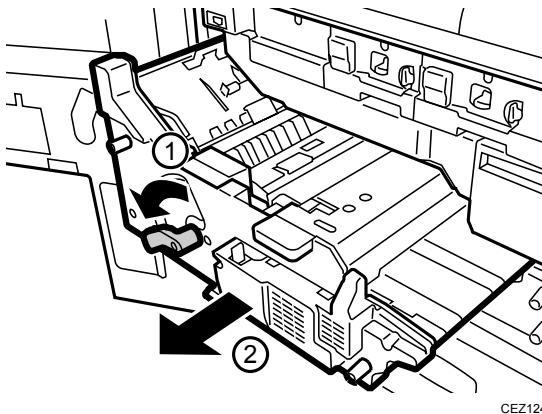
CEZ124

1. Make sure that the system is turned off and the machine power cord is disconnected from the power source.
2. Open the left and right front covers.
3. Lower the lever C1, and then pull the left drawer out completely until it stops.

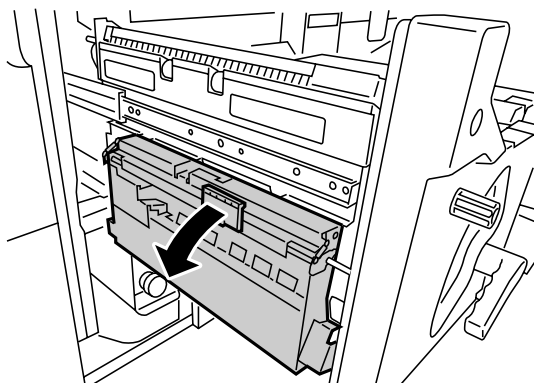
CEZ255

4. Pull down and open the cover D5.

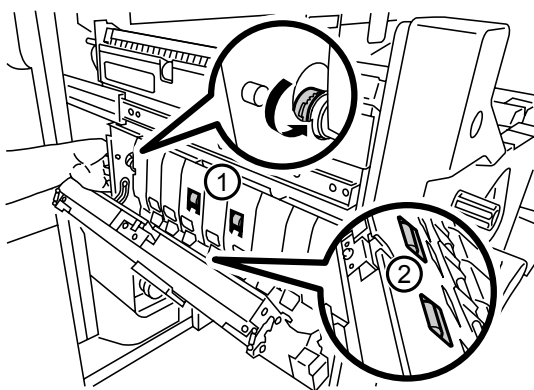
CEZ258

5. Turn the gear in the back while using a slightly damp cloth on:

(1) Invert exit drive rollers 1 (as you rotate the gear)

(2) Invert exit idle rollers 2

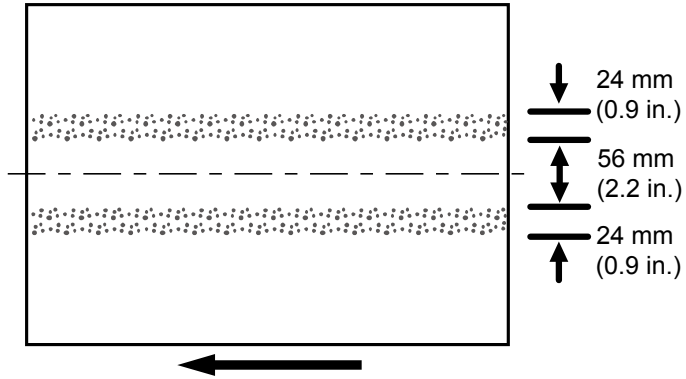
3.1.8 Two 24-mm Wide Streaks

Two 24-mm wide streaks parallel to the paper feed direction appear.

The exit drive rollers, exit idle rollers, exit relay drive rollers, or exit relay idle rollers in the machine's left drawer are soiled.

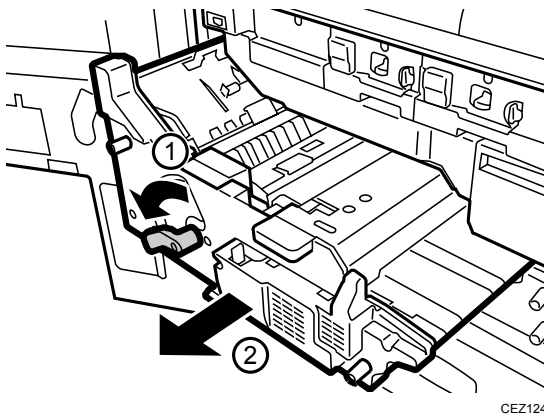
1. Make sure that the system is turned off and the machine power cord is disconnected from the power source.
2. Open the left and right front covers.
3. Lower the lever C1, and then pull the left drawer out completely until it stops.

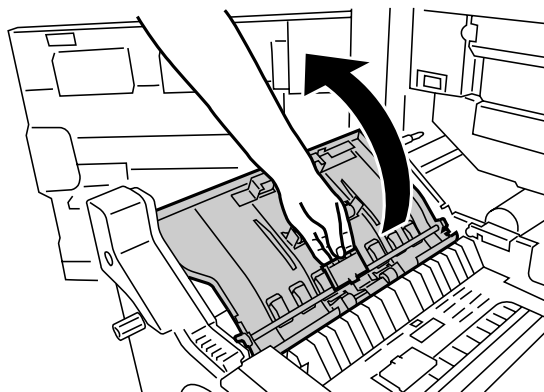
CEZ249

4. Pull up and open the cover D4.

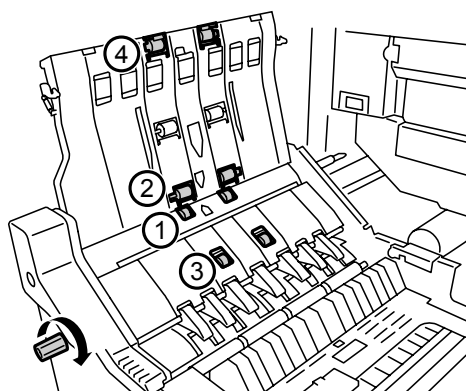
CNT015

5. Turn the knob D1 while using a slightly damp cloth on:

- (1) Exit drive rollers
- (2) Exit idle rollers
- (3) Exit relay drive rollers
- (4) Exit relay idle rollers

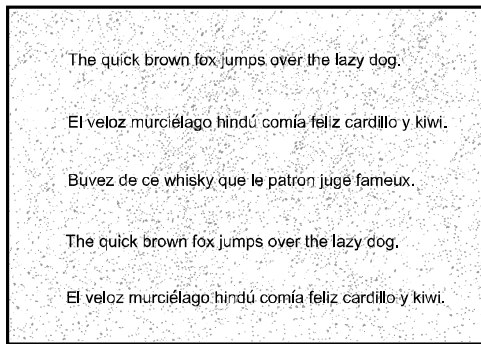
CEZ543

Completely stained background

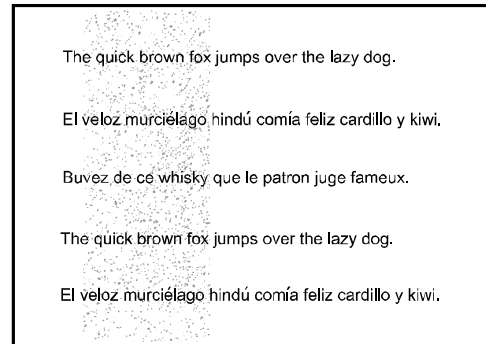
CEZ544

Partially stained background

This may occur because of wearing of the developer and drum unit or staining of the charge roller.

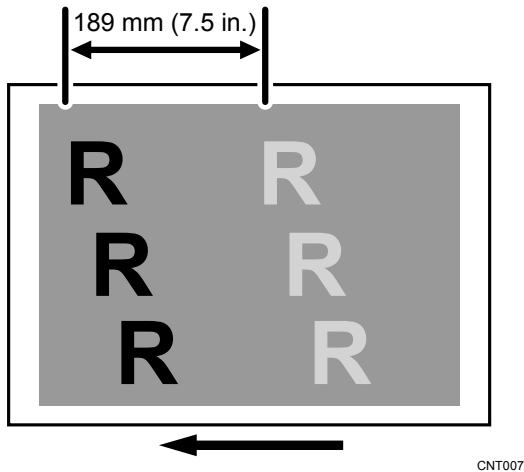
3.1.11 Ghosting

A ghost image of an image to be printed appears at a distance of 189 mm (7.5 inches) to the side of the intended image.

The image transfer current is transmitted to the drum, where a potential difference occurs between a developed area and non-developed area and causes the intended image to be reproduced.

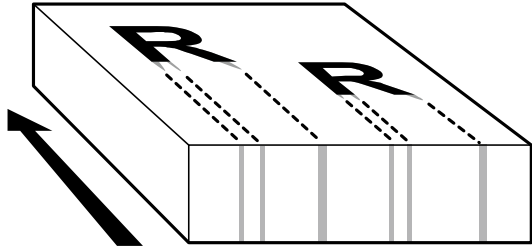
CNT008

3.1.12 Scratched Images and Stained Paper Edges

Scratched images or soiled paper edges appear.

When a relatively stiff, thick paper is delivered, the entrance guide plate for the transfer unit is warped toward the intermediate transfer belt due to the stiffness of the paper. The edge of the entrance guide plate comes into contact with the toner on the belt to cause images to be scratched and paper edges to be soiled.

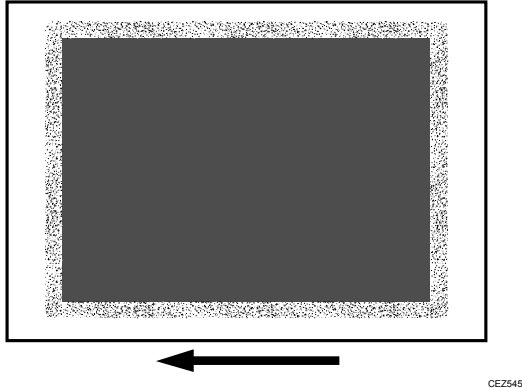
3.2.1 Toner Scatter (1)

Toner is scattered around a solid-fill print.

This may occur if printed at low temperature or humidity.

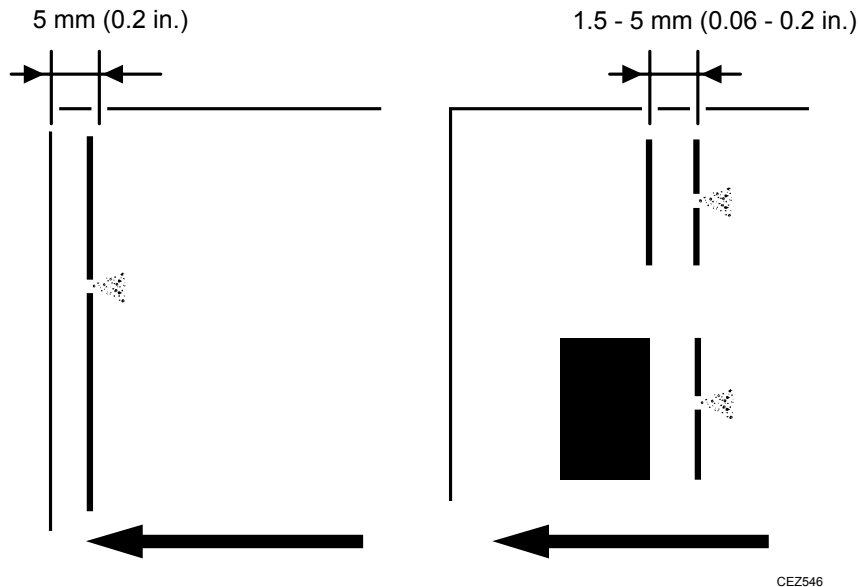
3.2.2 Toner Scatter (2)

Parts of a line exhibit splatter. This may occur in a line that is 5 mm (0.2 inches) or less from the leading edge, or in a line that is 1.5 to 5 mm (0.06 to 0.2 inches) from an image on the side of the image facing the trailing edge.

This may occur when printing lines on coated or other slippery paper.

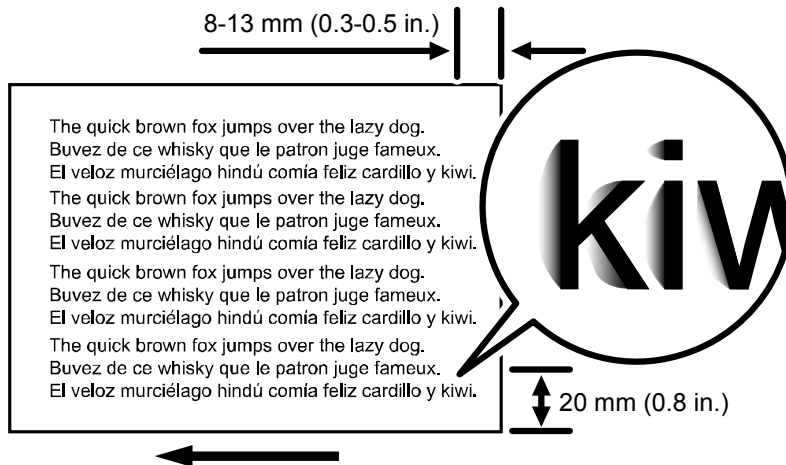
CNT009

3.2.3 Toner Scatter (3)

Parts of a line or character exhibit splatter. This may occur in a line or character that is 8 to 13 mm (0.3 to 0.5 inches) from the trailing edge and 20 mm (0.8 inches) or less from the left edge facing the paper feed direction.

A shock jitter occurs when the trailing edge of the paper leaves the paper guide during paper transfer and causes toner scattering.

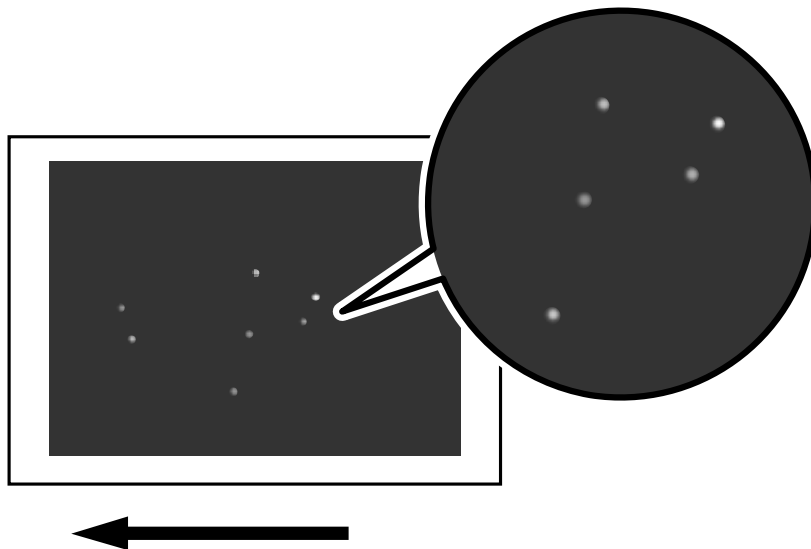
CEZ547

3.3.1 Colorless Spots

Colorless spots appear in solid-filled areas.

If the toner contains small clots, they fail to be transferred, producing colorless spots.

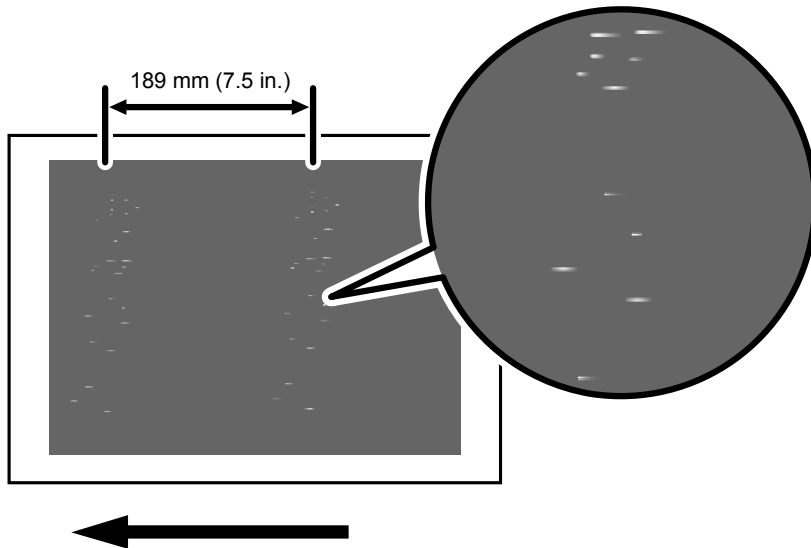
CEZ548

3.3.2 White Dots/Lines

White dots or short lines appear, spaced at intervals of 189 mm (7.5 inches) in the direction of the paper feed.

Cause: The drum unit is stained.

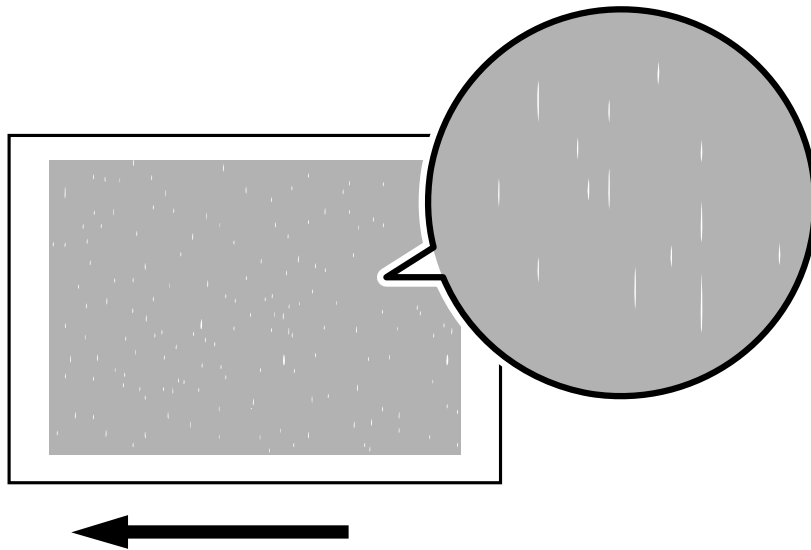
CEZ604

3.3.3 Vertical White Streaks

White streaks of 1 to 8 mm (0.04 to 0.3 inches) long and perpendicular to the paper feed direction appear.

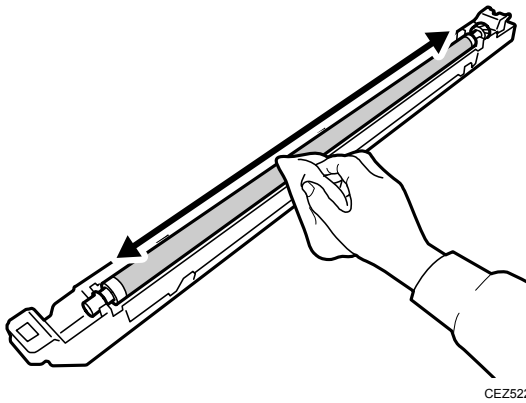
CEZ522

1. To identify the affected color, print three full-page, halftone A3 or DLT sheets for each of cyan, magenta, yellow, and black.
2. Detach the charge roller of the affected color, wipe its surface with a well-wrung-out damp cloth, wipe it with a dry cloth until no moisture remains, and then reattach the roller.

Do not use ethanol or any other organic solvent to clean the charge roller. Otherwise it may cause damage to the charge roller.

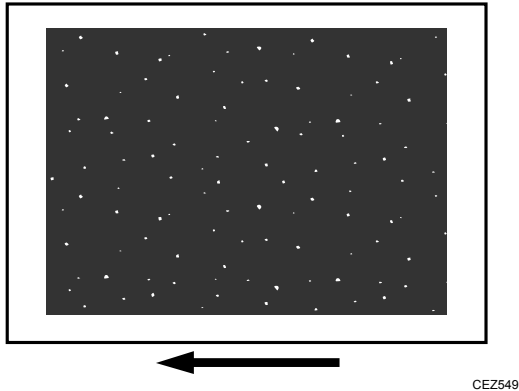
3.3.4 White Spots

White spots of 0.2–0.3 mm (0.008–0.01 inches) in diameter appear.

This may occur if printed at low temperature or humidity.

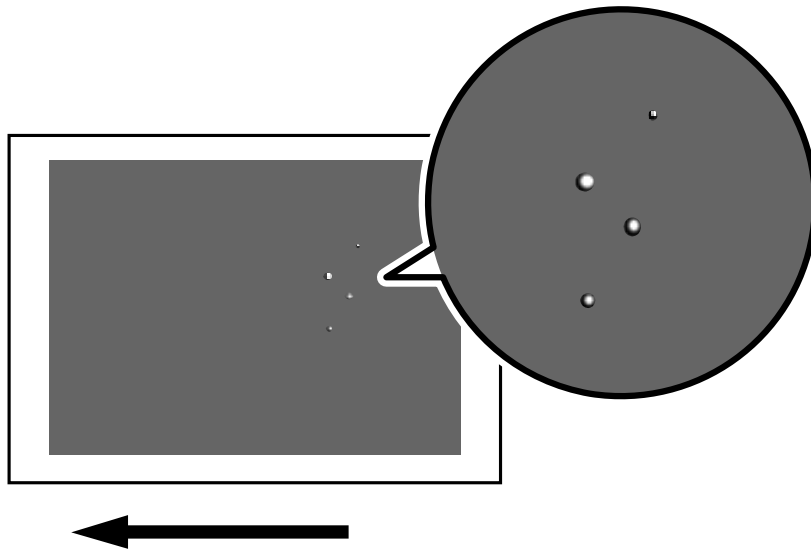
CEZ602

3.3.5 Blister-like White Spots

White spots 0.3–0.5 mm (0.01–0.02 inches) in diameter surrounded by denser spots (blister-like white spots) appear.

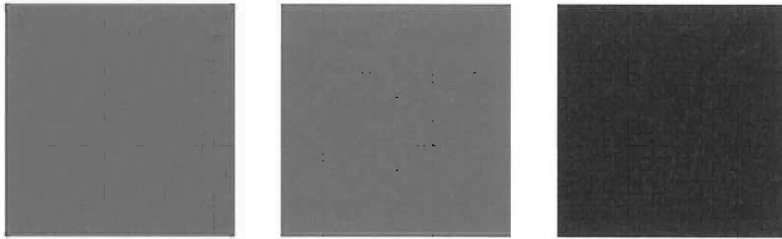
Normal

Mottling occurs in solid-filled areas.

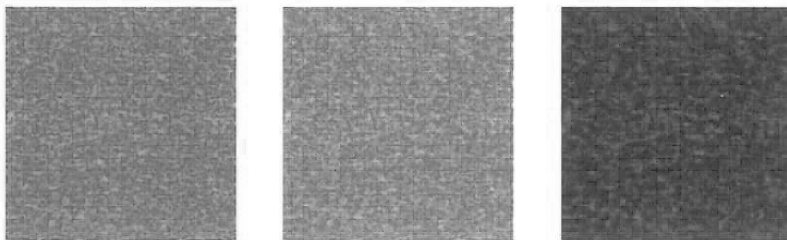
Mottled

- Using paper with a rough surface
- Continuously printing solid fills covering small areas
- Printing in a low humidity environment
- Printing in a high humidity environment

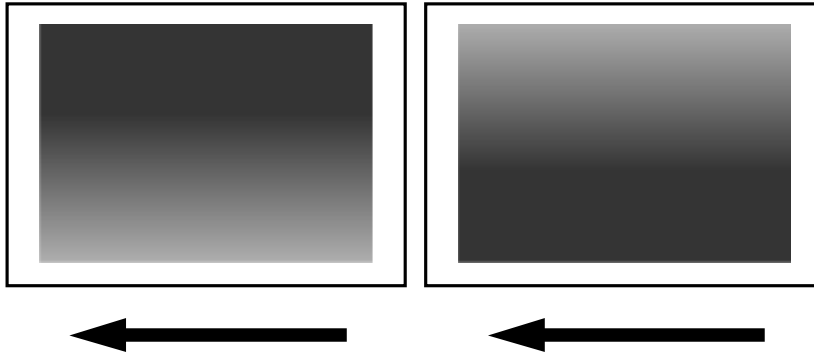
CEZ561

3.4.2 Uneven Density from Top to Bottom

The density is uneven from top to bottom.

This may occur at high temperature or humidity.

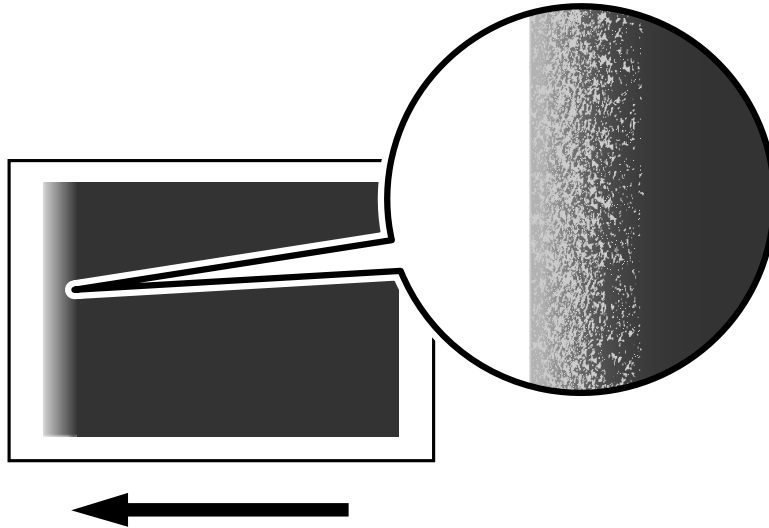
CEZ562

3.4.3 Fainter Leading Edge

The leading edge is fainter.

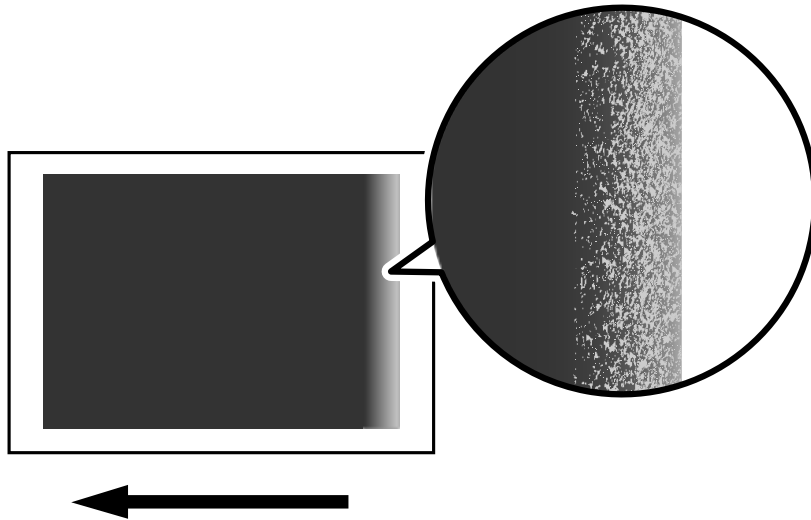
CEZ563

3.4.4 Fainter Trailing Edge

The trailing edge is fainter.

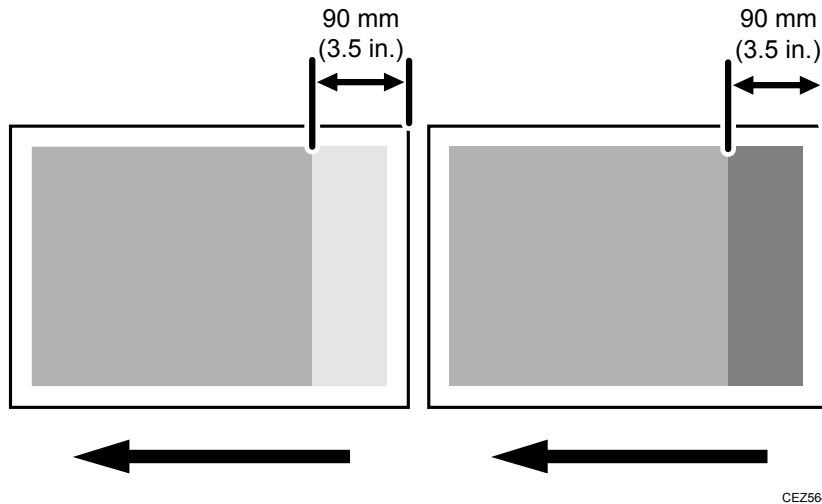
3.4.5 Uneven Density within 90 mm (3.5 in.) of the Trailing Edge

Printing in the area extending approximately 90 mm (3.5 inches) from the trailing edge is fainter or denser when the temperature or humidity is low.

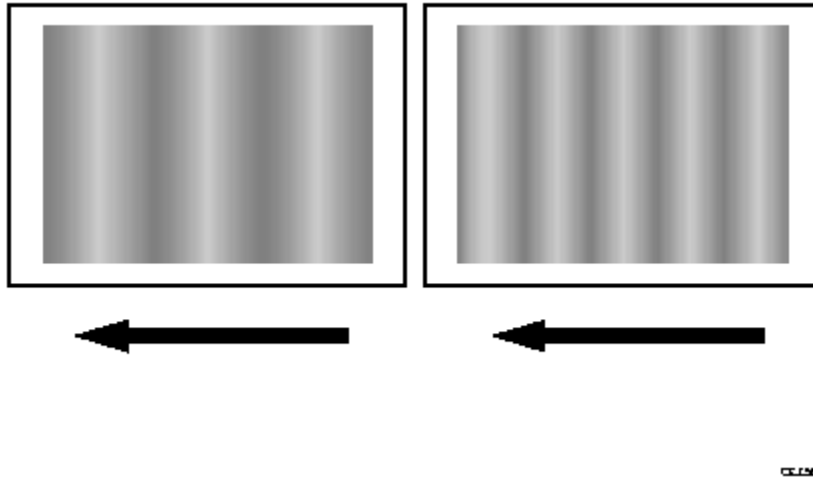
3.4.6 Periodic Density Fluctuation (1)

The vertical density fluctuates periodically.

Interval	Solution
Approximately 12-18 mm (0.5-0.7 inches)	Contact your service representative.
Approximately 50 mm (2 inches)	<u>Replace the charge roller.</u> If the problem persists, contact your service representative.
Approximately 60 mm (2.4 inches)	<u>Replace the transfer unit.</u> If the problem persists, contact your service representative.
Approximately 95 mm (3.7 inches)	Contact your service representative.
Approximately 190 mm (7.5 inches)	<u>Replace the drum unit.</u> If the problem persists, contact your service representative.

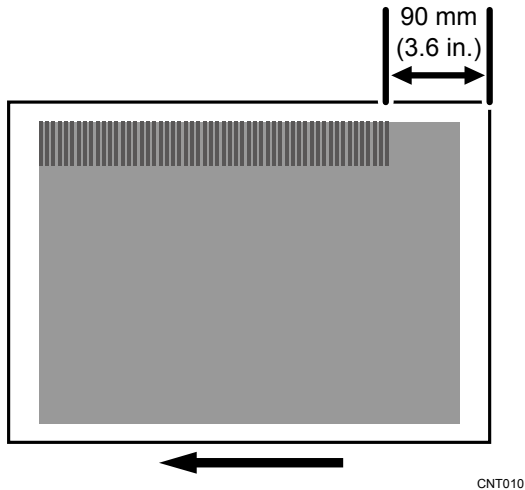
3.4.7 Periodic Density Fluctuation (2)

The vertical column density fluctuates at 11 mm (0.4 inches) intervals on the right edge perpendicular to the paper feed direction. This fluctuation does not occur in the area that is 90 mm (3.6 inches) or less from the trailing edge.

The speed of the transfer timing roller is less than that of paper transfer.

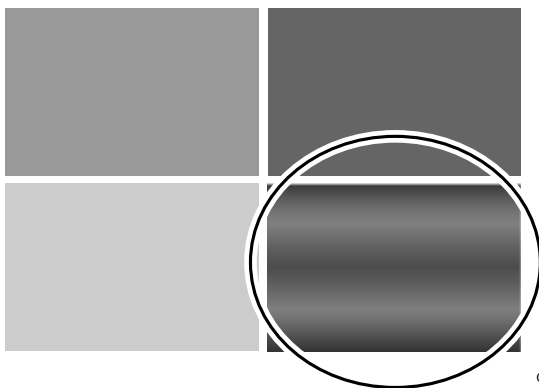
CEZ584

Black is fainter than normal during full color printing.

Black is fainter

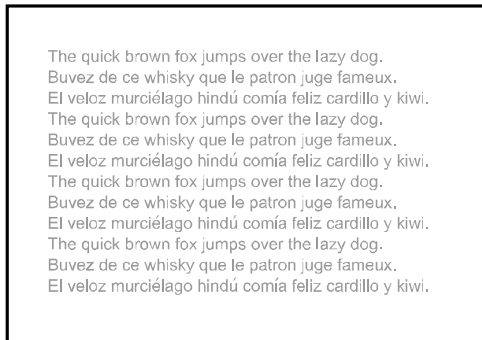
CEZ585

3.4.9 Color (2): Entire Image Faint

The entire image is fainter than normal.

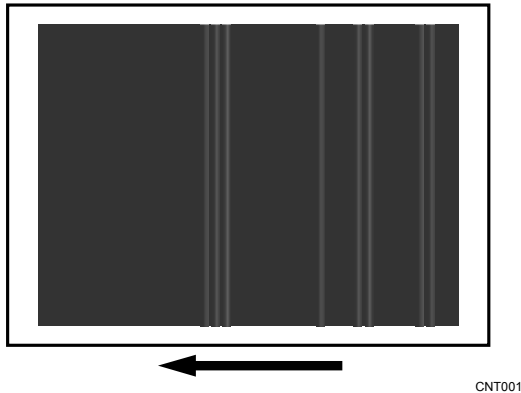
3.4.10 Color (3): Faded Vertical Streaks During Full Color Printing

Faded vertical streaks may appear during full color printing.

- Printing is done at low temperature or humidity
- Coated paper or paper that produces high paper-to-paper friction is used
- Printing is done in full color mode

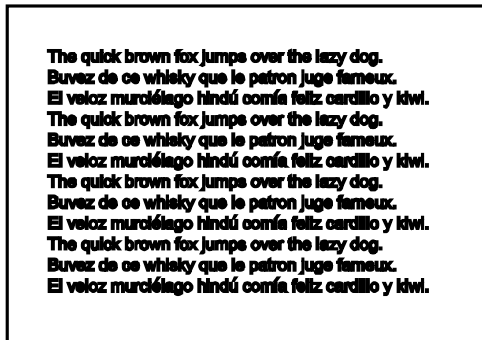
CEZ568

3.4.11 Color Is Too Dense

The entire image is denser than normal.

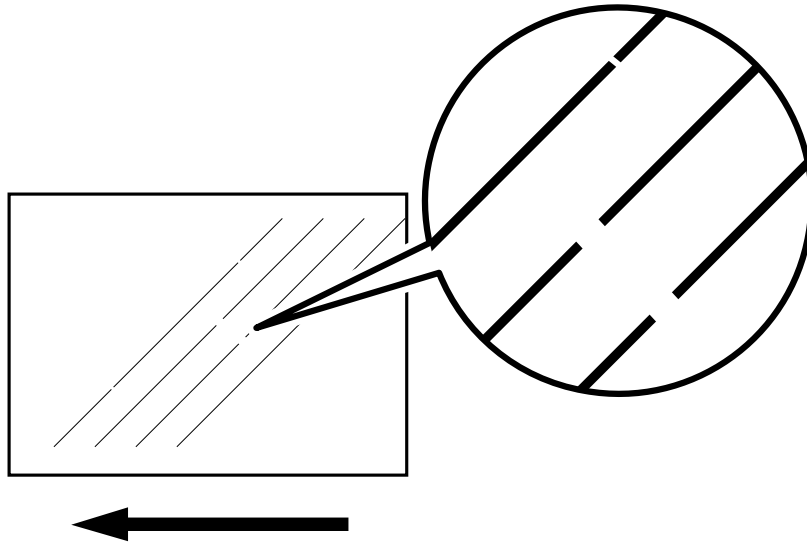
CEZ569

3.4.12 Broken Thin Lines

Thin lines (1 dot lines in 1200 dpi images) break.

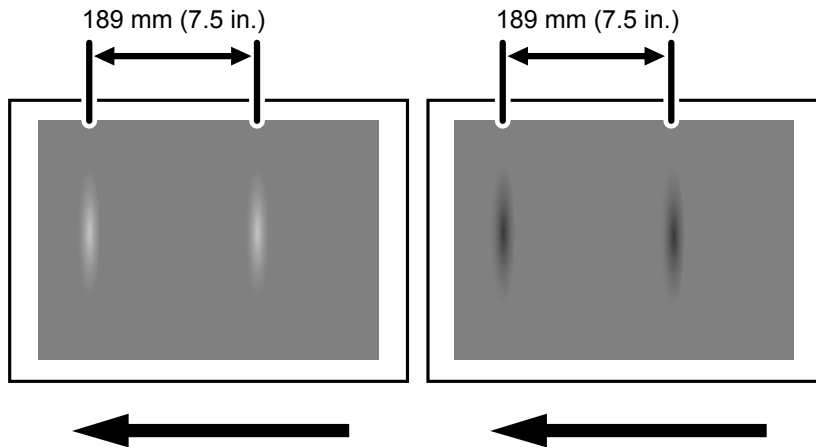
CNT002

3.4.13 Blurred Images

Lens-shaped blurred images appear at 189 mm (7.5 inches) intervals.

If the machine is left unattended for a long period in an environment where temperature and humidity are high, corona products on the drum absorb moisture to prevent a buildup or removal of static electricity on the drum.

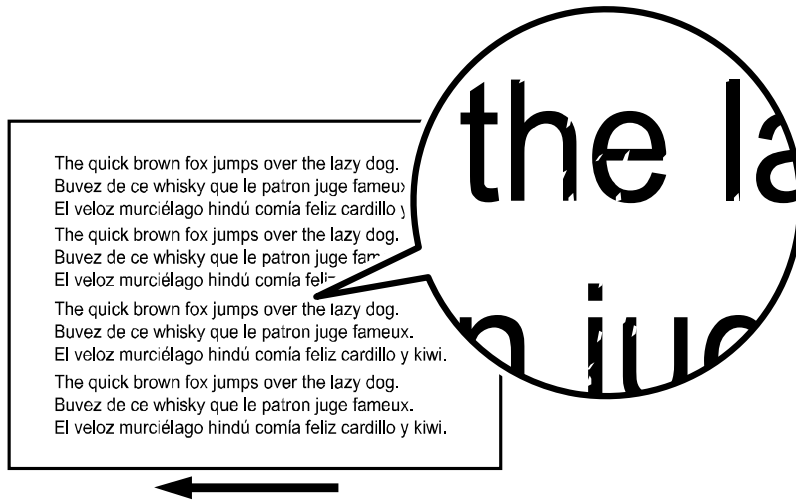
CNT003

3.4.14 Dropouts (Character Voids)

Dropouts (character voids) occur when characters or lines are printed in black-and-white mode.

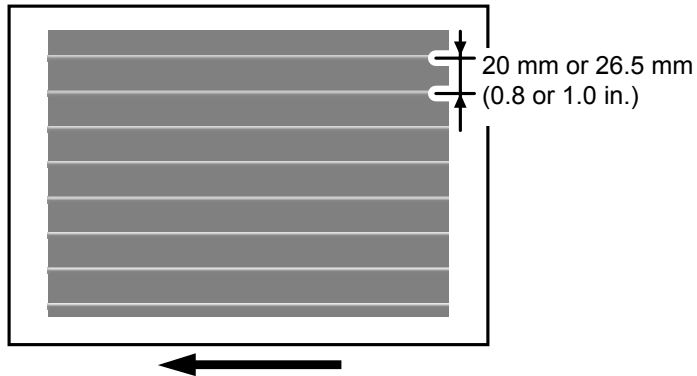
CEZ570

3.5.1 Glossy Lines

Glossy lines appear every 20 or 26.5 mm (0.8 or 1.0 inches).

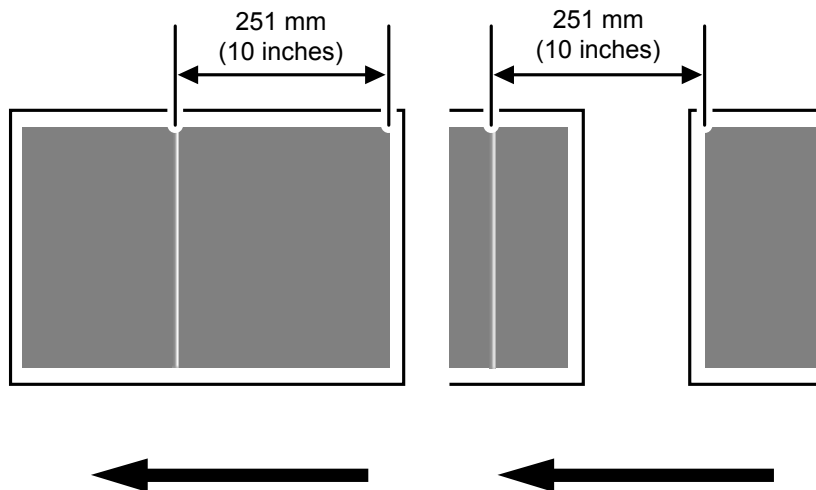
CEZ603

3.5.2 Vertical Glossy Lines

Glossy lines perpendicular to the paper feed direction appear.

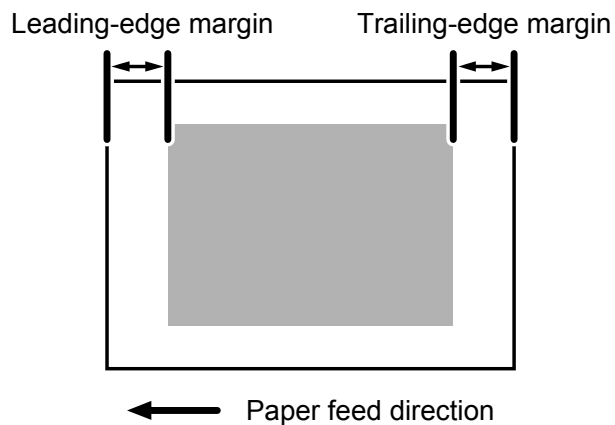
CEZ586

- Thin or coated paper is used
- A solid image that consumes a lot of toner is printed at the leading edge
- The leading/trailing edge margin is too narrow

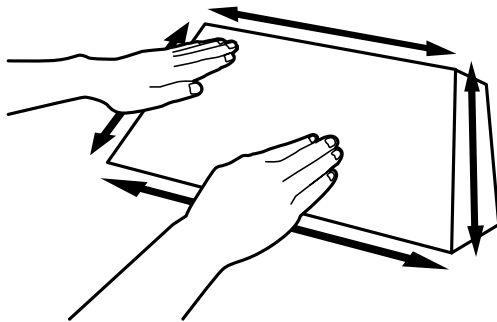
CEZ500

Flatten the envelope and all its edges to eliminate air before loading. If the envelope is curled, decurl it before loading.

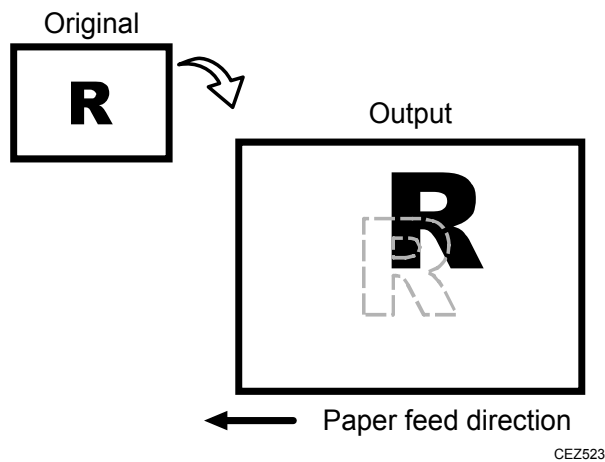
4.8.1 The Image Is Positioned Incorrectly

Depending on the paper thickness, floppiness, edge roughness, and curl, the image may become mispositioned.

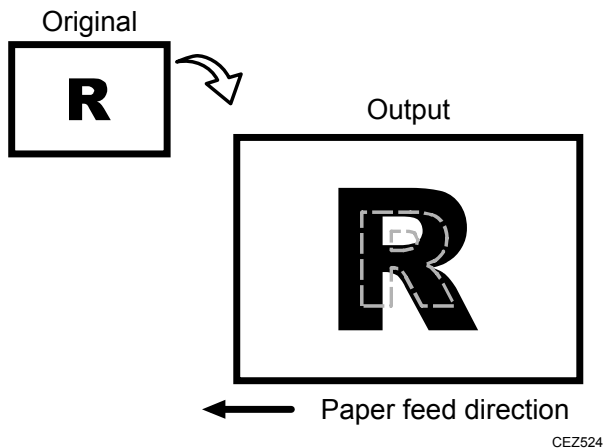
4.8.2 Image Scaling Error on the Side 1 of Paper

An image scaling error may occur because of expansion or contraction of the paper.

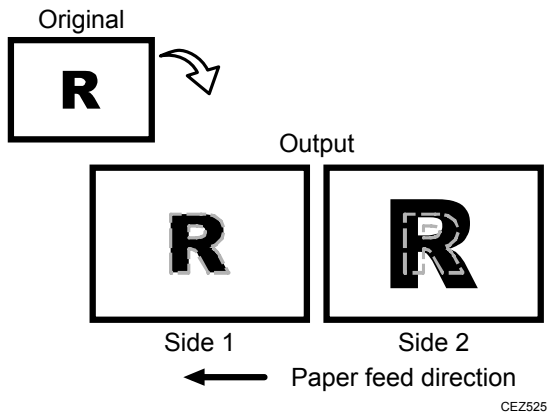
4.8.3 Image Scaling Error on the Side 2 of Paper

An image scaling error on the side 2 of the paper may occur because the paper expands or contracts after the image on the side 1 of the paper has been fused.

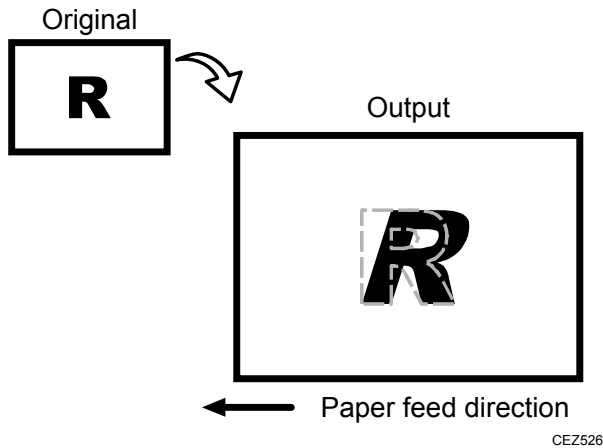
4.8.4 Image Skewing

Depending on the machine's operating environment (levelness and temperature), the printed image may become vertically skewed.

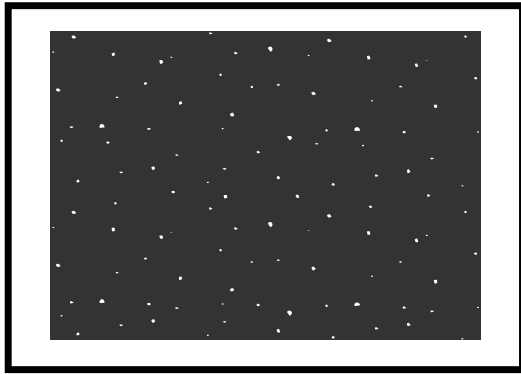
CEZ527

4.8.5 White Spots

← Paper feed direction

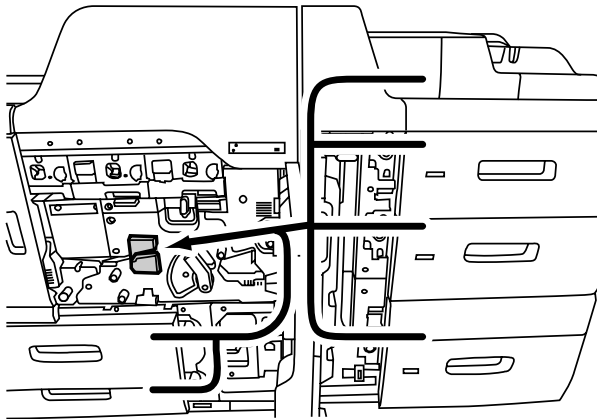
CEZ501

Clean the paper feed path (dust catcher, transfer timing roller, guide board, and paper feed roller) between the paper tray in use and the transfer unit's nip (where the images are transferred from the intermediate transfer belt to the paper).

The paper feed paths between each paper tray and the nip are as follows:

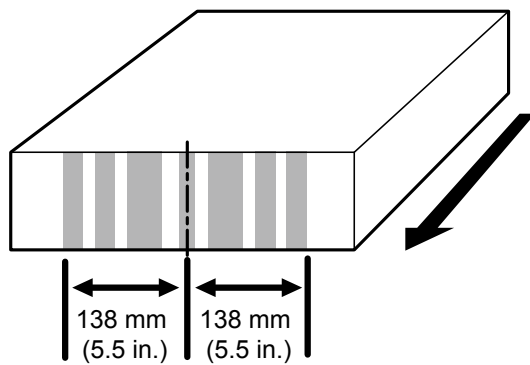
CNT011

4.8.6 Paper Edges Are Soiled (1)

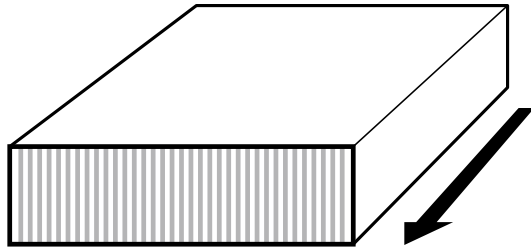
CNT012

4.8.7 Paper Edges Are Soiled (2)

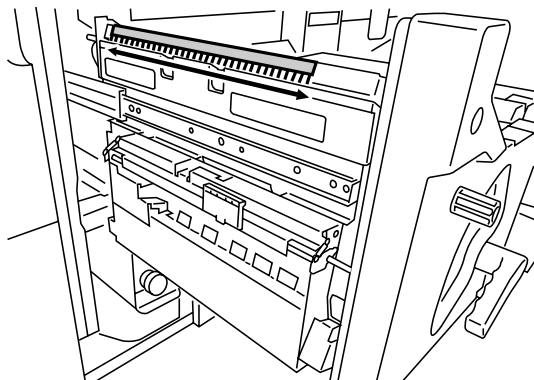
CEZ256

Clean the antistatic brushes in the exit transport and inverter transport of the machine's left drawer with a blower brush.

- The antistatic brush in the exit transport

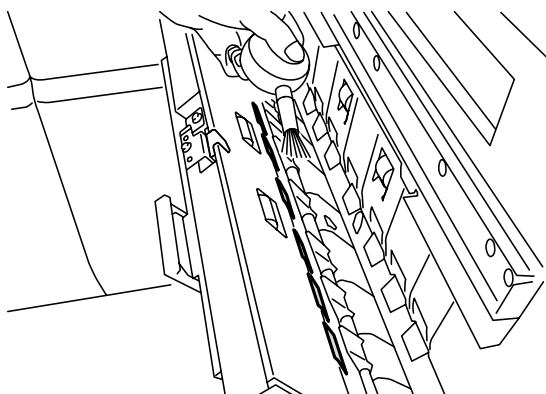
CNT019

- The antistatic brush in the inverter transport

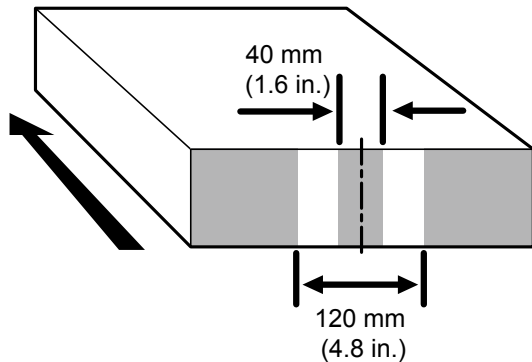
CNT014

4.8.8 Paper Edges Are Soiled (3)

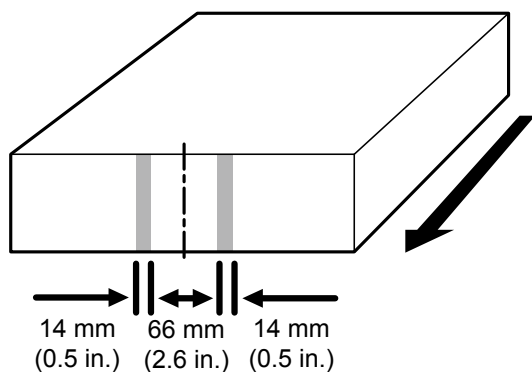
CNT013

4.8.9 Paper Edges Are Soiled (4)

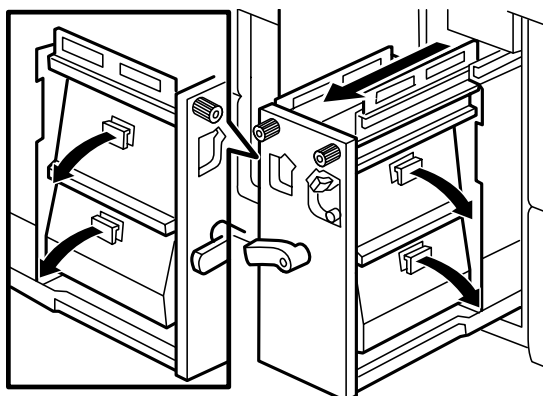
1. Pull out the buffer pass unit and open the guide plates.

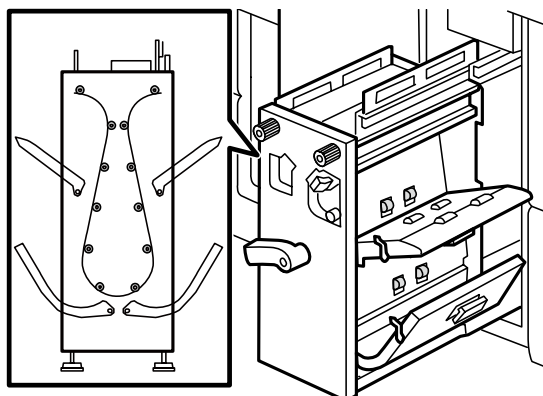
2. Wipe the rubber rollers for the transport rollers with a slightly damp cloth. There are twenty-four rubber rollers for the twelve transport rollers.

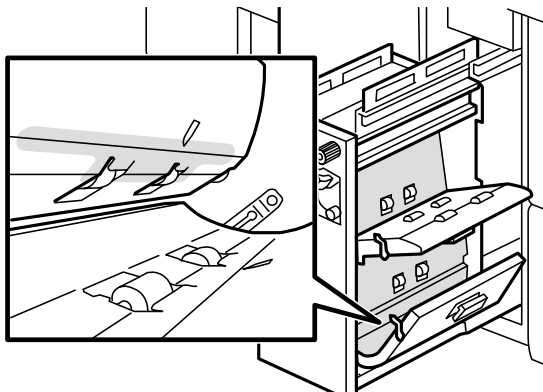
CNT018

3. Wipe the guide plates (especially the ridgelines of the bends and the cut-and-bent portions) with a cloth moistened with alcohol.

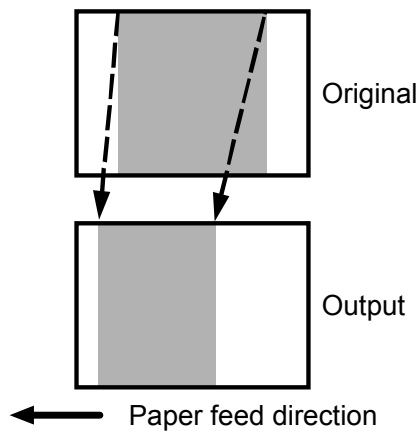
CEZ528

The leading edge margin is too narrow and the image has shrunk lengthwise.

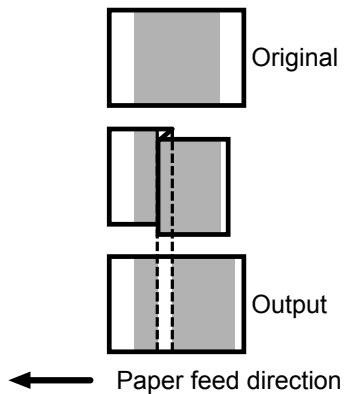
CEZ529

The paper has creased and no print appears where the crease has occurred.

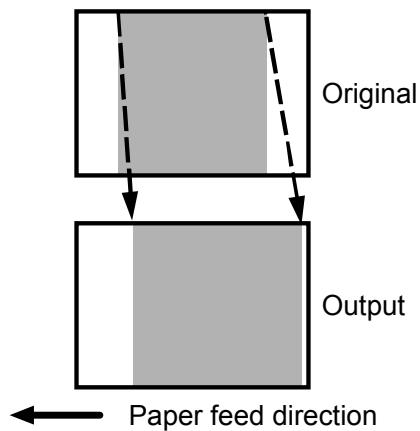
CEZ530

The leading edge margin is too wide and the image has stretched lengthwise.

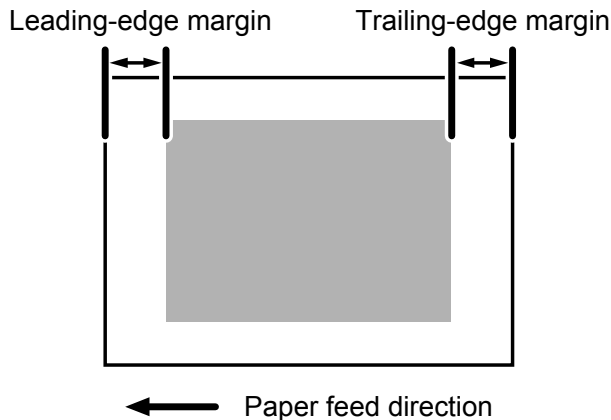
CEZ586

In some custom paper presets, the leading/trailing edge margins are wide enough to prevent paper jams.

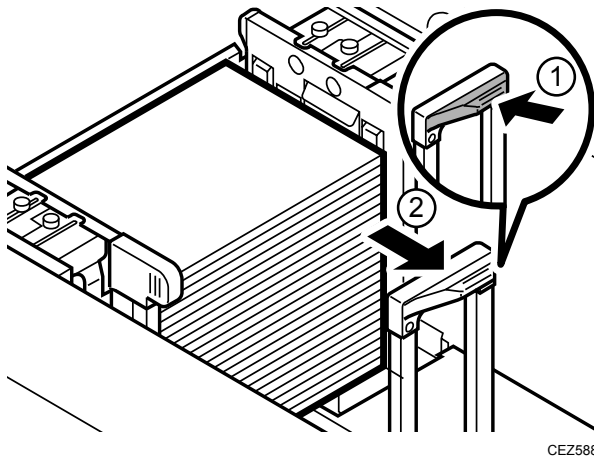
1. Unlock the end fence, and then slide it away from the paper.

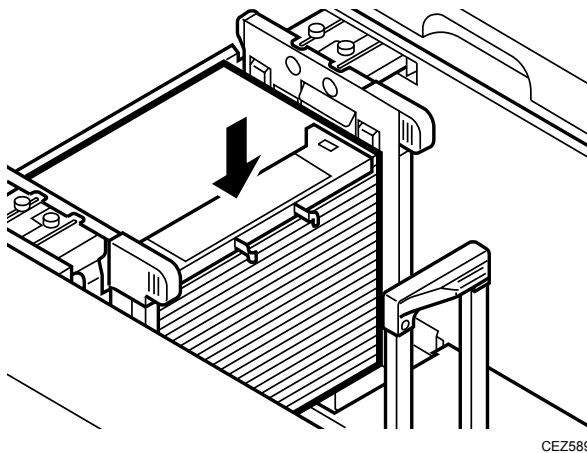
2. Place the tab sheet holder on the paper.

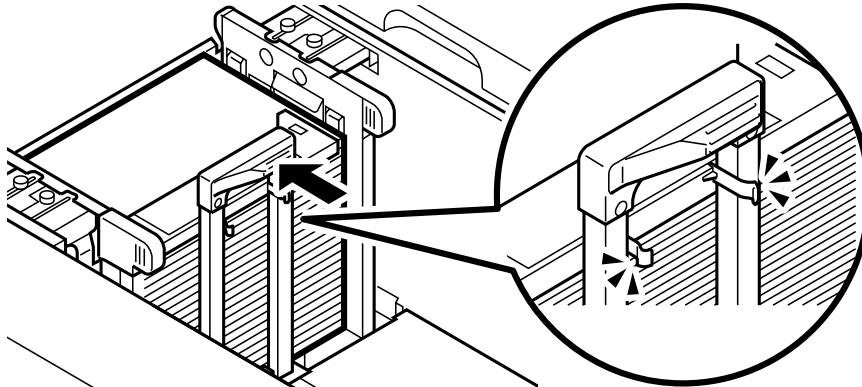
CEZ590

3. Slide the end fence against the paper so that the tab sheet holder's clips pass through the fence and click into place.

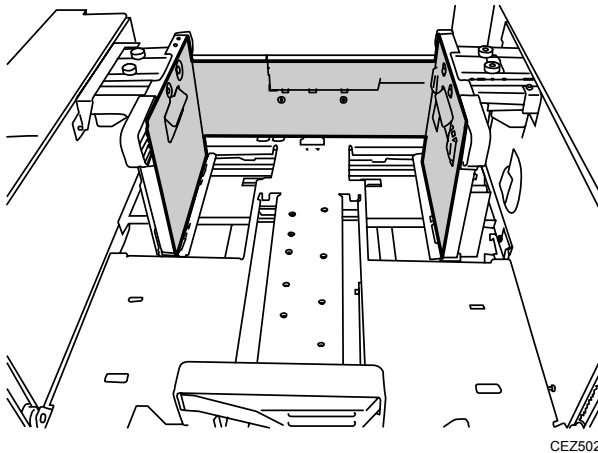
1. Open the wide LCT front cover.
2. Pull open the top tray (Tray 3) until it stops. If there is any paper in the tray, remove it.
3. Clean the side fences and front guide.

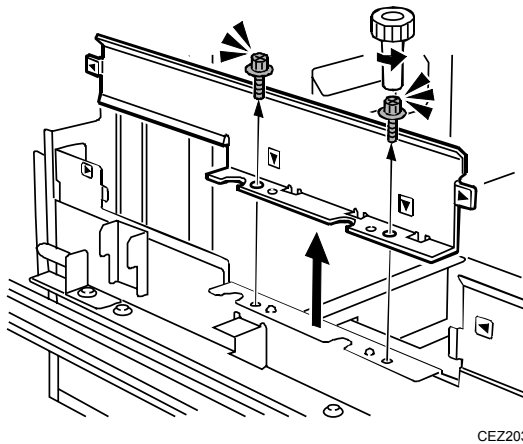
4. Remove the two black screws on the side plate, and then remove the plate.

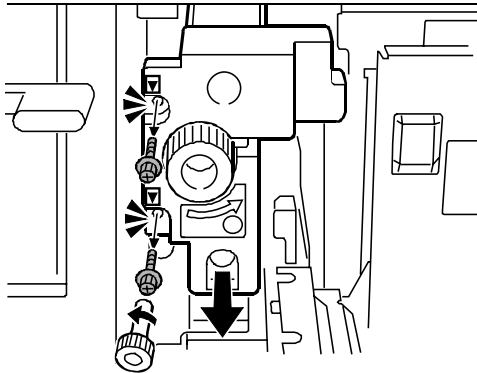
CEZ204

5. Remove the two black screws on the paper feed unit U2, and then pull out the paper feed unit U2 until it stops.
