Troubleshooting: TCRU

Model Name:

Pro C651EX/Pro C751EX/Pro C751

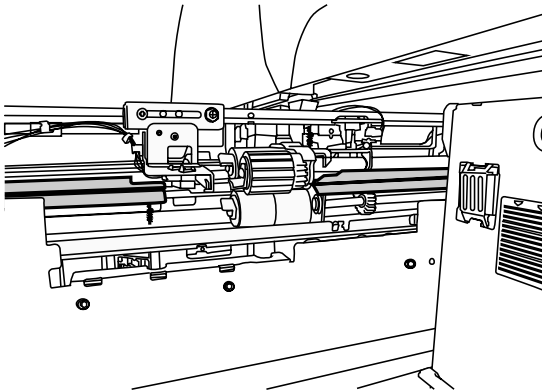
CEZ503

6. Clean the paper feed rollers.
For details about detaching and reattaching the paper feed rollers, see the Replacement Guide.
7. Clean the guide board of the paper feed unit.

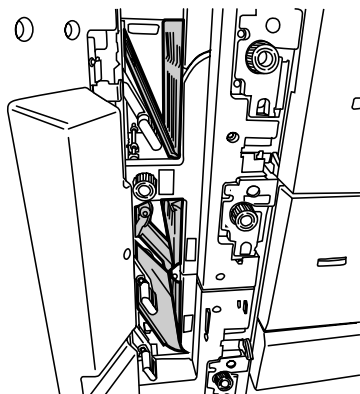
CEZ504

8. Open the guide board U1, U3, and U5, and then clean the guide board interior.

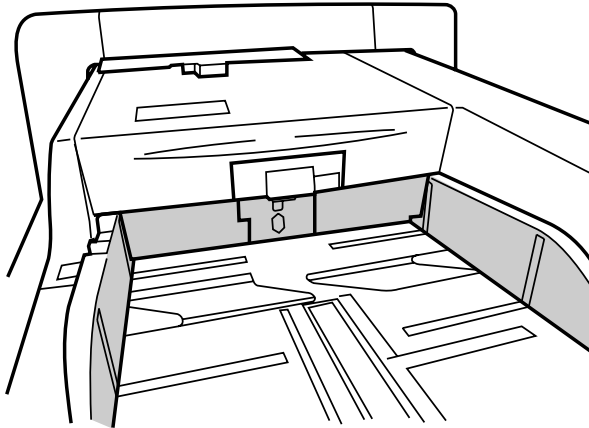
CEZ587

1. Remove the loaded paper.
2. Clean the side fences and front guide.

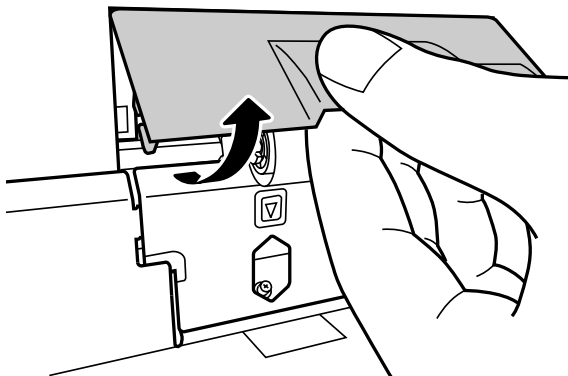
CEZ168

3. Pull off the snap-off cover.

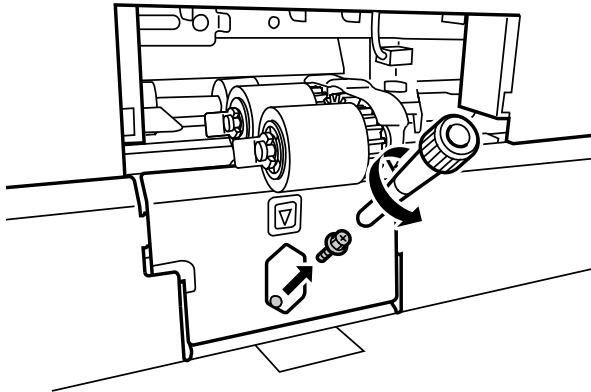
CEZ169

4. Remove the black screw.

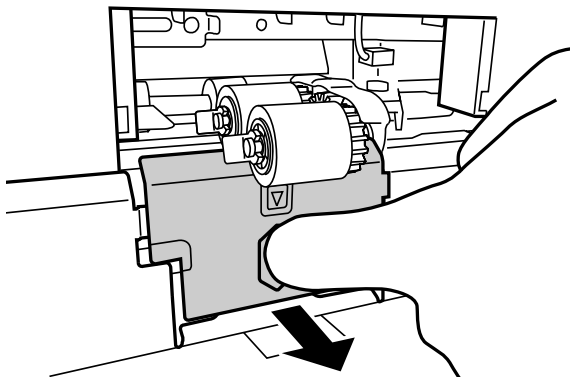
CEZ170

5. Remove the plate.

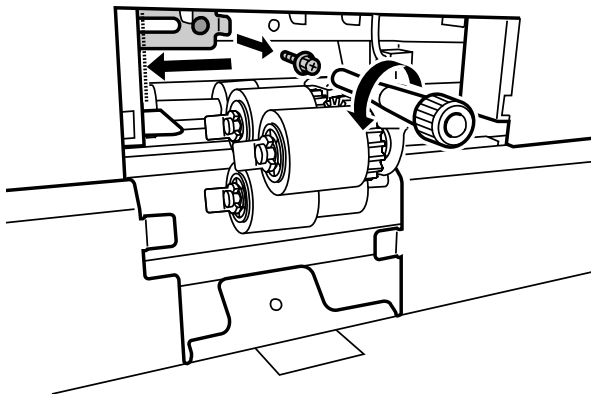
CEZ171

6. Remove the black screw on the sensor positioning plate.

7. Push the sensor positioning plate to the left.
If this plate is not pushed to the left, the feed roller cannot be removed.

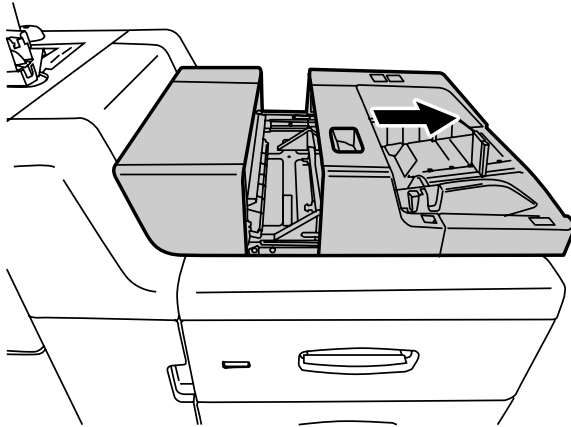
CEZ505

9. Slide the paper tray to the right.

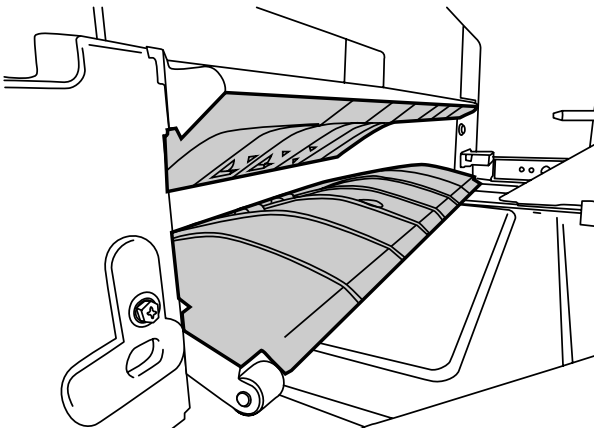
CEZ506

10. Clean the guide board.

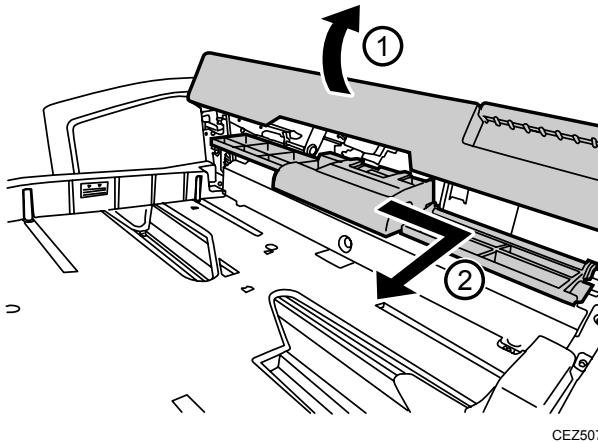
1. Remove the loaded paper.
2. Open the upper cover, and then detach the paper feed unit.
Pull it out slightly, release the metal shaft, and then detach it.

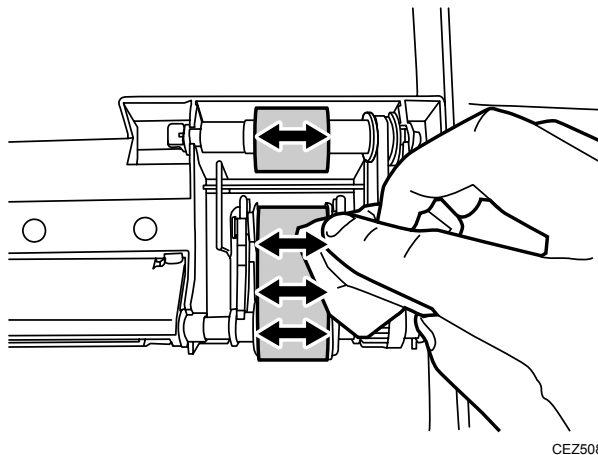
3. Clean the paper feed belt and paper feed rollers in the detached paper feed unit.

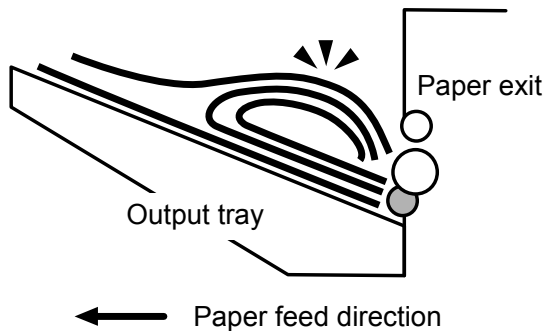
CEZ594

◆Sheet bending

The leading edge of the delivered sheet bends upward and backward.

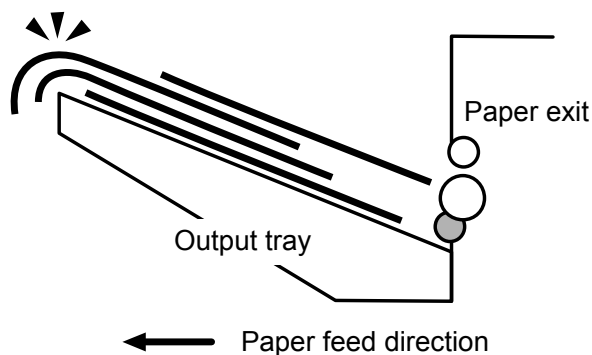
CEZ595

◆One sheet pushing out another

Because of high paper friction, the delivered sheet may get stuck and push out other sheets of paper.

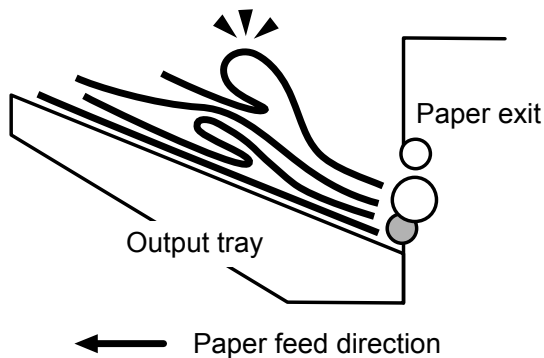
◆Paper deflection

Because of high paper friction, the delivered sheet may arch up and become crimped.

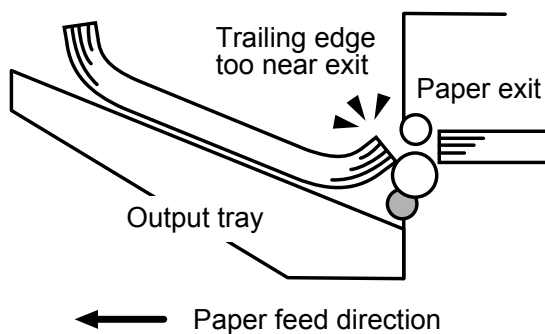
CEZ593

This is likely to occur if:

- There is a tight curl on a delivered set of stapled sheets.
- Limp paper such as thin or recycled paper is used.

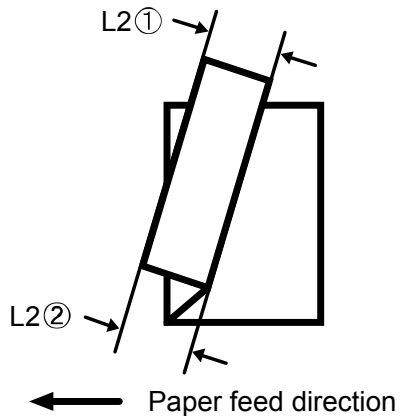
CEZ531

For example, in the following illustration, the dimensional difference between the top (L2[2]) and bottom (L2[1]) edges is a deviation.

<Folding deviation sample of L2 for Z-fold>

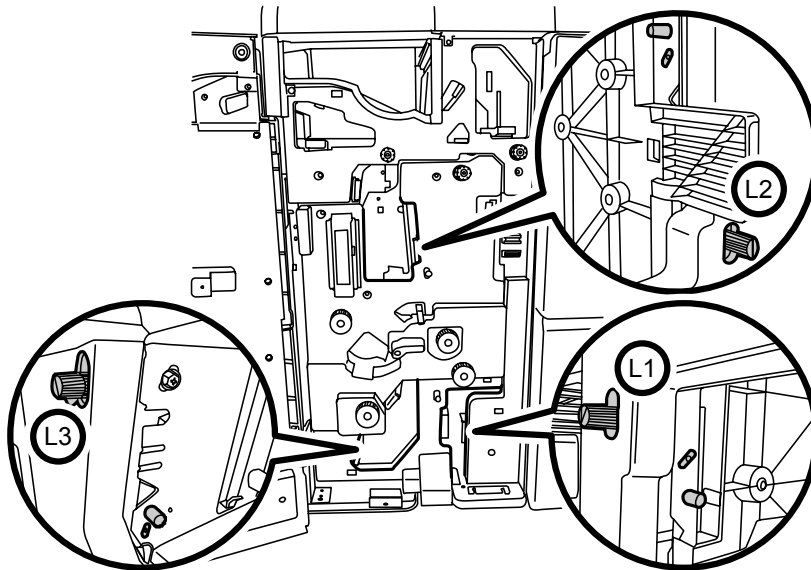
CEZ509

The multi-folding unit has three adjusting screws (L1, L2, and L3) to adjust deviation.

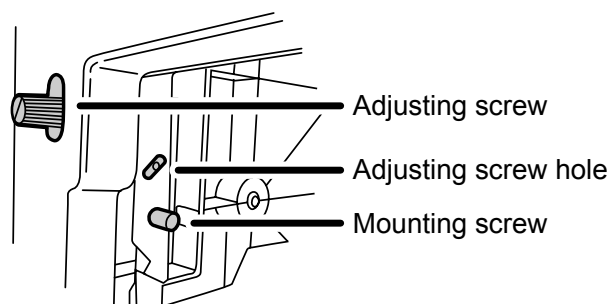
CEZ599

◆L1

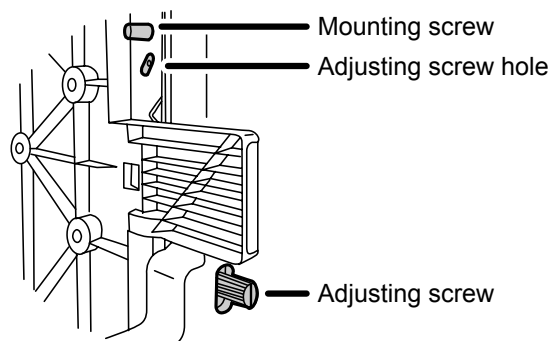
CEZ600

◆L2

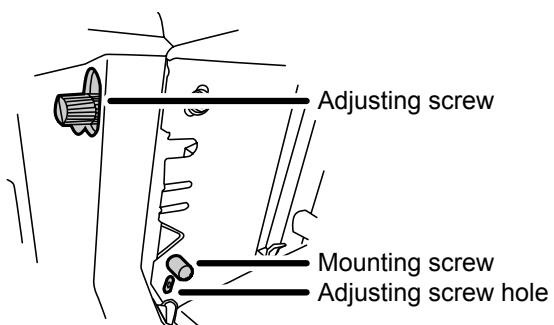
CEZ601

◆L3

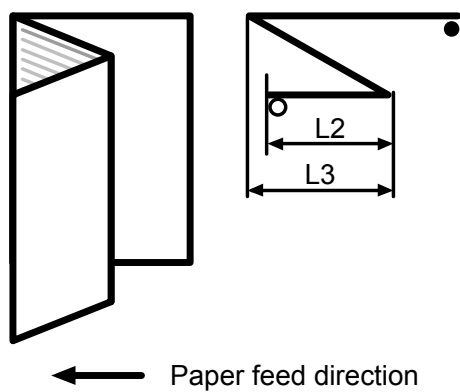
CEZ532

◆Z-fold

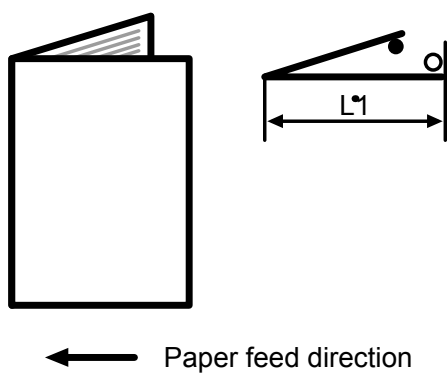
CEZ533

◆Half Fold

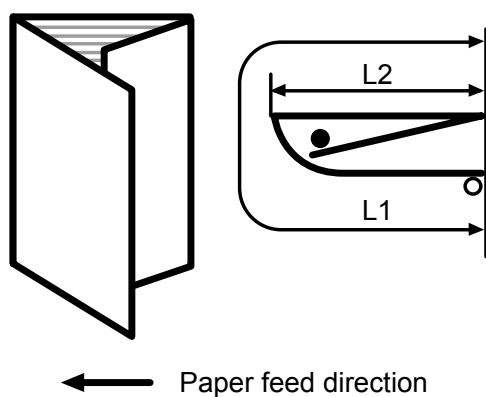
CEZ535

◆Letter Fold-in

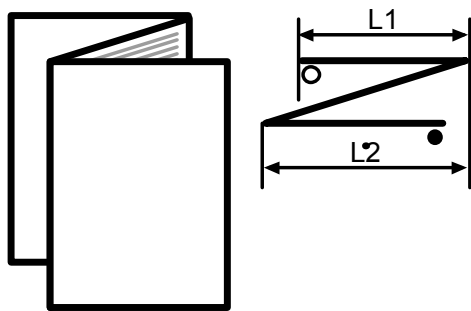
CEZ534

◆Letter Fold-out

← Paper feed direction

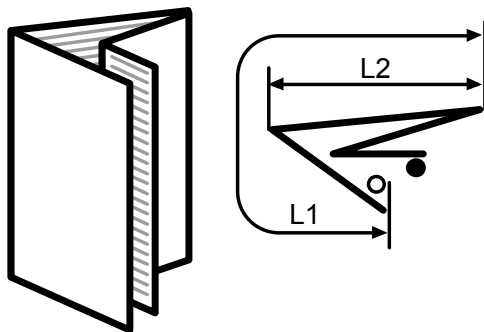
CEZ536

◆Double Parallel

← Paper feed direction

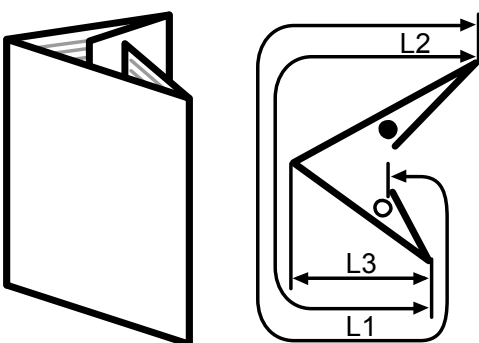
CEZ537

◆Gate Fold

← Paper feed direction

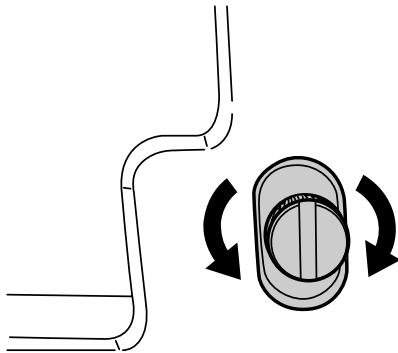
CEZ510

1. Open the front cover of the multi-folding unit.
2. Remove the mounting screw.
If the mounting screw is attached to the adjusting screw hole, unfasten it.
3. Turn the adjusting screw to adjust the deviation.
 - To increase the length at the bottom part of paper, turn the screw clockwise.
 - To decrease the length at the bottom part of paper, turn the screw counterclockwise.

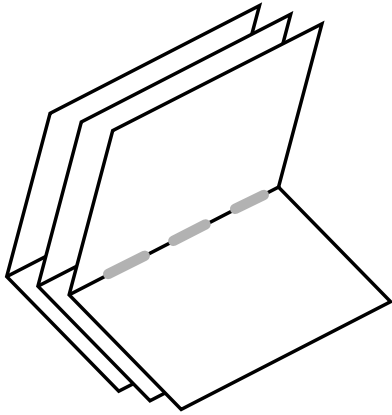
CEZ571

If multi-sheet folding is performed after a large number of Z-folds have been performed, the tip of the blade used for the multi-sheet folding may be soiled, resulting in soiled paper.

This will produce paper soil of 1-3 cm (0.4-1.2 inches) in width (equal to the width of the blade) in the fold in the center of paper.

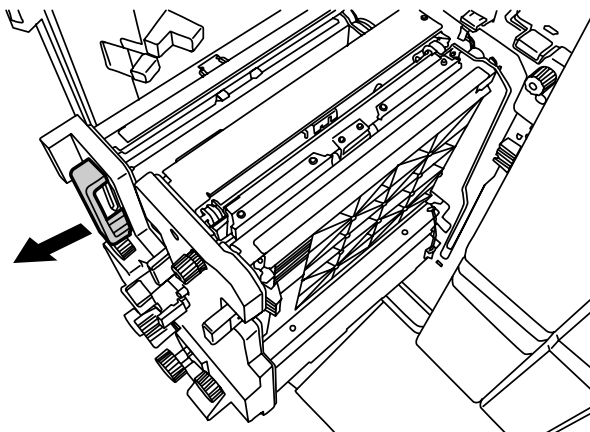
CEZ511

1. Open the front cover of the multi-folding unit.
2. Pull the multi-folding unit out.

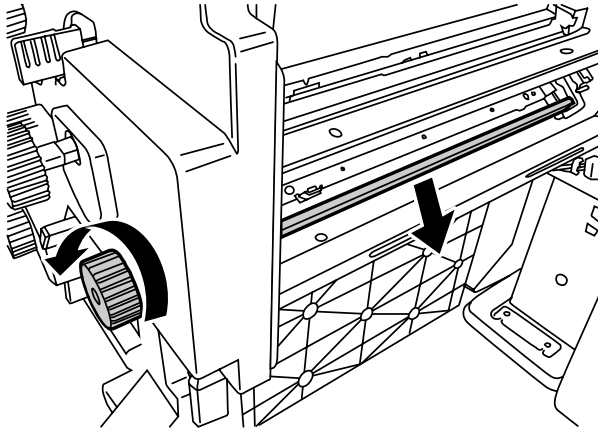
CEZ512

3. Turn the N11 dial counterclockwise until the blade appears.
The blade is located in the right part of the multi-folding unit.

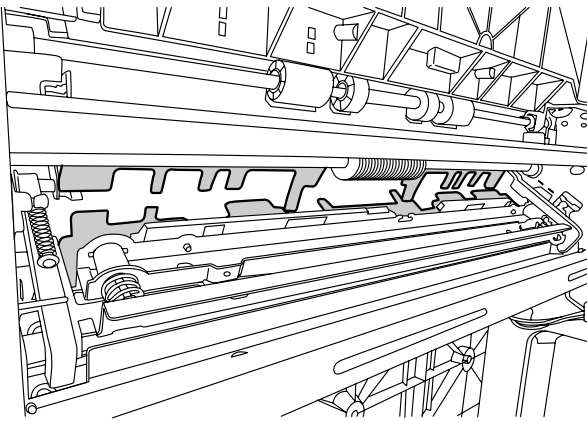
CEZ513

4. Wipe the tip and top of the blade with a soft dry cloth.
Be careful not to damage the blade.

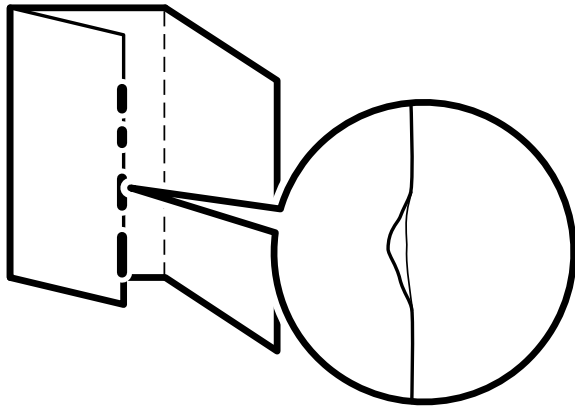
CEZ592

When letter folding is applied, the edge of the inner flap may become bent.

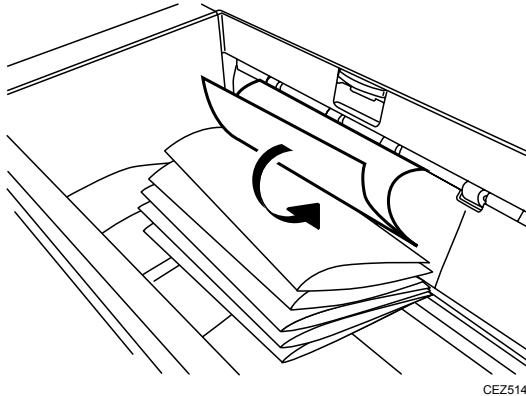
- Thick, relatively stiff paper is used.

As a bundle is delivered, its folded edge may droop and catch on the stacked bundles, causing the delivered bundle to flip over.

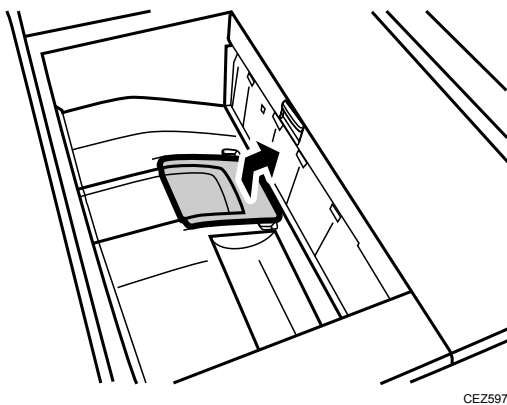
Use the Z-fold support tray for multi-folding unit.

This will reduce the angle of stacked bundles and prevent bundles flipping over as they are delivered.

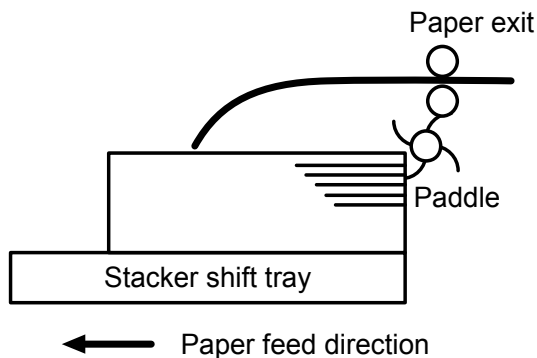
(1) Downward curled paper is delivered to the stacker tray.

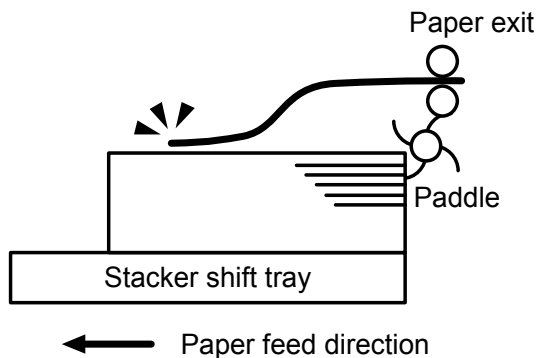
(2) The leading edge of the sheet, while delivered, causes strong paper-to-paper friction against the top sheet of the stack. As there is no air gap between the sheets, and the delivered sheet becomes stuck.

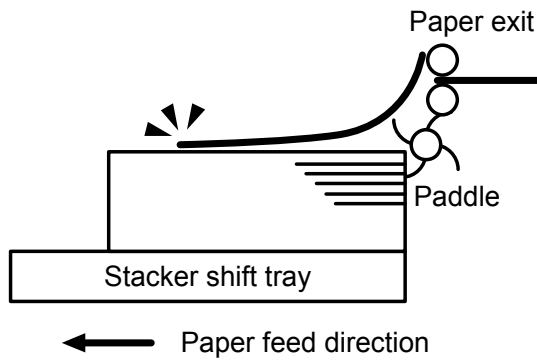
CEZ575

- (3) The trailing edge of the sheet, while delivered, is left in the paper exit.

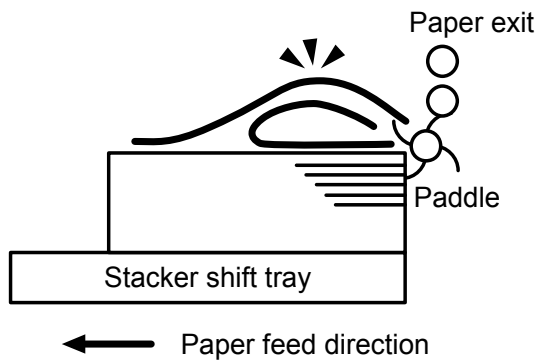
CEZ576

- (4) The next sheet to be delivered slips under the sheet still in the paper exit and bends back.

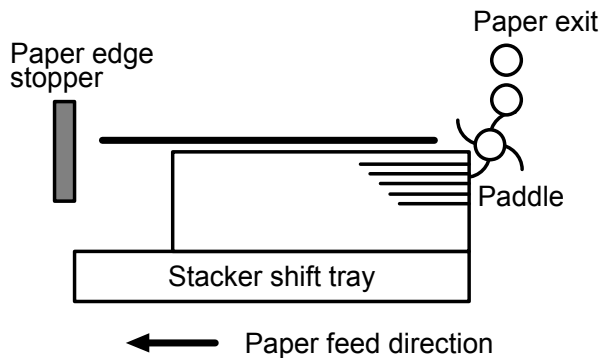
CEZ577

(1) An uncurled sheet is delivered to the stacker shift tray.

When sheets are delivered to the stacker tray, because of paper-to-paper friction, the paddle fails to pull the trailing edge back into the front guide, resulting in misalignment.

The paper edge stopper also fails to push back the protruding leading edge.

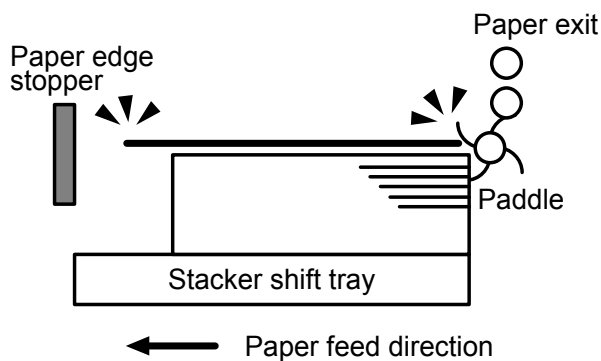
CEZ578

(2) Strong friction occurs at the trailing edge so that the paddle cannot pull the sheet back and align the edges of the sheet with those of the stack.

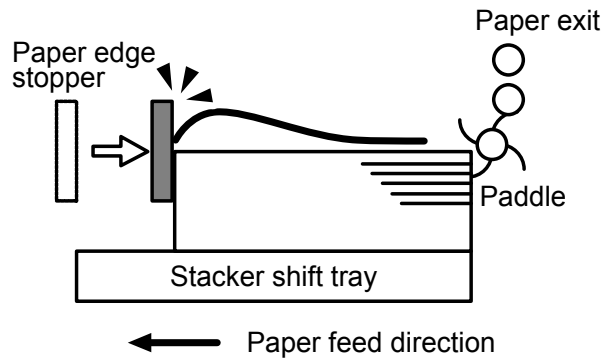
CEZ579

- (3) The paper edge stopper fails to push back the protruding leading edge and align the sheet as required.

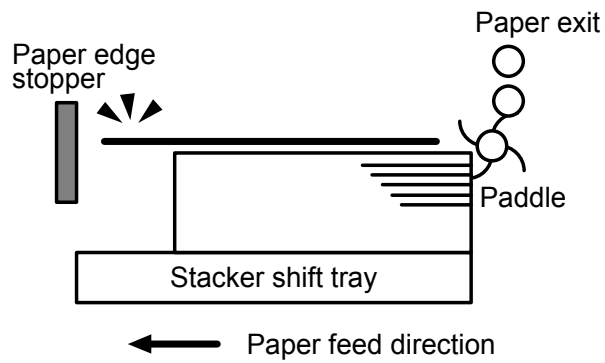
CEZ580

- (4) Stacked sheets are not aligned properly.

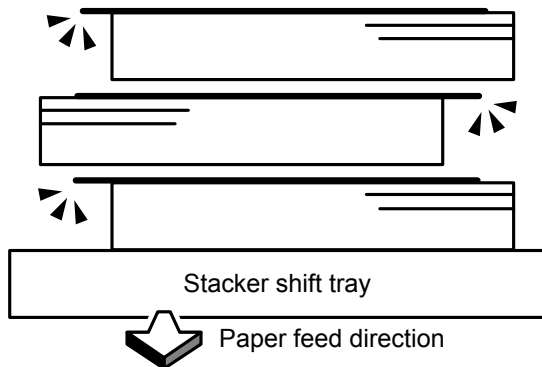
CEZ605

- The top sheet of each offset bundle of delivered sheets may protrude above the rest of the bundle by about 7 mm.
