# Novell® NEST Autoroute<sup>TM</sup>

Function Upgrade Card Type 140 Plus Novell® NEST<sup>TM</sup>

Feature Expander Type 100 2M Plus Novell® NEST<sup>TM</sup>

**SERVICE MANUAL**

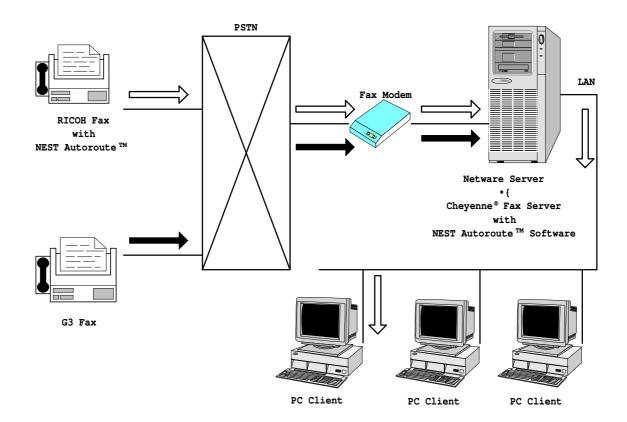
H130V500.wmf

Novell<sup>®</sup> Embedded System Technology (NEST) Autoroute<sup>TM</sup> is an alternative routing methodology, patented by Novell<sup>®</sup>. It allows a user to send a fax to a NetWare network and have the fax routed directly to the recipient's PC clients.

Using the standerd Group 3 T.30 protocol for routing information, NEST Autoroute TM works by including an Autoroute ID code with each fax transmission. The code, which is sent in the TSI frame, provides the information required to deliver a fax to its destination.
