Model: VM Option Type C		Date:10-Jul-06	No.: RB861001
Subject: Firmware update procedure for VM Option		Prepared by: K. Moriizumi	
From: 1st Tech. Support Sec. Service Support Dept.			
Classification:	<input type="checkbox"/> Troubleshooting <input type="checkbox"/> Mechanical <input type="checkbox"/> Paper path <input type="checkbox"/> Product Safety	<input type="checkbox"/> Part information <input type="checkbox"/> Electrical <input type="checkbox"/> Transmit/receive <input type="checkbox"/> Other (     )	<input type="checkbox"/> Action required <input type="checkbox"/> Service manual revision <input checked="" type="checkbox"/> Retrofit information

## Firmware Update Procedure (SD Card Only) for the VM Option

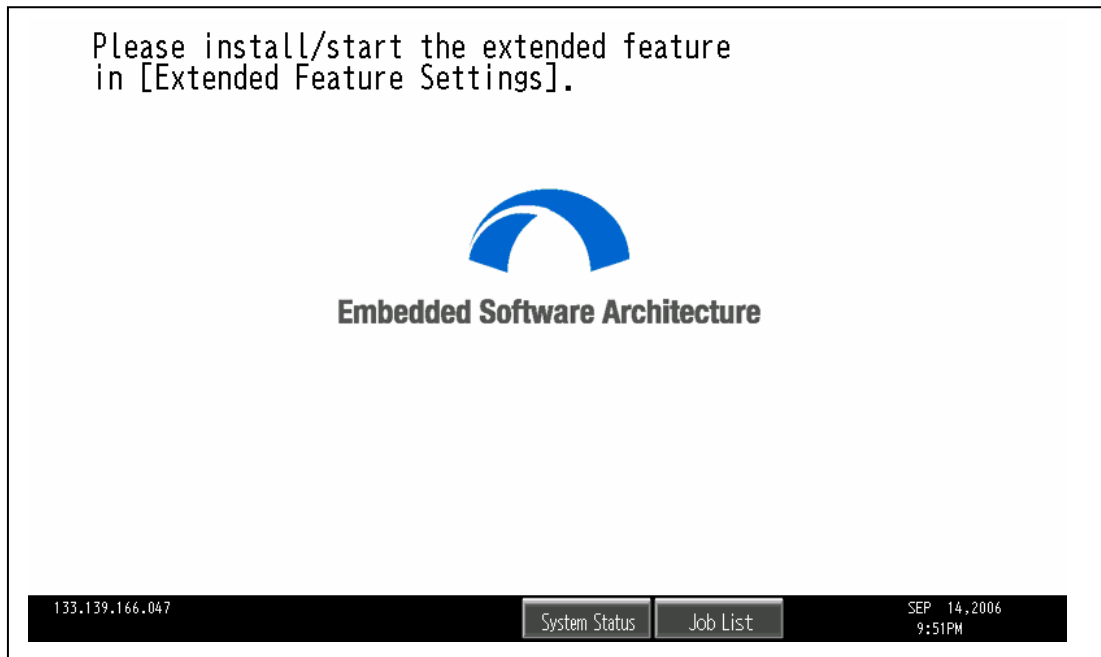
5. Wait five minutes, and then press the “Other function” key. You will hear two beeps.
  - If the screen does not change, this means the installation is not finished yet. Wait a few more minutes and then press the “Other function” key again.
  - When the installation is finished, the following will be displayed:

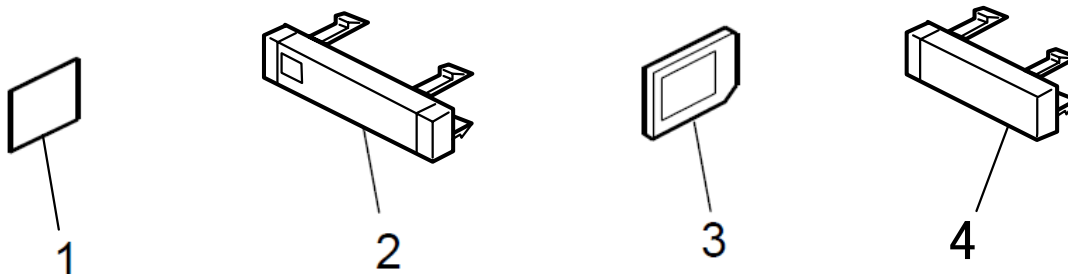
A new illustration (index 4) was added. As a result, the index number of the following parts was corrected.
