Toscana-P1/Toscana-P1N/Piemonte-P1N
Machine Code: J007/J010/J011

Repair Center Manual

May. 26th, 2006
Subject to change

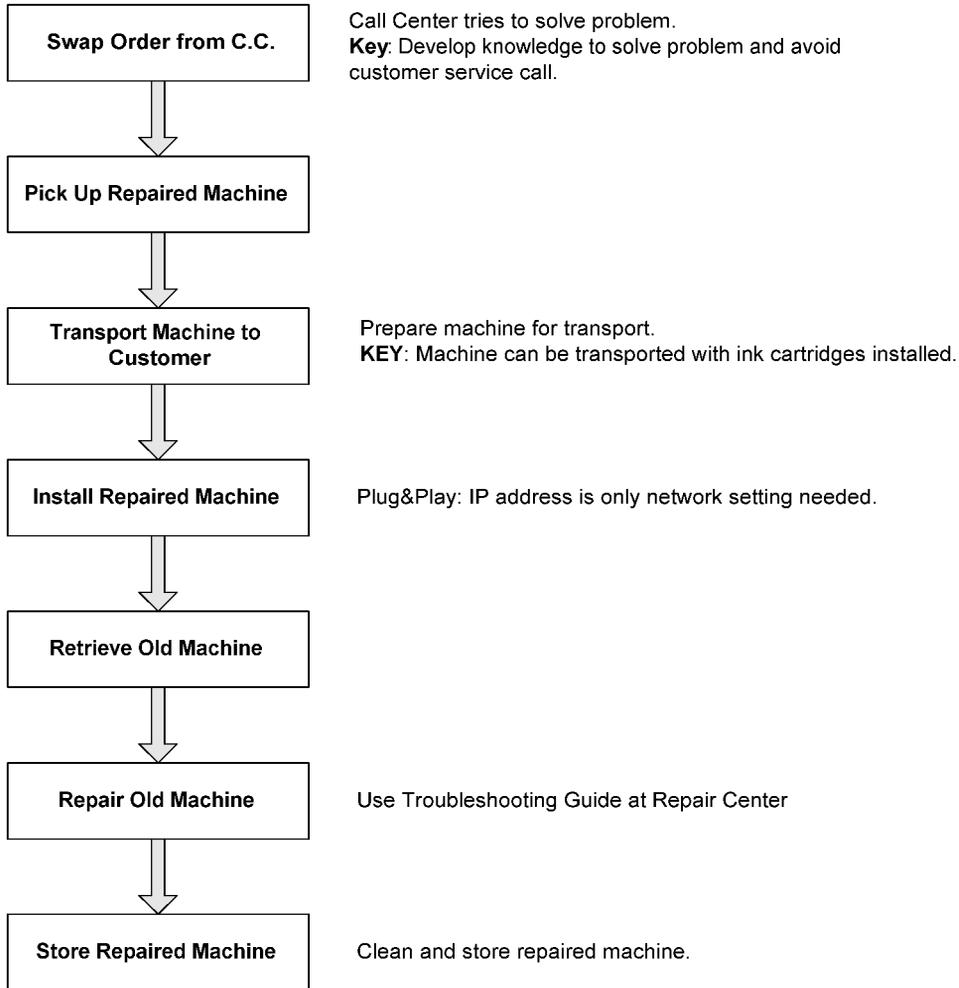
J011E107

Swap and Repair Flow

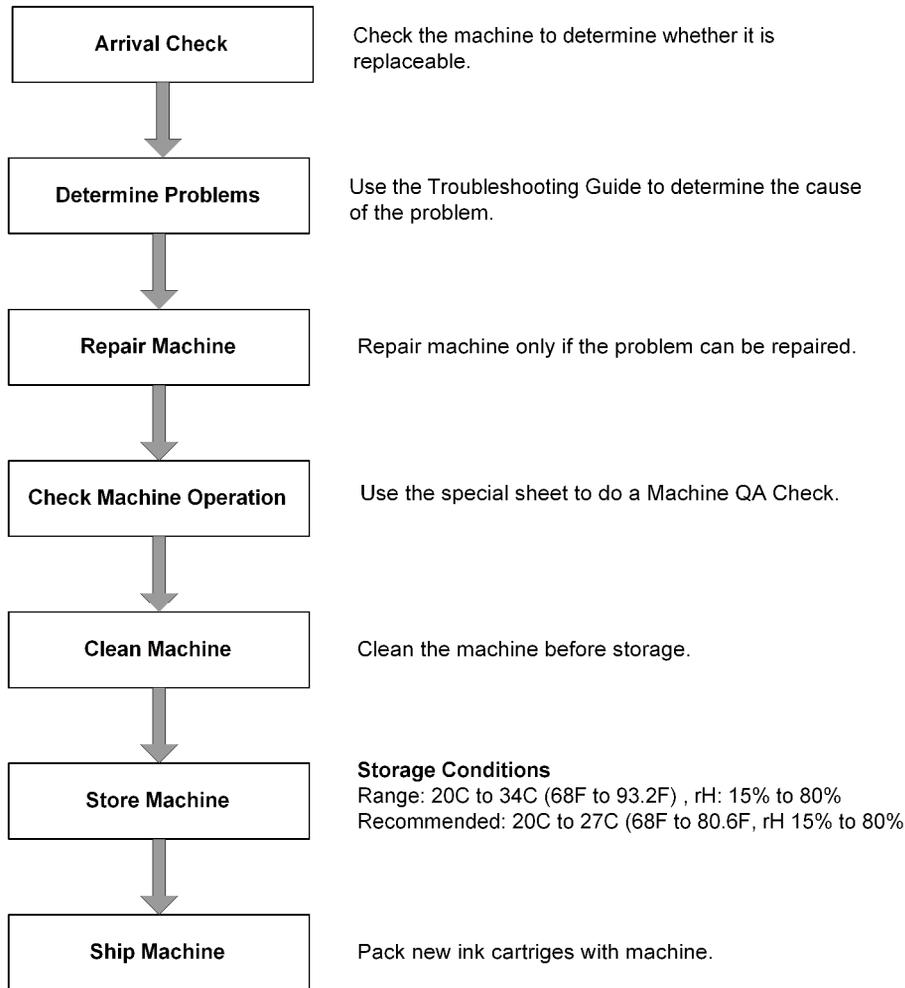
J011E108

Repair Center Work Flow

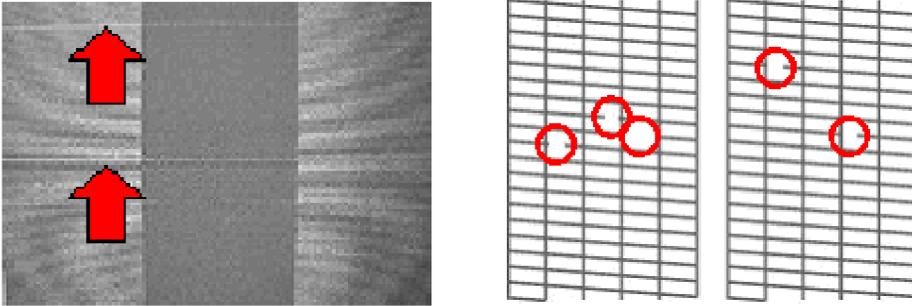
A02

4. Press and hold down [Ctrl]+[Shift]+[1] then click the [Next] button.
5. Check the printed pattern.

6. Determine if the print heads are operating normally:

- Any colors missing?
- Colors uneven?
- Any lines crooked or broken?
- Any white spots or streaks?

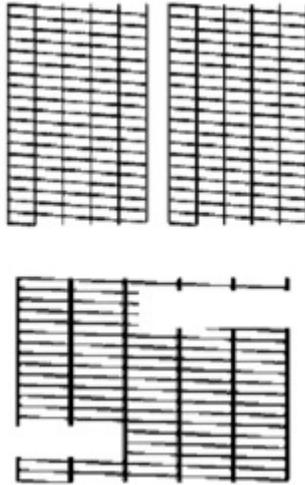
- 1. Push [Menu], select "Maintenance", and push [#Enter].**
- 2. Select "Nozzle Check" and press [#Enter]. The Nozzle Check pattern prints.**
- 3. Examine the Nozzle Check pattern for broken lines or white patches. The first sample below is normal, the second sample shows white patches.**

1. Determine if the print heads are operating normally:

- Any colors missing?
- Colors uneven?
- Any lines crooked or broken?
- Any white spots or streaks?

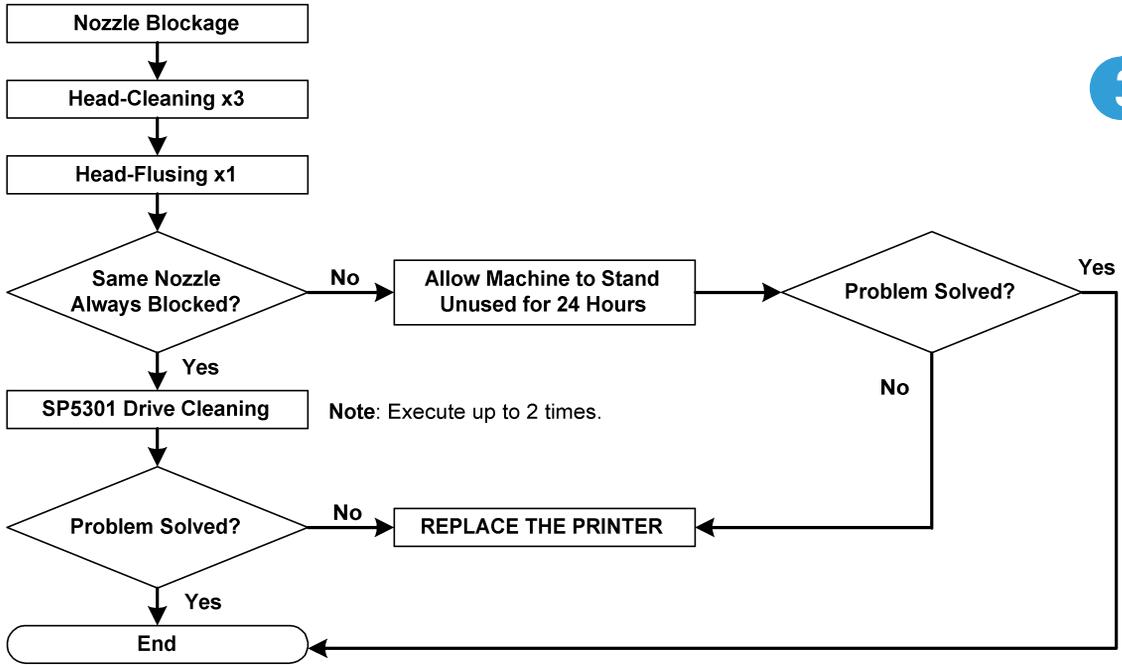
J011E209

Before you begin, make sure that you understand the basic procedures for cleaning the print heads.

For more details about the print head cleaning procedures, see "Print Head Cleaning" in "5. Important Procedures".

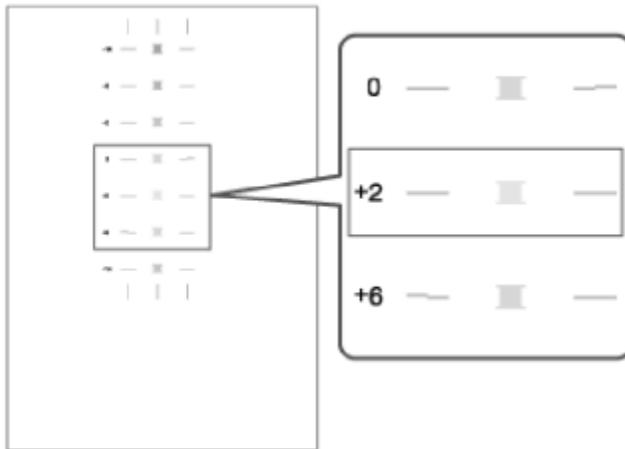
Print the 'Adjust Paper Feed Test Pattern' and do this adjustment if you see broken horizontal lines or uneven colors in the printouts:

1. Push [Menu], select "Maintenance", then push [#Enter].
2. Select "Adj. Paper Feed" and push [#Enter].
3. Select "Pr. Test Print" and push [#Enter]. The test pattern prints.

1. Examine the test print. Note the number of the best pattern. The best pattern is the pattern where the horizontal lines should be perfectly flat.
2. Select "Adjustment" and push [#Enter].
3. Enter the number of the pattern you selected in Step 4 and push [#Enter]. This completes the adjustment.
4. Push [Online] to leave the menu mode.

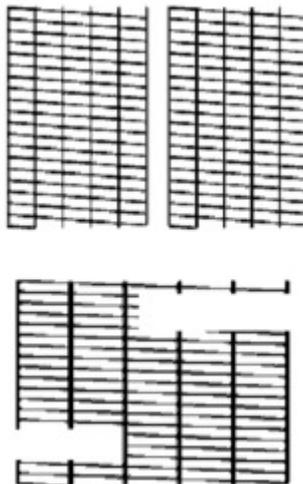
1. Push [Menu], select "Maintenance", and push [#Enter].
2. Select "Nozzle Check" and press [#Enter]. The Nozzle Check pattern prints.
3. Examine the Nozzle Check pattern for broken lines or white patches. The first sample below is normal, the second sample shows white patches.

1. Note which colors are not printing normally.
2. Do the print head cleaning procedure for the print head that is blocked.

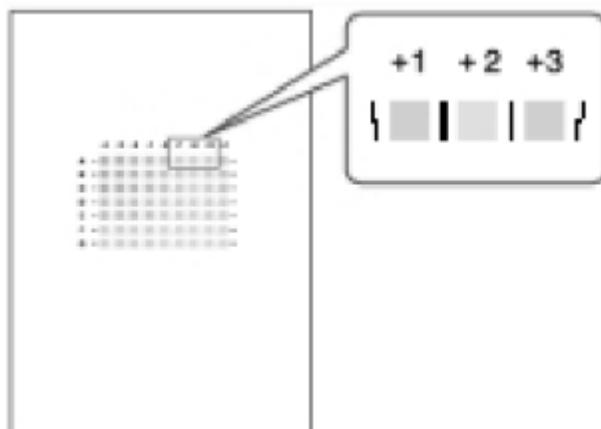
1. Push [Menu], select "Maintenance" and push [#Enter].
2. Select "Head Position" and push [#Enter].
3. Select "Pr. Test Pattern" and push [#Enter].
4. Select the test pattern for print head position adjustment and push [#Enter]. The test pattern prints.

1. **Select the best pattern.**
 - The best pattern is the gray square with straight vertical lines on both sides.
 - The pattern setting is read as a matrix value from the pattern. For example, if the best pattern is in column "+2", line "A", the entry for adjustment will be "A" then "+2"
2. Select "Adjustment" and push [#Enter].
3. Select same setting selected for "Pr. Test Pattern" (High Speed, etc.) and push [#Enter].
4. Select the letter of the line of the best pattern noted in Step 5 and push [#Enter].
5. Select the number of the line of the best pattern noted in Step and push [#Enter]. This completes the adjustment.
6. Push [Online] to leave the Menu mode.

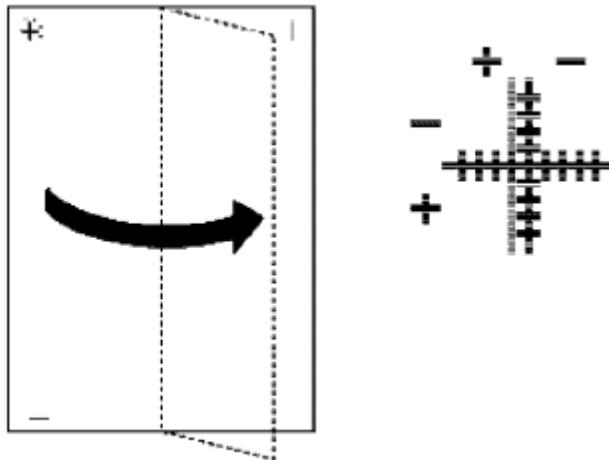
1. Push [Menu] select "Maintenance", and push [#Enter].
2. Select "Registration" and push [#Enter].
3. Select "Pr. Test Sheet" and push [#Enter].
4. Select the paper tray ("Tray 1 for example) and push [#Enter].
5. Select the paper type and push [#Enter]. The test pattern for Registration prints.

1. Fold the printed sheet in half lengthwise as shown above.
2. Determine the 1st adjustment for the Read Direction.
 - After folding the test print in half parallel to its long edge as shown above, the adjustment value in the **Read Direction** is the difference between the single vertical line and cross vertical line that you can see when the folded sheet is held up to the light.
 - If the difference is one calibration mark, for example, the adjustment is +1.0.
3. Fold the sheet in half widthwise.
4. Determine the 2nd adjustment for the Feed Direction.
 - The value read after folding the sheet widthwise, is the adjustment value for the Feed Direction.
5. Select "Adjustment" and push [#Enter].
6. Select the paper tray and push [#Enter].
7. Select the paper type and push [#Enter].
8. Enter the adjustment for the Read Direction determined in Step 7 and push [#Enter].

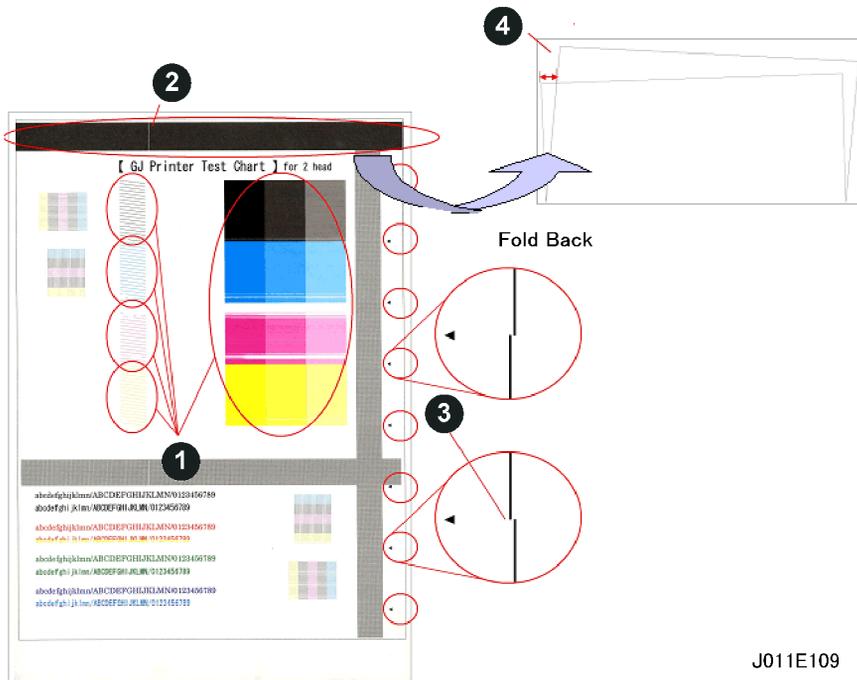
J011E109

Checking the QA Sheet

No.	Check Item	Check Point	Correction
1	Nozzle Check	Colors uneven? Colors missing?	1. Do "Head-Cleaning" 3 times. 2. Do "Head-Flushing" once.
2	Encoder Check	No white vertical lines, streaks?	1. Clean horizontal encoder film strip with alcohol. 2. Replace encoder
3	Offset Check (Ruled Lines)	No line shifting larger than 1 line width?	1. Clean guide shaft 2. Make sure top cover is closed. 3. Check amount of skew again.
4	Skew Check	Less than 2 mm?	1. Check tray fences. 2. Check tray bottom plate, reverse guide.

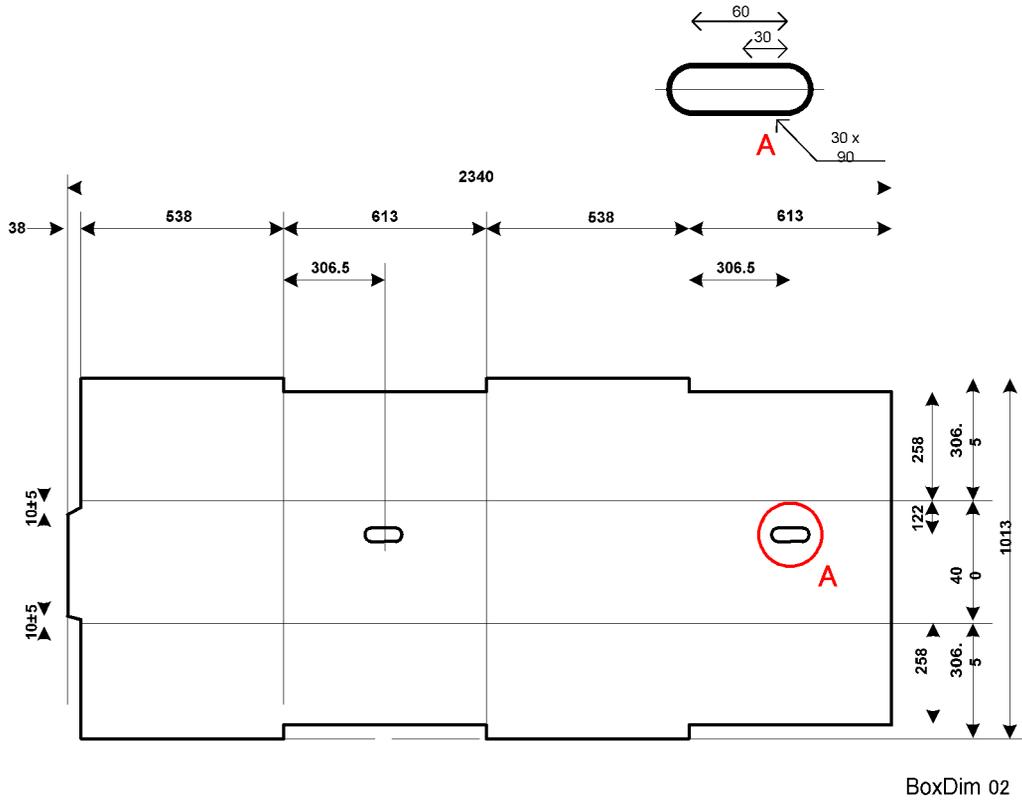
Toscana

Box Specifications

- All measurements are millimeters.
- The illustration is not drawn to scale.

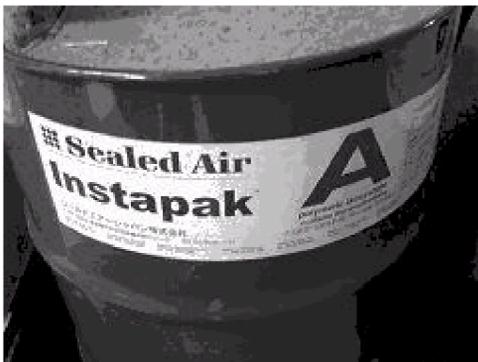
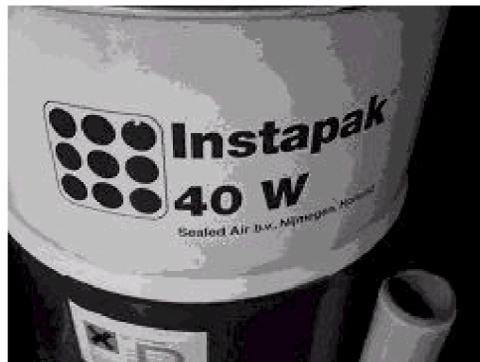
I01_02

Left	Right
A Liquid	B Liquid

Mixing the A and B liquids produces the foam.

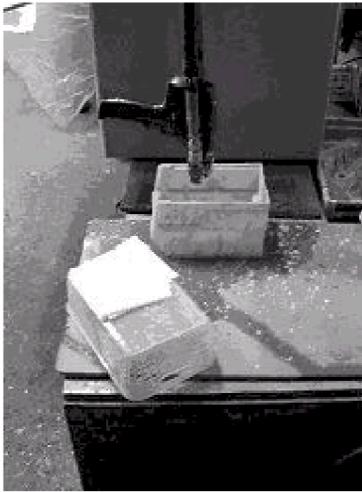
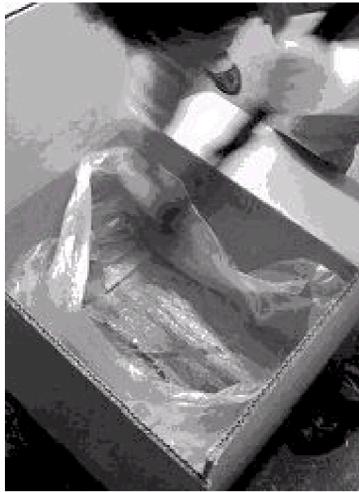
I03_04

Left	Right
Foam Spray Gun	Vinyl Bag

The mixture of liquids A and B is sprayed into a vinyl bag.

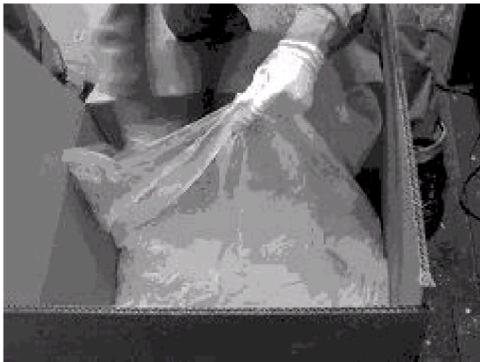
I05

Foam Spray Gun

The foam begins to form a few seconds after the mixture is sprayed into the bag and then gradually begins to harden. More can be added if the first injection of foam is not sufficient. Place the bottom of the machine on top of the bag so the foam molds itself to the shape of the machine.

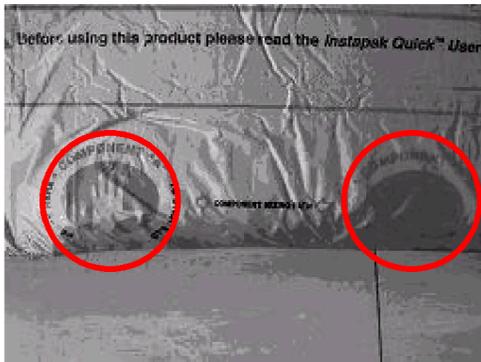
I14

Instapak Quick Packet

When the blue circles on the packet are pressed together this releases the A, B liquids and allows them to mix to instantly start forming urethane foam. This eliminates the need for a spray gun.

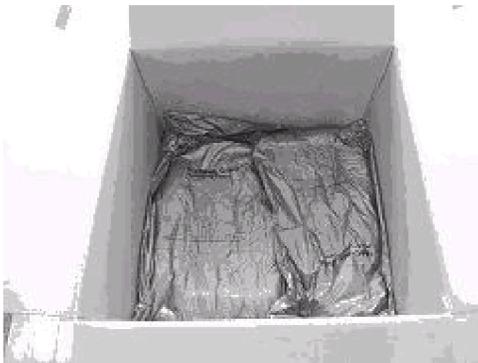
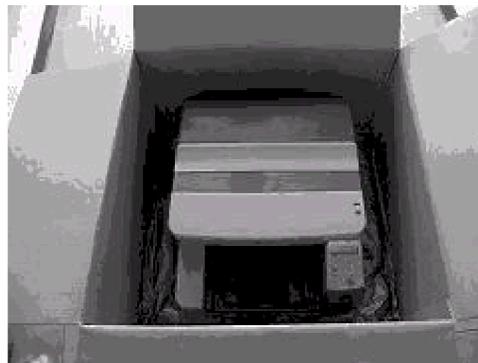
I15_16

Left	Right
Instapak Quick for Toscana (1)	Instapak Quick for Toscana (2)

Two packets have been placed into the box (left), then the machine placed on top of the packets (right).

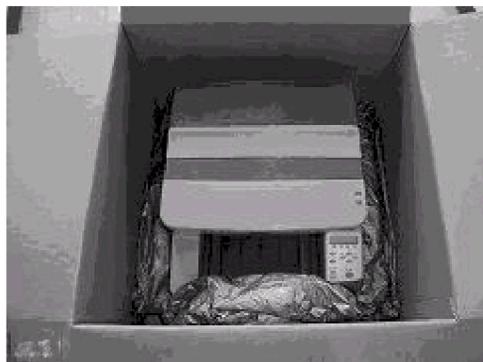
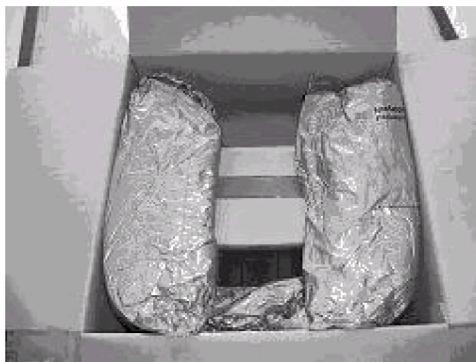
117_18

Left	Right
Instapak Quick for Toscana (3)	Instapak Quick for Toscana (4)

One packet is placed in front of the machine (left), then one packet is placed on the left and one on the right side of the machine.

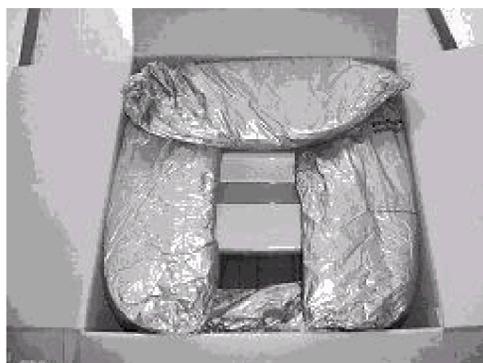
119

Instapak Quick for Toscana (5)

Finally, one packet is placed behind the machine.

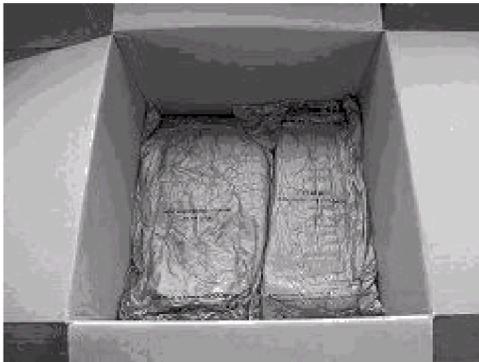
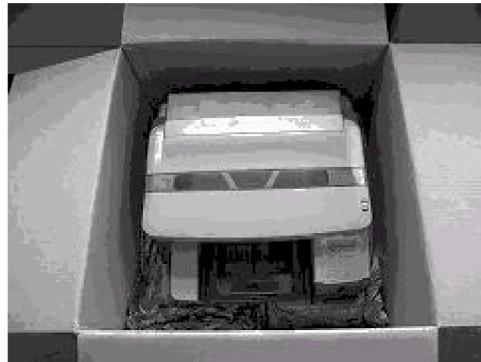
I20_21

Left	Right
Instapak Quick for Piemonte (1)	Instapak Quick for Piemonte (2)

Two packets have been placed into the box (left), then the machine placed on top of the packets (right).
