Pro C9100/C9110

Operating Instructions

Troubleshooting: TCRU/ORU

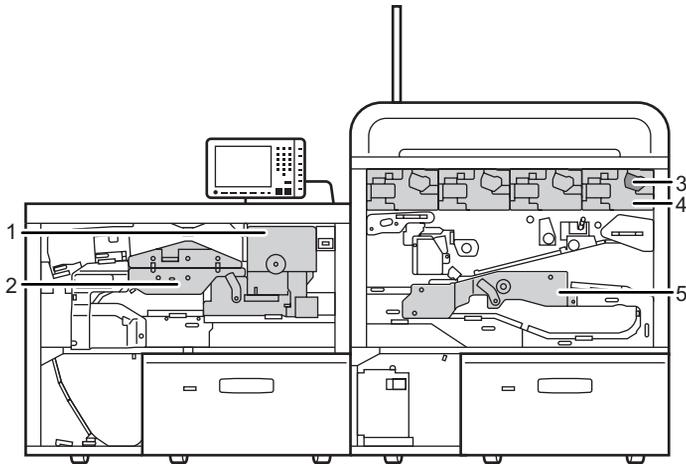
DFT046

1. Left drawer unit

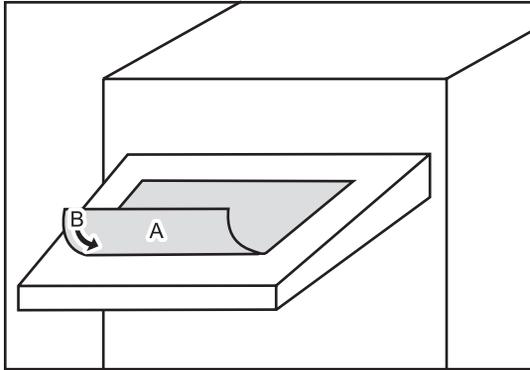
Single-sided printing: Printed side face down

A. Side 1

B. Paper feed direction of Side 1

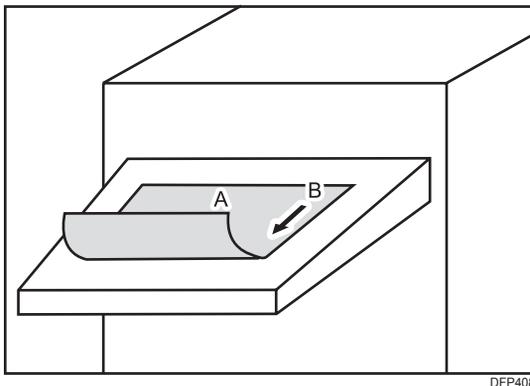
Single-sided printing: Printed side face up

A. Side 1

B. Paper feed direction of Side 1

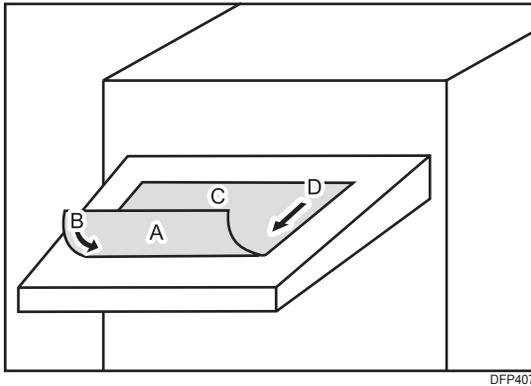
Duplex printing

- A. Side 1
- B. Paper feed direction of Side 1
- C. Side 2
- D. Paper feed direction of Side 2

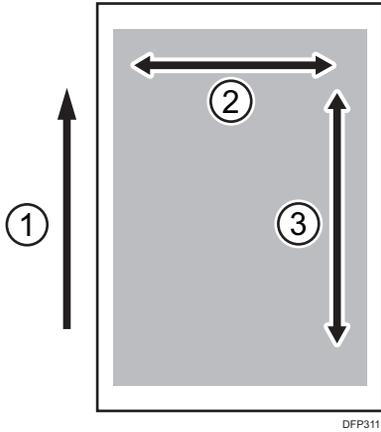
In this manual, with regard to the paper feed direction, the vertical and horizontal directions are as shown below:

1. Paper feed direction
2. Horizontal
3. Vertical

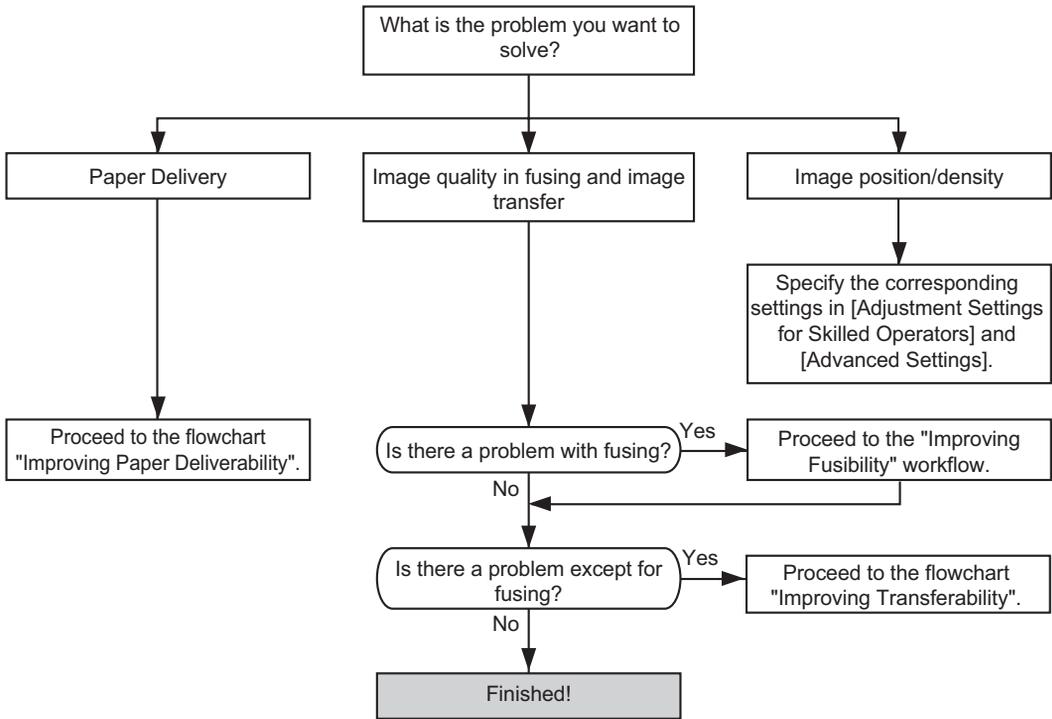
DFT076

Paper Setting Flowchart

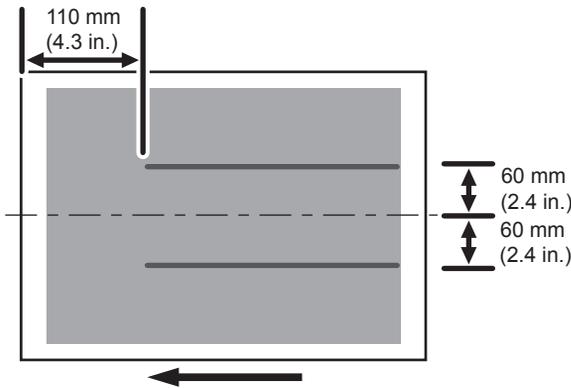
Vertical Black Streaks (1)

Black streaks appear at intervals of approximately 60 mm (2.4 inches) from the center. This occurs Side 1 only.

Because of inconsistent air volumes of the suction fan of the paper tray or the use of paper from different lots, black streaks may appear on parts where the belt and paper surface come into contact.

<p>DFP754</p>	<ul style="list-style-type: none"> • See page 41 "Vertical Black Streaks (1)". • See page 42 "Vertical Black Streaks (2)".
<p>Vertical white streaks Image missing in the shape of streaks in the paper feed direction.</p>

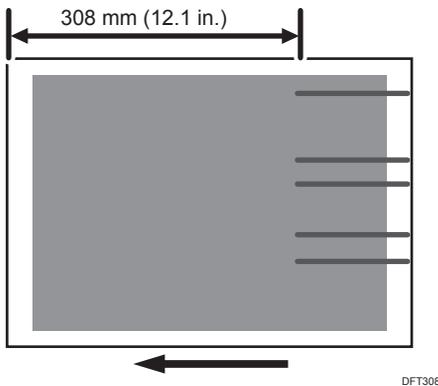
Black or cyan streaks that look like something was dragged appear parallel to the paper feed direction from approximately 308 mm (12.1 inches) from the leading edge.

This occurs when the paper is soiled with toner if it accumulates in the cleaning unit for the photoconductor unit and falls through the lubrication blade.

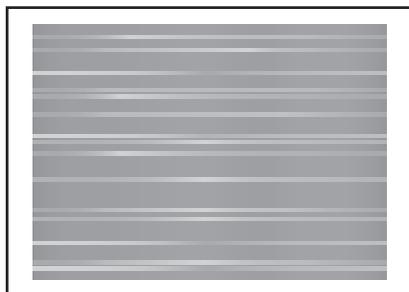
DFT091

Vertical White Streaks

White streaks appear in parallel to the paper feed direction.

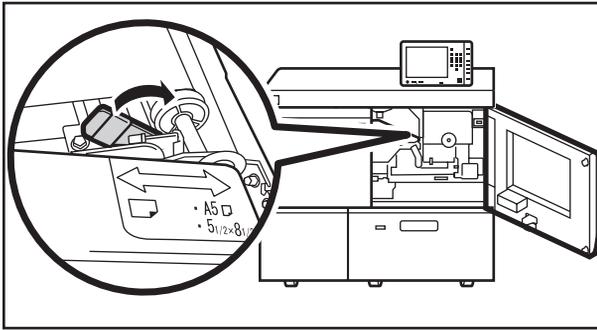
DFT090

1. Open the right front cover of the left unit, and then lower the lever for A5/Half Letter to the right.

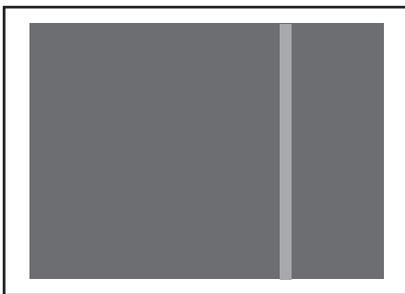
DFT022

Horizontal Streaks: When Using Thick Paper (1)

When thick paper is used, streaks appear in the horizontal direction to the paper feed direction.

The jitter that occurs when paper is fed through the paper transfer roller has caused image disturbances in the image transfer unit.

<p>DFP704</p>	<ul style="list-style-type: none"> • See page 44 "Horizontal Streaks: When Using Thick Paper (1)". • See page 46 "Horizontal Streaks: When Using Thick Paper (2)". • See page 46 "Horizontal Streaks: When Using Thick Paper (3)".
<p>Horizontal white streaks Image missing in the shape of streaks in the direction perpendicular to the paper feed direction.</p>

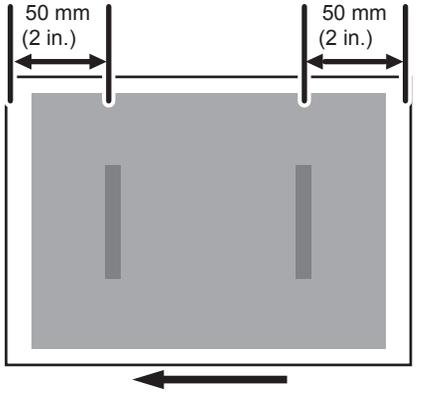
Horizontal Streaks: When Using Thick Paper (2)

Streaks appear at approximately 50 mm (2 inches) away from the leading or trailing edge of the paper.

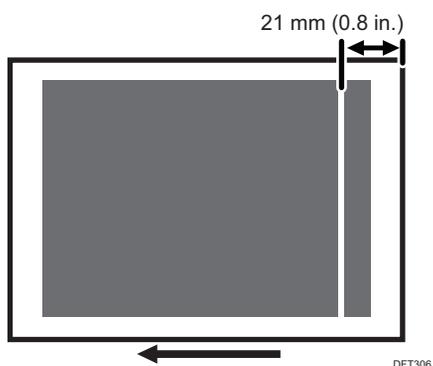
Horizontal Streaks: When Using Thick Paper (3)

When using thick paper, white streaks appear in the area 20 to 22 mm (0.78 to 0.86 inches) from the trailing edge of the paper.

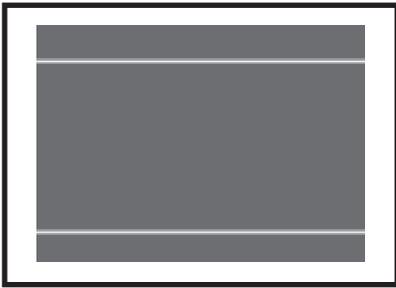
DFP455

Glossy Lines at the Edge of the Paper

A glossy line appears in parallel to the paper feed direction. This may occur on solid-fill images.

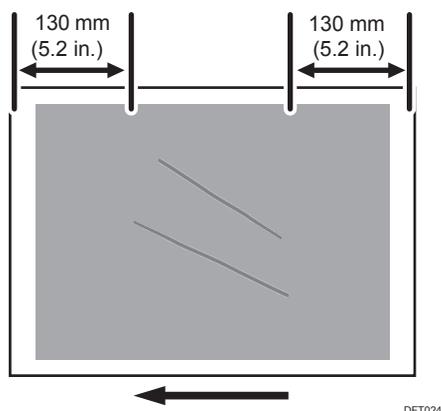
Oblique Wavy Streaks

Creases occur at the center of the paper and not in areas within 130 mm (5.2 inches) from the leading or trailing edge of the paper.

Due to the leading edge of the paper being curled or wavy directly after fusing, an angled force is applied to the paper until the trailing edge of the paper moves out of the fusing unit, producing oblique creases.

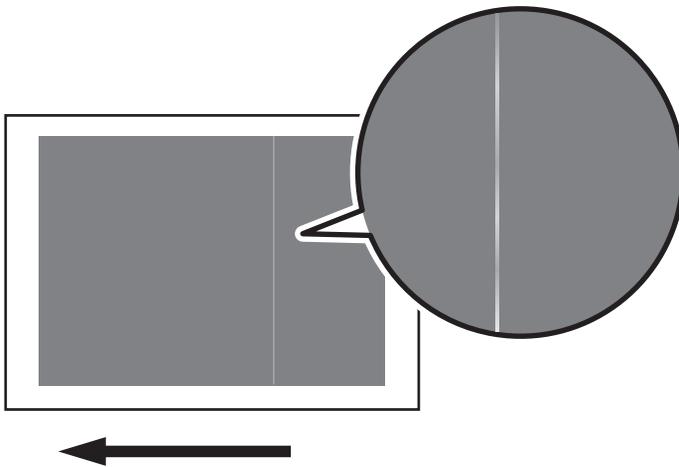
DFT300

Streaks like defect imagery Appear on the Paper Surface

Streaks appear as if scratched a needle, so that the background can be seen.

The paper path is stained.

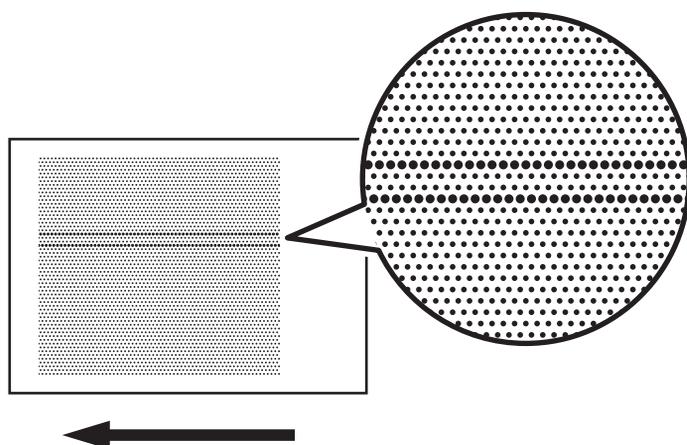
DFT054

Vertical Black Bands

Black bands that are 5 to 6 mm (0.2 inches) wide appear on a halftone image parallel to the paper feed direction.

The corona wire or grid in the charge roller unit is stained.

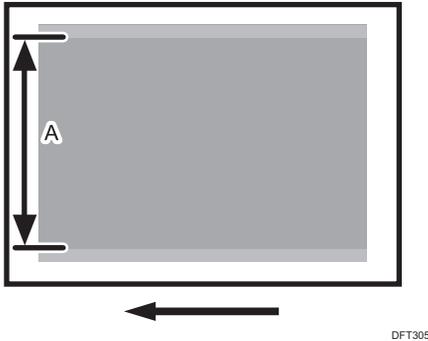
Vertical White Bands

When printing on large paper after continuously printing on small paper, concentration differences occur on the inner and outer sides of the small paper width (A).

The amount of lubricant on the intermediate transfer belt is uneven.

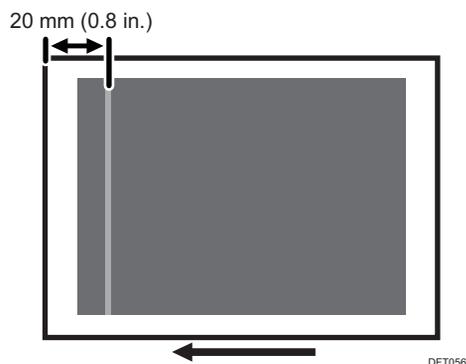
Horizontal Streaks at the Area within 20 mm (0.8 inches) from the Leading Edge

An area within approximately 20 mm (0.8 inches) from the leading edge of the paper may be affected by thick density, insufficient density, toner blasting, or streaks.

- Thick paper is used
- Coated paper is used
- Printing is done at low temperature or humidity

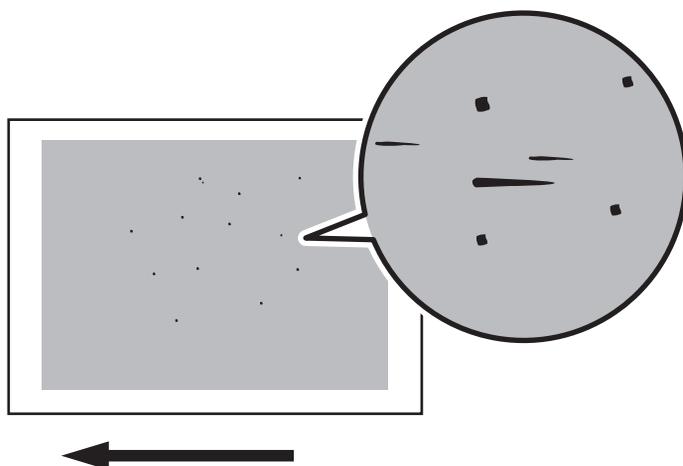
Black (color) Spots (1)

Black or colored spots appear.

This may occur if you use toner which has been left at high temperature and humidity.

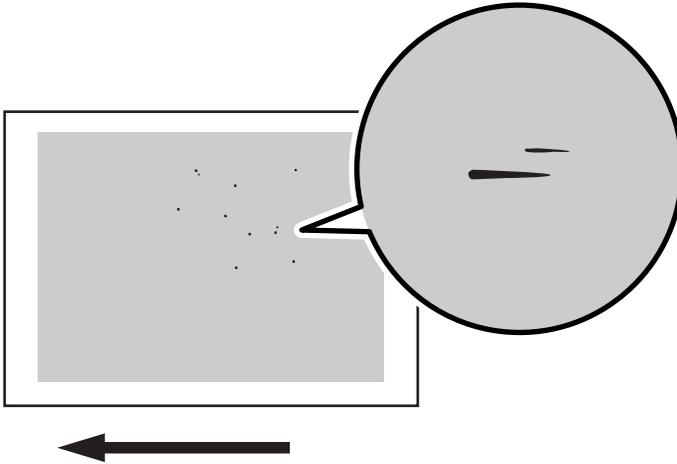
CEZ538

Black (color) Spots (2)

Paper is stained with toner spots of 0.5–1 mm (0.02–0.04 inches) in diameter.

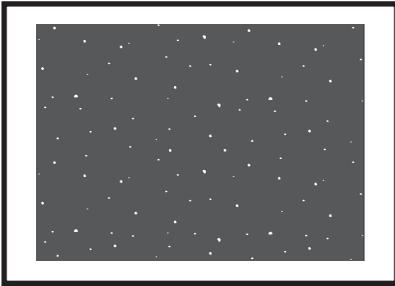
CEZ527

White Spots

White spots of 0.2 to 0.3 mm (0.008 to 0.01 inches) in diameter appear.

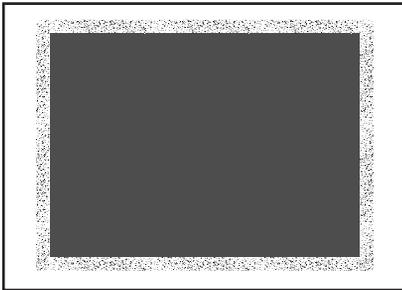
CEZ546

Toner Blasting

Toner is scattered around a solid-fill print.

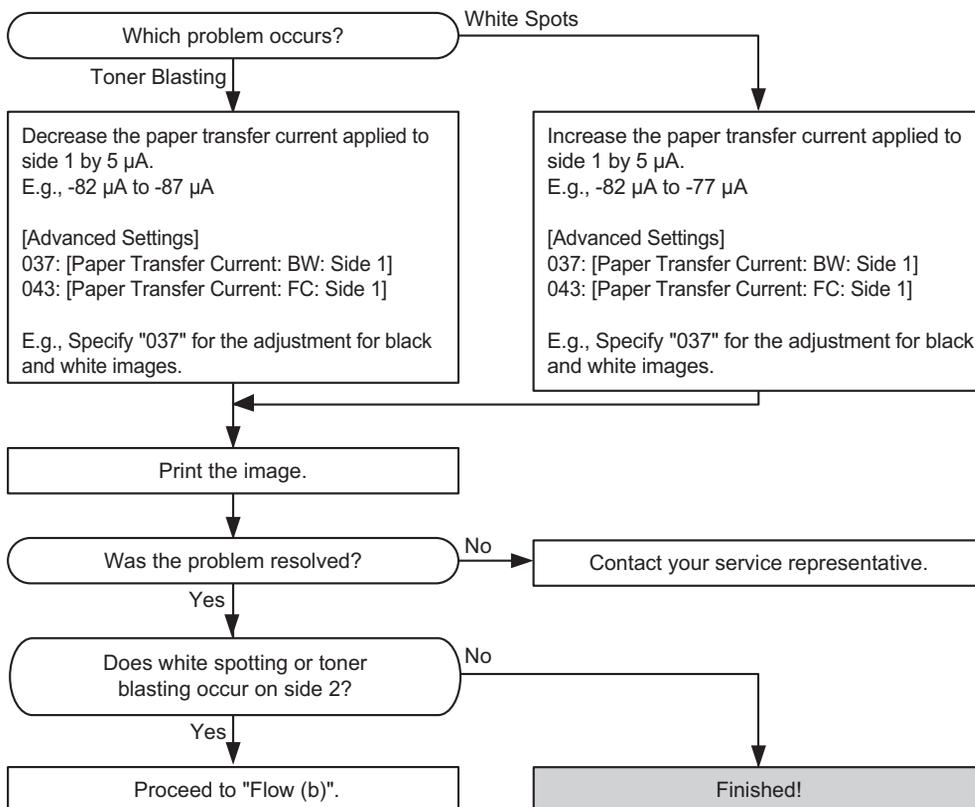
DFT087

<a: If the problem occurs on side 1>

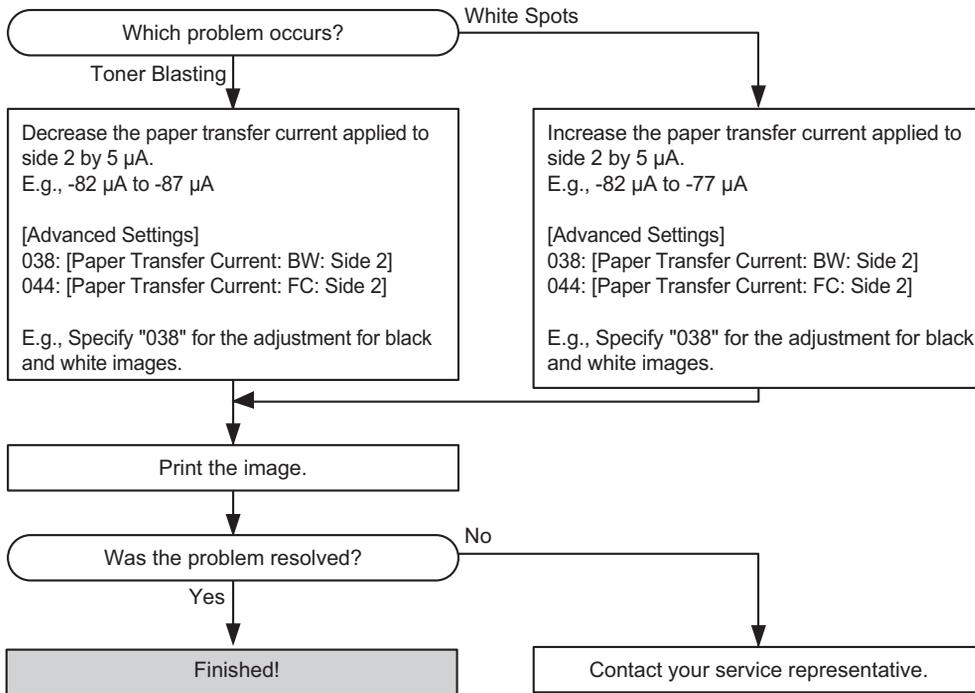
DFT068

If the problem occurs on side 2

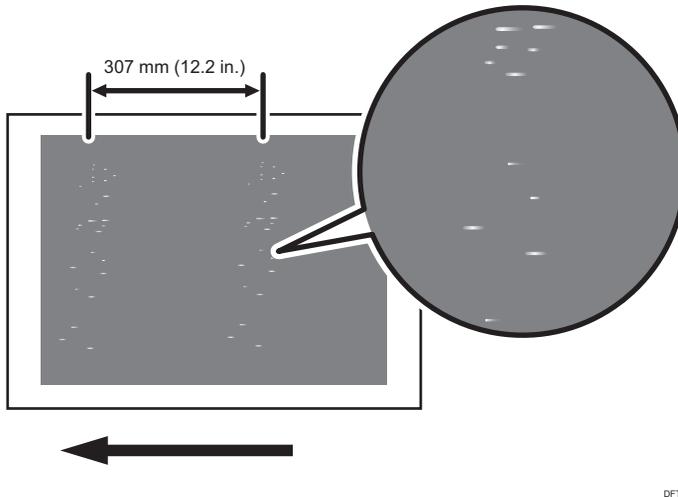
DFT040

Medaka (White Spots)

White dots or short lines appear, spaced at intervals of 307 mm (12.2 inches) in the direction of the paper feed.

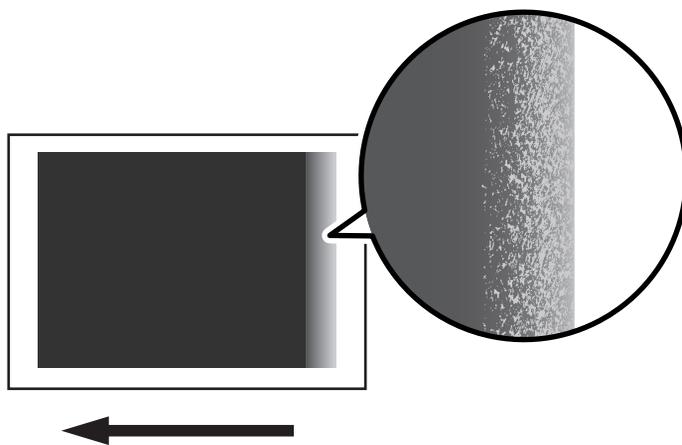
CEZ563

Fainter Trailing Edge

The trailing edge is fainter.

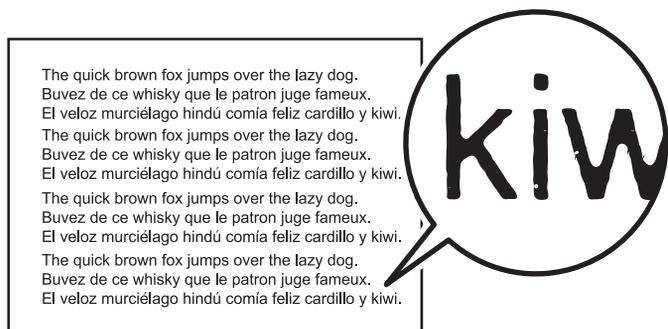
DFT057

Faint Printing

Small text and lines are printed faintly.

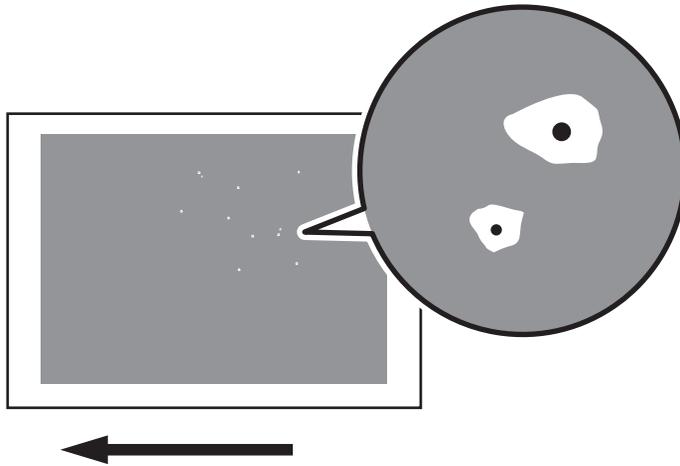
DFT058

Colorless Spots

White spots appear randomly.

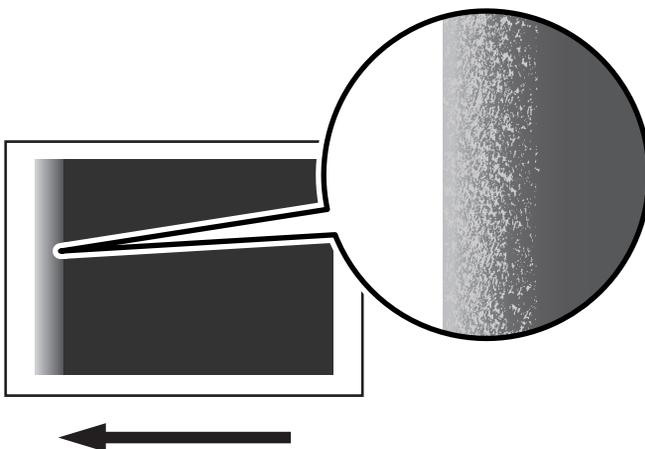
CEZ562

Density Fluctuation at the Leading Edge (When Using Thick Paper)

The leading edge is fainter or denser when using thick paper.

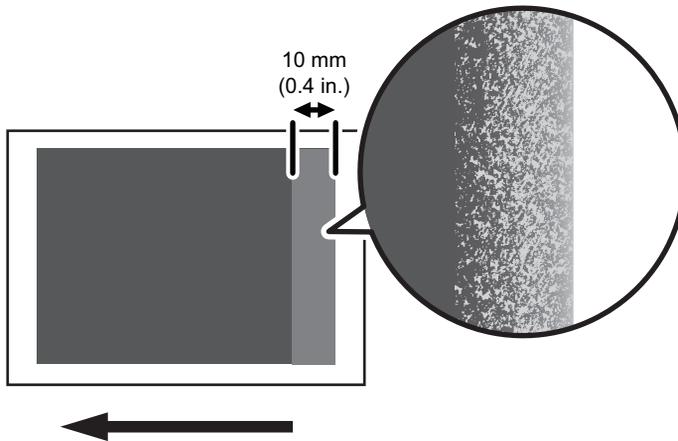
DFT059

Density Fluctuation at the Trailing Edge (When Using Thick Paper)

The trailing edge is fainter or denser when using thick paper.

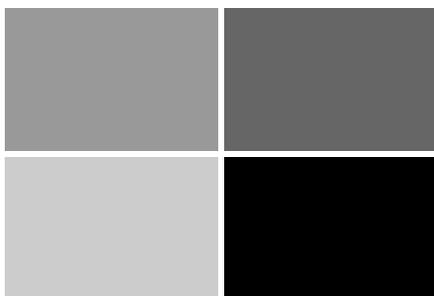
CEZ566

Black is fainter than normal during full color printing.

Normal

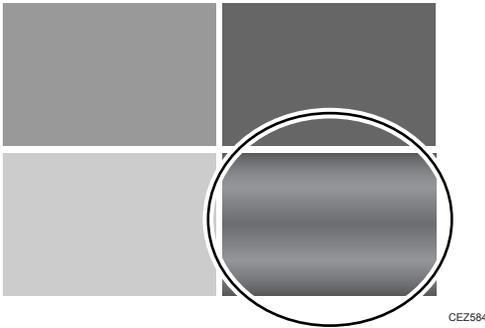
Black is fainter

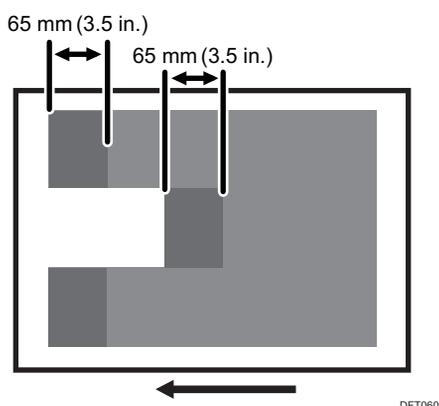
Higher Density at the Leading Edge

The area within approximately 65 mm (3.5 inches) from the leading edge of the image or at the trailing edge of the blank area is dense.

Printing is done at low temperature or humidity.

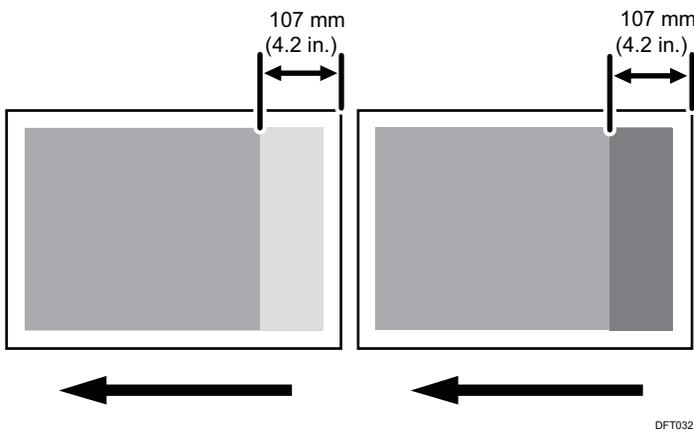
Uneven Density within 107 mm (4.2 inches) of the Trailing Edge

Printing in the area extending approximately 107 mm (4.2 inches) from the trailing edge is fainter or denser.

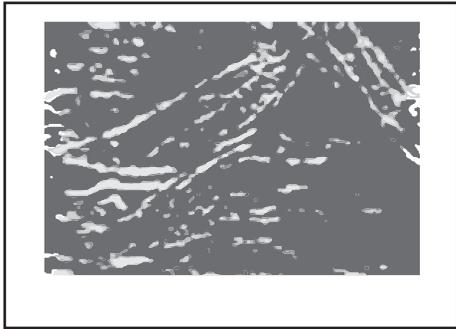
CXM001

White Spots on a Textured Surface

White spots appear on indentations.

<p style="text-align: right; font-size: small;">DFP723</p>	<ul style="list-style-type: none"> • See page 65 "Fainter Trailing Edge". • See page 79 "White Spots on a Textured Surface".
<p>Wormholes</p> <p>The outline of a letter (or a line) is reproduced but the inside of it is missing.</p>

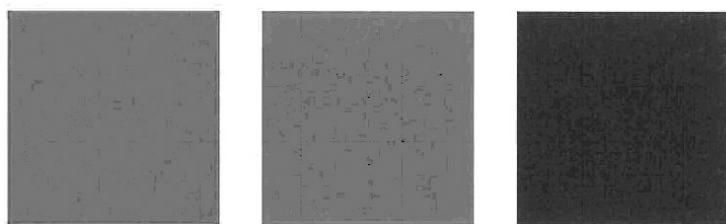
Mottling occurs in solid-filled areas.

Normal

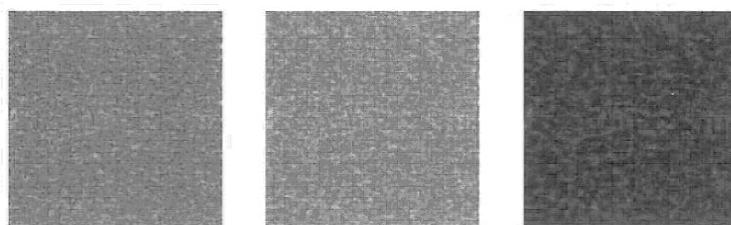
Mottled

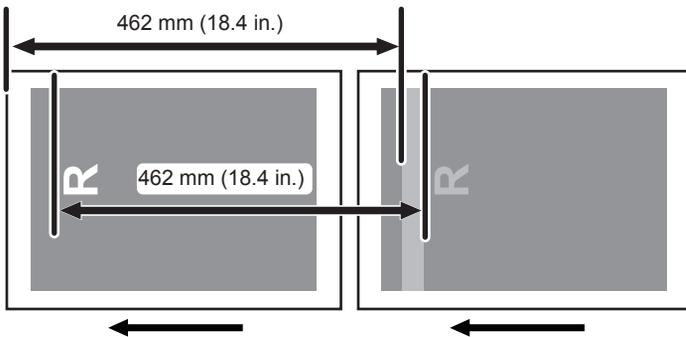
DFT061

A ghost image of a printed image appears at a distance of 462 mm (18.4 inches) to the side of the image.

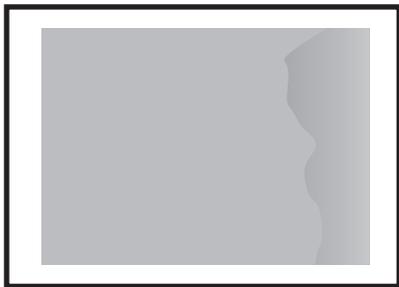
DFT042

Uneven Gloss: Wavy

When duplex printing is performed on paper whose paper thickness level is between 1 and 4, wavy density fluctuations may occur on side 2.

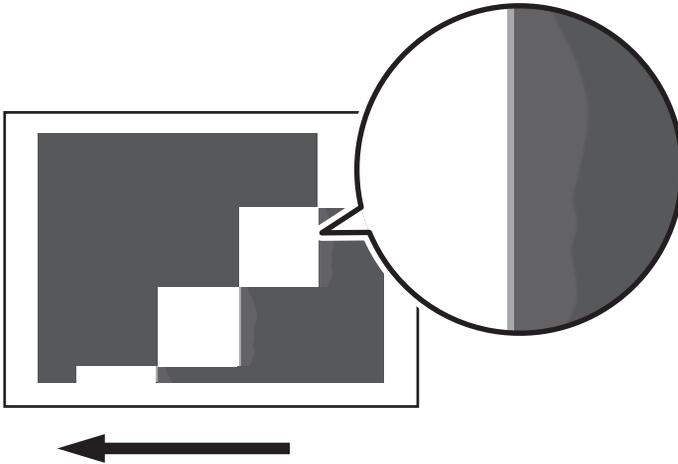
DFT047

Uneven Gloss: Foggy

Glossiness is insufficient at the trailing edge of the blank area.

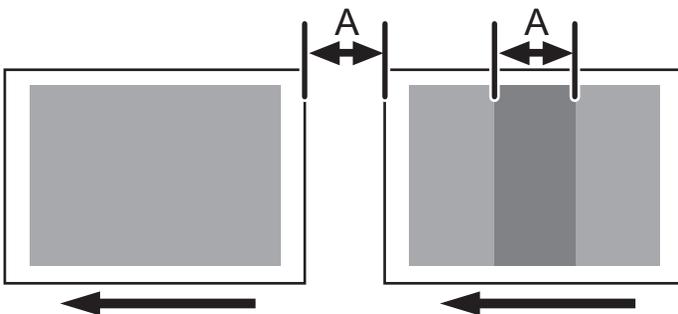
DFT072

Uneven Gloss: Thick Paper

When duplex printing is performed on thick paper, uneven glossiness having the same width as the interval between the previous sheet (A) appears on Side 1.

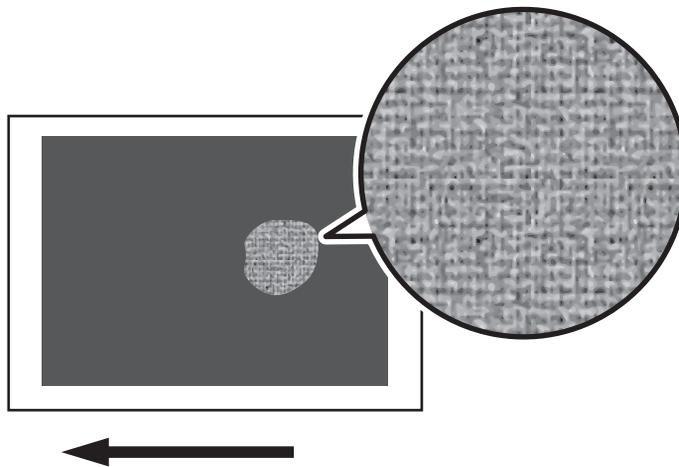
DFT048

Uneven Gloss: Orange Peel

Uneven glossiness occurs when solid-fill images are printed.

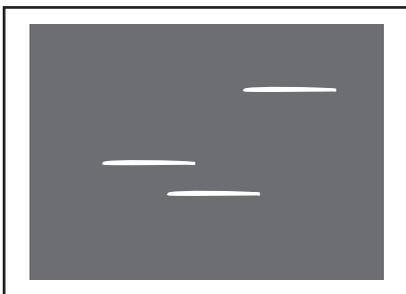
DFT026

Uneven Glossiness due to Cooling

Image-defect-like glossy streaks appear randomly.

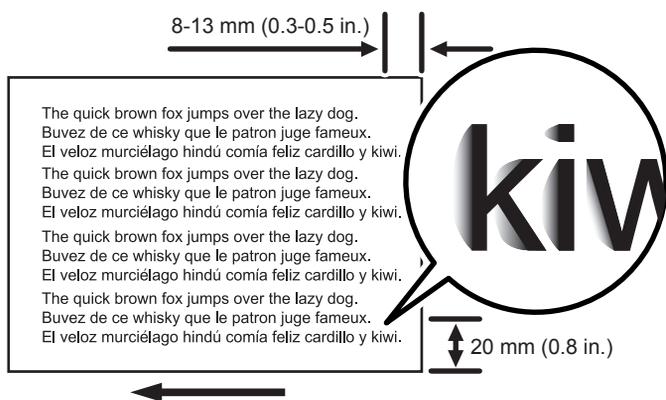
CNT009

Toner Scattering: Trailing Edge

Parts of a line or character exhibit splatter. This may occur in a line or character that is 8 to 13 mm (0.3 to 0.5 inches) from the trailing edge and 20 mm (0.8 inches) or less from the left edge facing the paper feed direction.

A shock jitter occurs when the trailing edge of the paper leaves the paper guide during paper transfer and causes toner scattering.

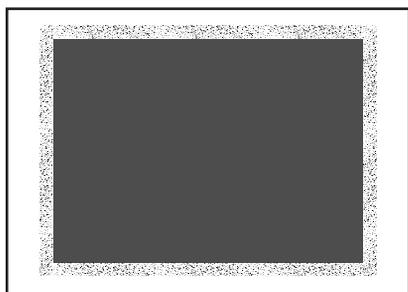
CEZ545

Toner Scattering: Around a Solid Fill Image

Toner is scattered around a solid-fill print.

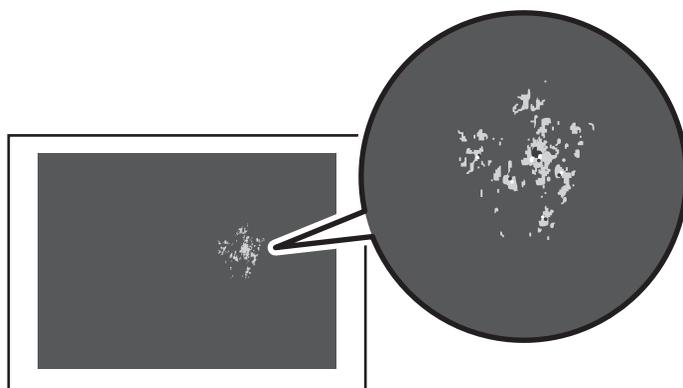
DFT062

Stained When Duplex Printing is Performed

When duplex printing is performed, side 1 of the paper becomes stained.

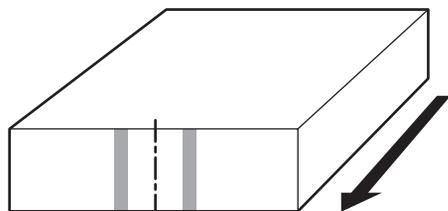
DFT322

Paper Edges are Stained

The paper path is stained.

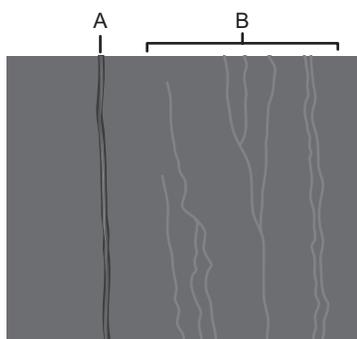
DFT303

B. Worm track

Wavy streaks appear.

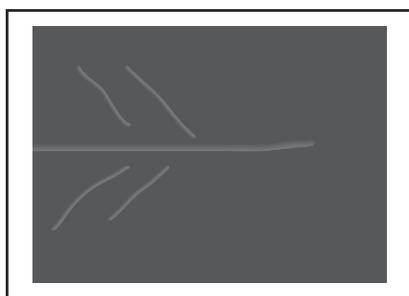
DFT304

Bent

Umbrella-like creases appear at the center of the paper.

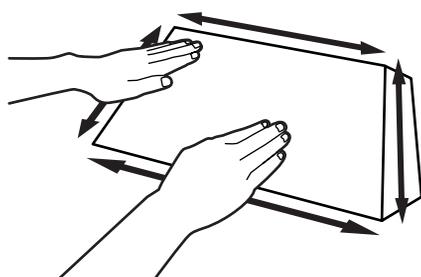
CEZ500

Flatten the envelope and all its edges to eliminate air before loading. If the envelope is curled, decurl it before loading.

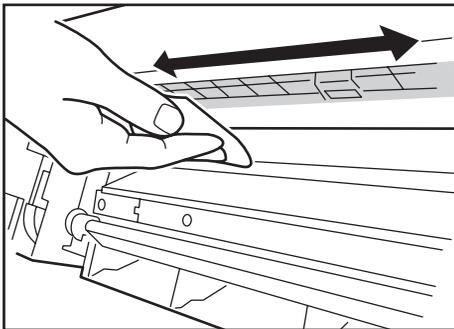
CZC348

Guide Plate

Wipe the guide plate with a well-wrung-out damp cloth. To clean the innermost recesses, use a cloth that is as large as your palm.

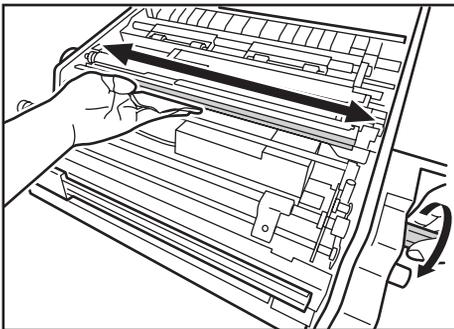
CZC349

Roller

Wipe the roller with a well-wrung-out damp cloth, and then wipe with a dry, unused, lint-free cloth until no moisture remains.

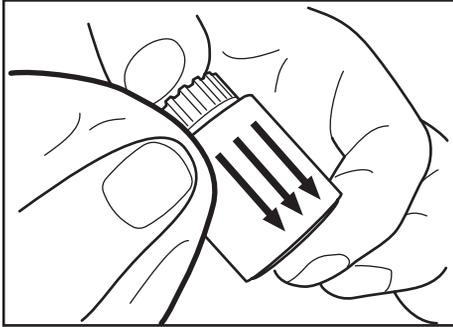
CZC350

Paper Feed Roller

Wipe the entire surface of the paper feed roller lengthwise with a well-wrung-out damp cloth, and then wipe with a dry, unused, lint-free cloth until no moisture remains.

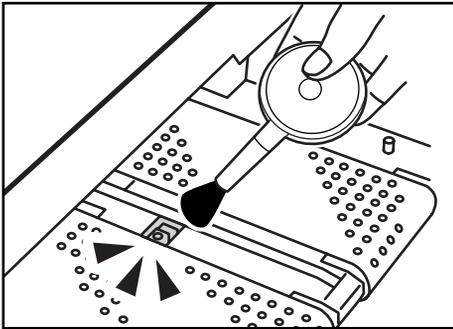
CZC347

Sensor

Remove dust with a blower brush.

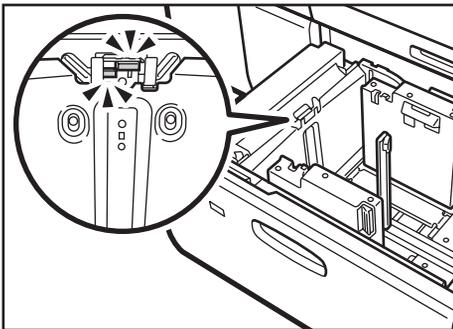
DFT002

1. Remove the paper tray.
2. Clean the sensors.

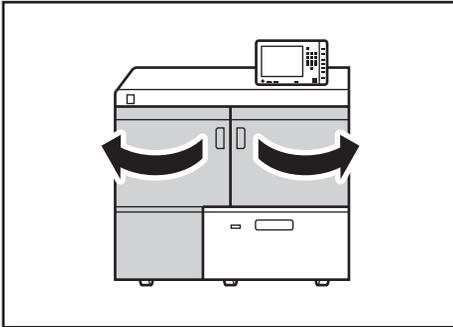
DFT003

1. Open the front cover of the left unit.

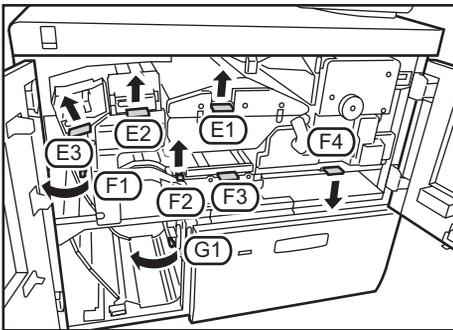
DFT004

2. Open the plates.

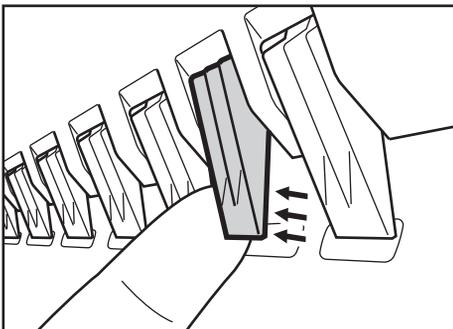
DFT311

3. Clean the rollers, sensors, and guide plates.
4. Open the F1 plate and clean the separation claw.

Lift the separation claw and clean the area around the tip on the side which comes into contact with the paper. Clean 7 claws.

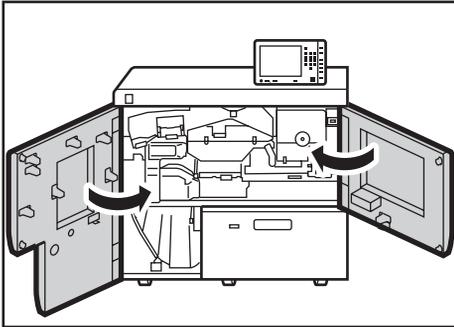
DFT006

6. Close the front covers.

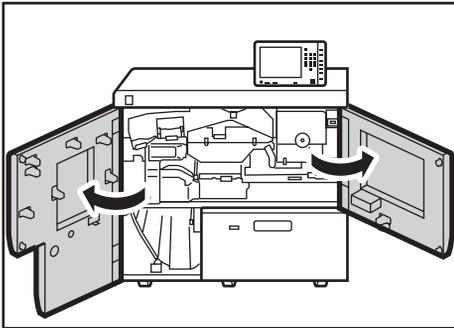
DFT005

1. Open the front cover of the left unit.

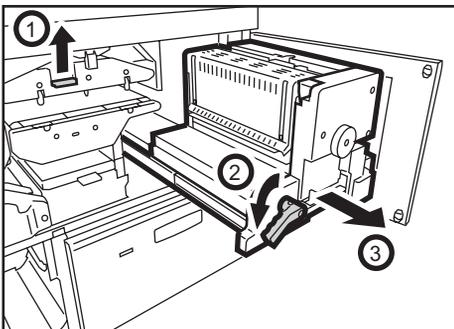
DFT007

2. Raise the E1 plate, lower the lever D1, and then pull out the unit in the left drawer until it stops.

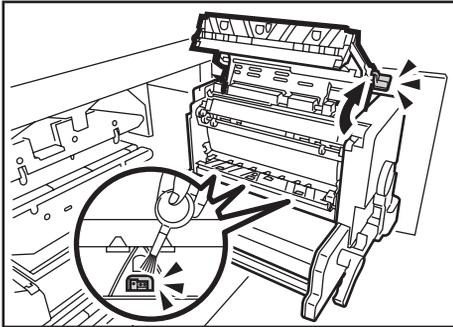
DFT008

3. Pull up the lever D2 and clean the sensors.

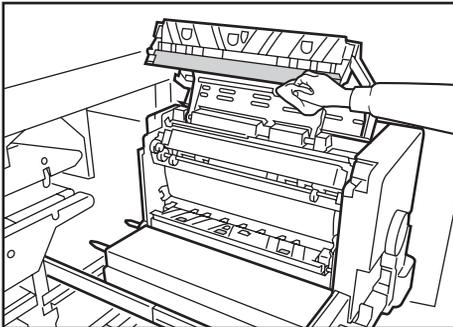
DFT009

4. Use a dry cloth to clean the plate.

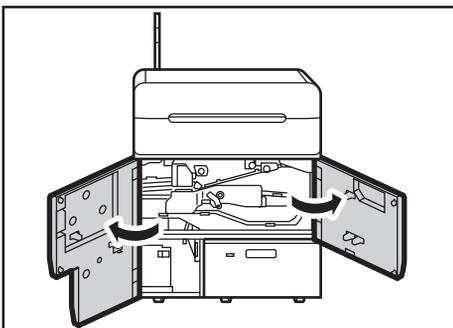
DFT010

1. Open the front cover of the right unit.

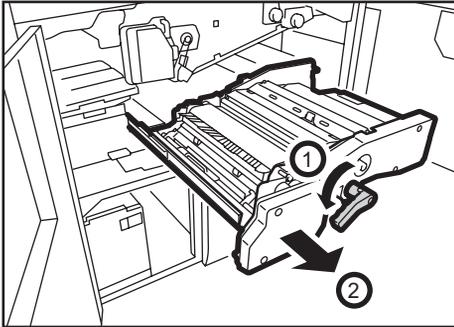
DFT011

- 2. Pull down the lever C2 and pull out the right drawer until it stops.

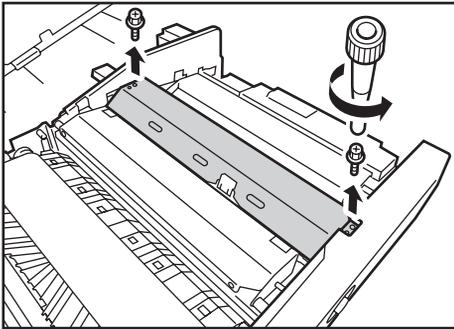
DFT012

- 3. Remove the two screws and then remove the cover plate.

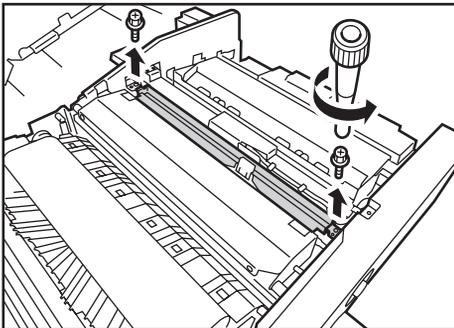
DFT013

- 4. Remove the two screws and then remove the dust catcher.

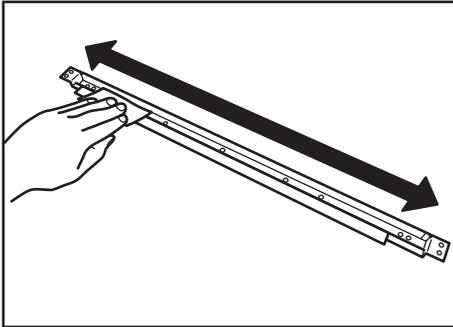
CEZ199

5. Use a clean dry cloth to remove any dust remaining in the dust catcher.

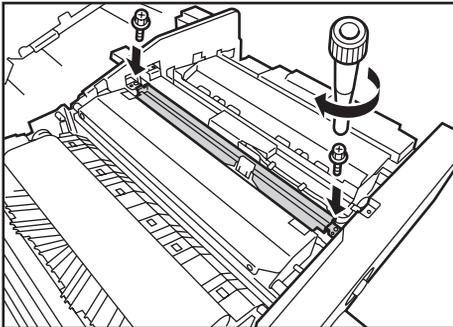
DFT014

6. Reattach the dust catcher with the two screws.

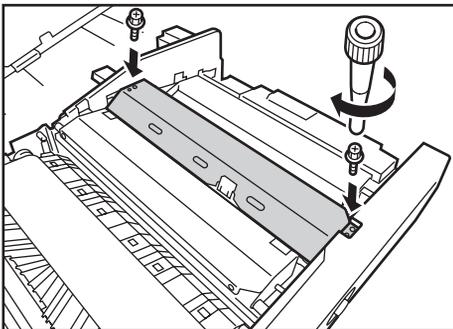
DFT015

7. Reattach the cover plate with the two screws.

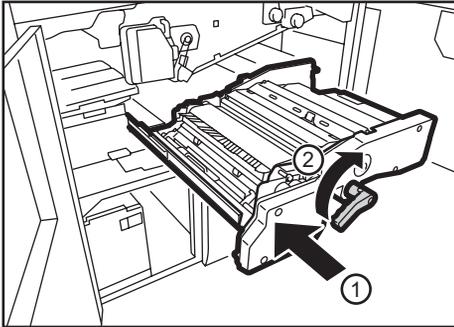
DFT016

8. Push the right drawer into the main unit until it stops, and then pull up the lever C2.

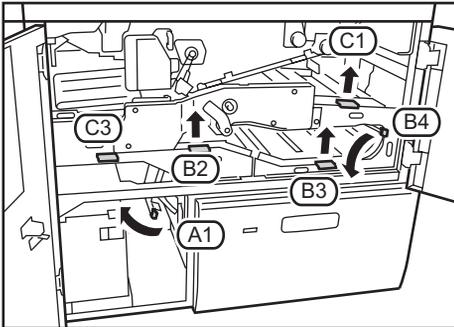
DFT017

9. Open the plates.

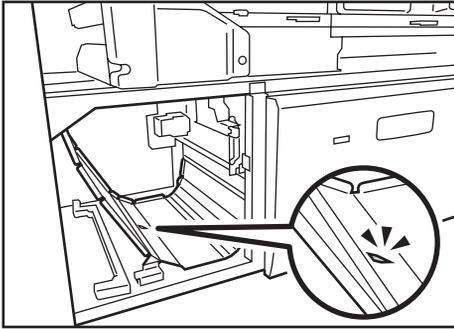
DFT018

3. Clean the sensors.

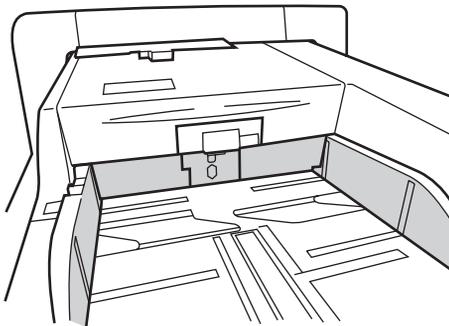
CEZ587

1. Clean the side fences and front guide.

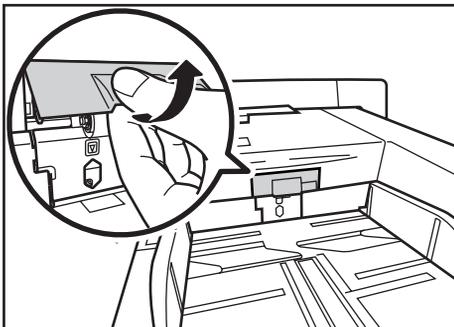
CZC128

2. Remove the cover.

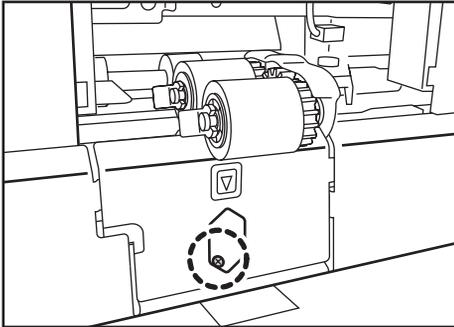
CZC124

3. Remove one screw.

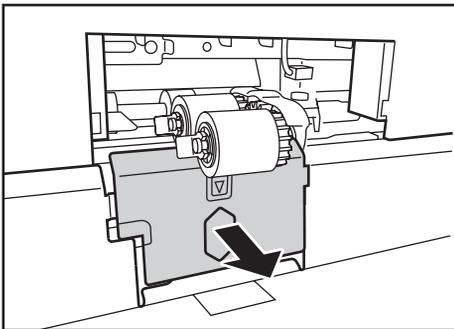
CZC129

4. Remove the plate.

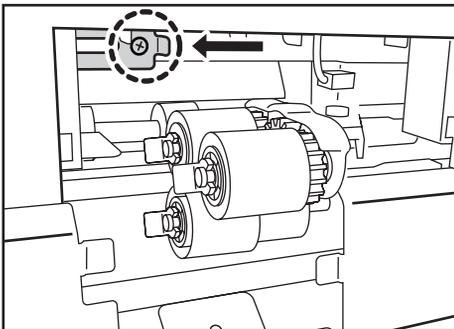
CZC125

5. Remove one screw and slide the bracket.

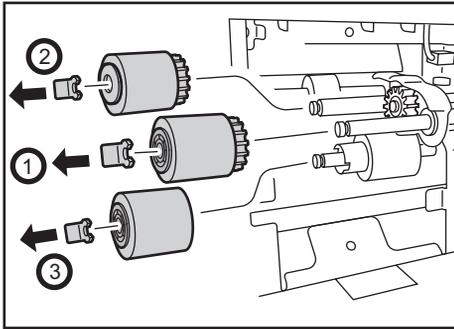
CZC132

6. Remove the paper feed rollers as follows:

- (1) Snap ring and pick-up roller
- (2) Snap ring and feed roller
- (3) Snap ring and separation roller

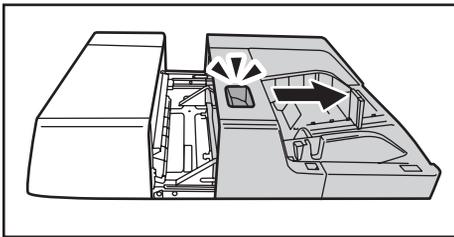
DFT312

7. Clean the paper feed rollers.
8. Attach the paper feed rollers, bracket, plate, and cover in the reverse order from the procedure to remove them.
9. Release the lock and slide the unit to the right.

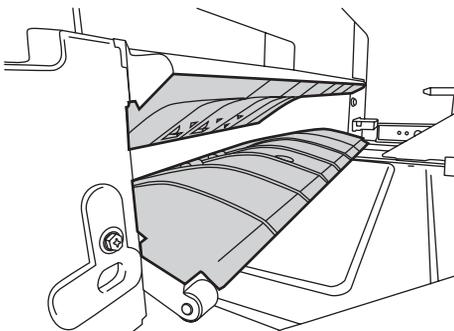
CEZ506

10. Clean the guide plate.

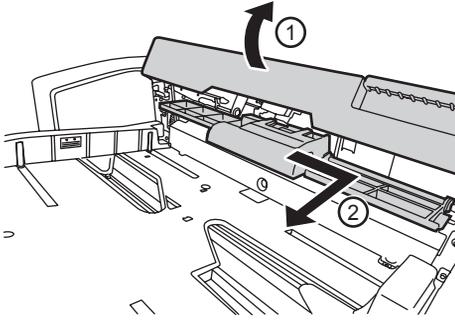
CEZ507

2. Open the upper cover, and then detach the paper feed unit.

Pull it out slightly, release the metal shaft, and then detach it.

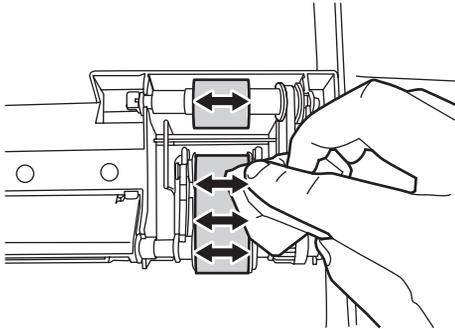
CEZ508

3. Clean the paper feed belt and paper feed rollers in the detached paper feed unit.

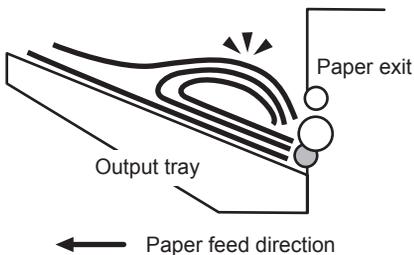
CEZ594

Sheet bending

The leading edge of the delivered sheet bends upward and backward.

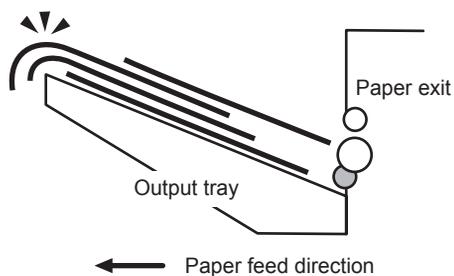
CEZ595

One sheet pushing out another

Because of high paper friction, the delivered sheet may get stuck and push out other sheets of paper.

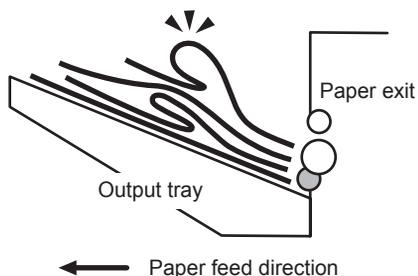
CEZ596

Paper deflection

Because of high paper friction, the delivered sheet may arch up and become crimped.

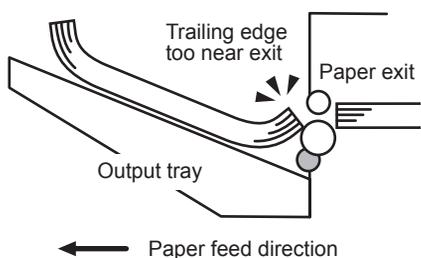
CEZ593

This may occur if:

- There is a tight curl on a delivered set of stapled sheets.
- Limp paper such as thin or recycled paper is used.

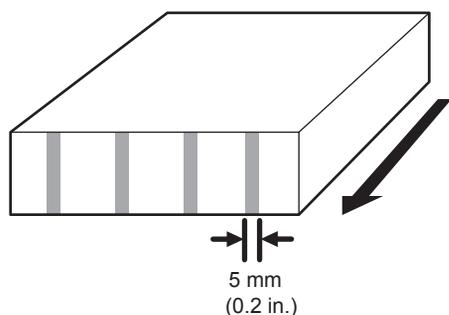
Paper Edges Are Stained (2)

When a particularly dense image is printed, the paper feed rollers may become soiled with toner and the paper edges may in turn be soiled by the toner on the paper feed rollers.

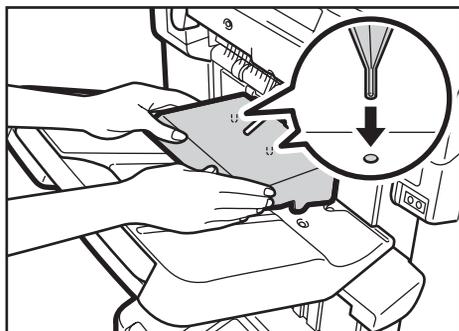
DFT089

Attach the Z-fold support tray to the finisher shift tray.

Attach the Z-fold support tray by inserting the two protrusions on its underside into the holes on the finisher shift tray.

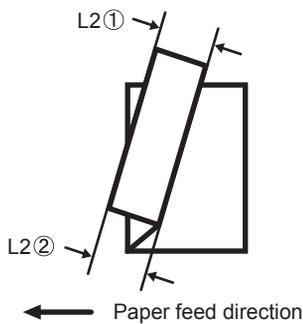
CEZ531

For example, in the following illustration, the dimensional difference between the top (L2[2]) and bottom (L2[1]) edges is a deviation.

<Folding deviation sample of L2 for Z-fold>

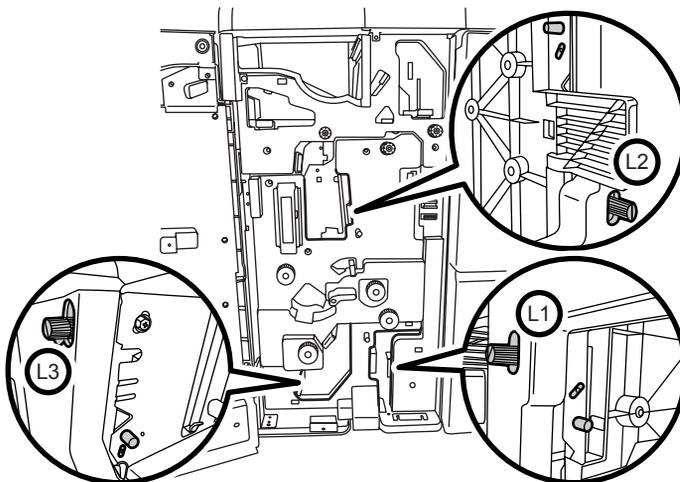
CEZ509

The multi-folding unit has three adjusting screws (L1, L2, and L3) to adjust deviation.

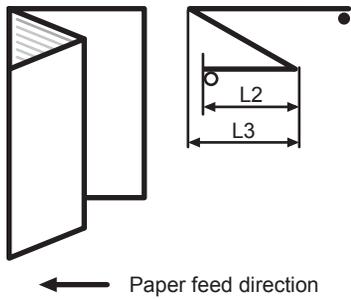
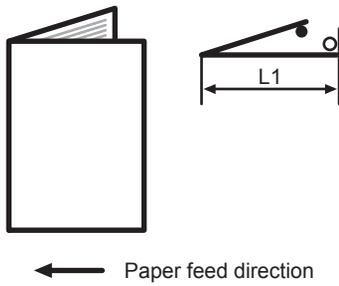
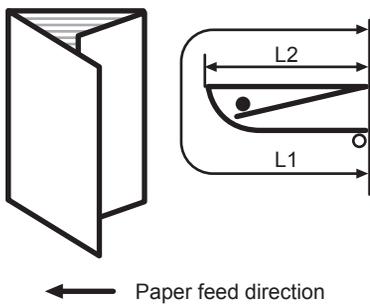
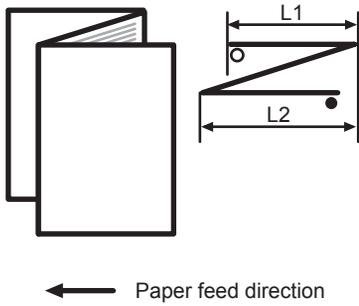
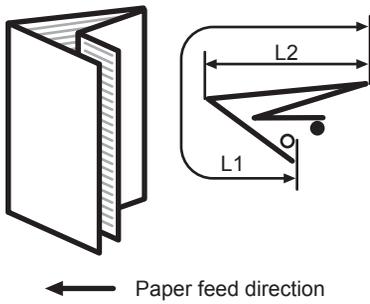
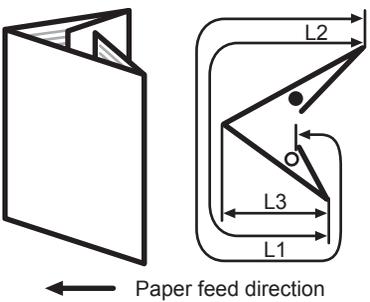
The screws adjust the folding deviations of the following parts:

The ○ mark indicates the leading edge (relative to the paper feed direction), and the ● mark indicates the trailing edge.

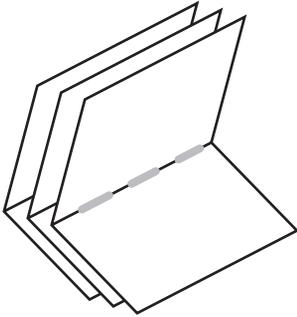
CEZ571

If multi-sheet folding is performed after a large number of Z-folds have been performed, the tip of the blade used for the multi-sheet folding may be stained, resulting in stained paper.

This will produce paper stain of 1-3 cm (0.4-1.2 inches) in width (equal to the width of the blade) in the fold in the center of paper.

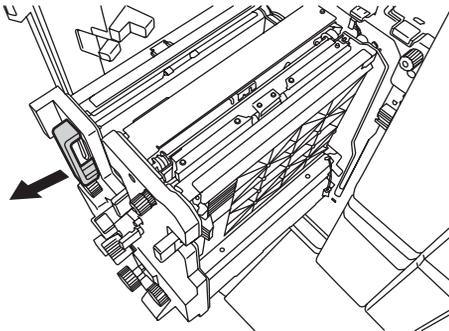
CEZ511

1. **Open the front cover of the multi-folding unit.**
2. **Pull the multi-folding unit out.**

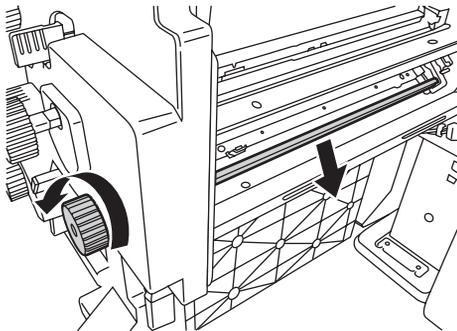
CEZ512

3. **Turn the N11 dial counterclockwise until the blade appears.**

The blade is located in the right part of the multi-folding unit.

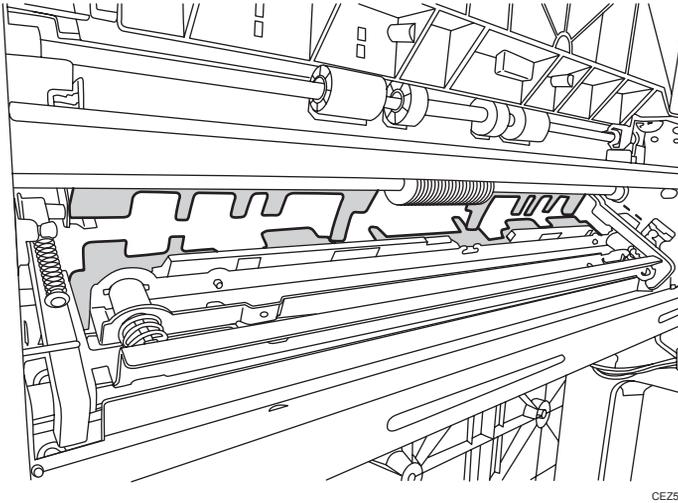
CEZ513

4. Wipe the tip and top of the blade with a soft dry cloth.

Be careful not to damage the blade.
