Pro C9100/C9110

Operating Instructions

Troubleshooting: TCRU/ORU

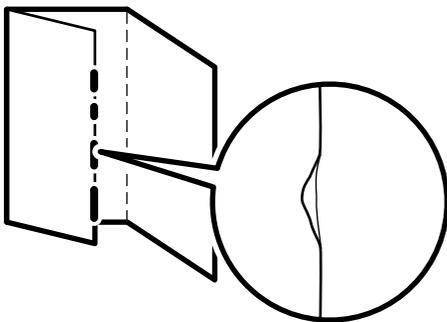
CEZ592

Edges of Letter Fold Bent

When letter folding is applied, the edge of the inner flap may become bent.

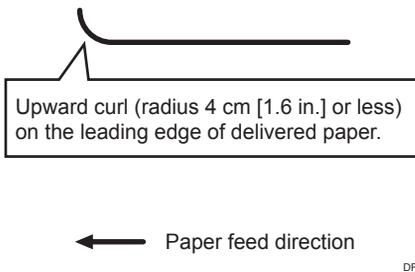
If a sheet is curled and its edge touches the guide plate, proper folding may not be possible.

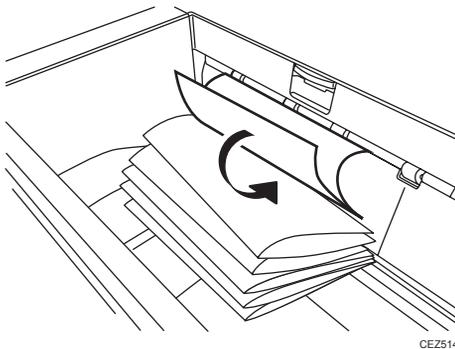
- Thick, relatively stiff paper is used.
- When 120: [Process Speed Setting] is set to [Low] in the [Advanced Settings] for the custom paper.

As a bundle is delivered, its folded edge may droop and catch on the stacked bundles, causing the delivered bundle to flip over.

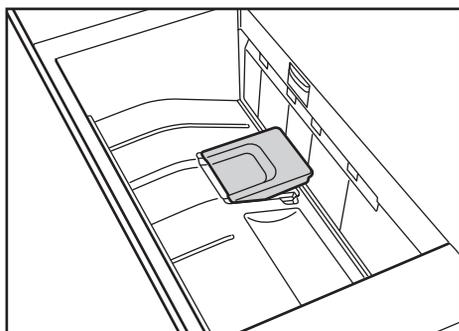
DFFP351

Use the Z-fold support tray for multi-folding unit.

This will reduce the angle of stacked bundles and prevent bundles flipping over as they are delivered.

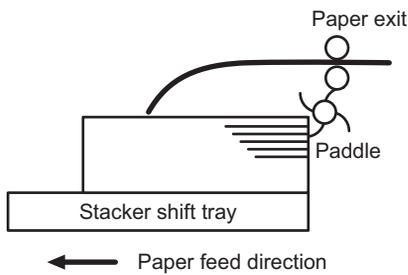
CEZ573

1. Downward curled paper is delivered to the stacker tray.

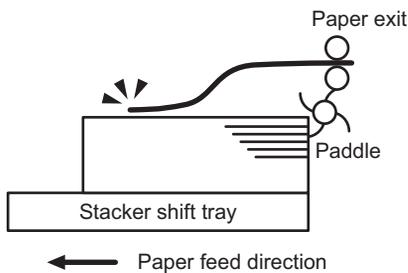
CEZ574

2. The leading edge of the sheet, while delivered, causes strong paper-to-paper friction against the top sheet of the stack. As there is no air gap between the sheets, and the delivered sheet becomes stuck.

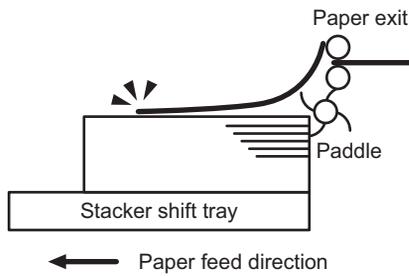
CEZ575

3. The trailing edge of the sheet, while delivered, is left in the paper exit.

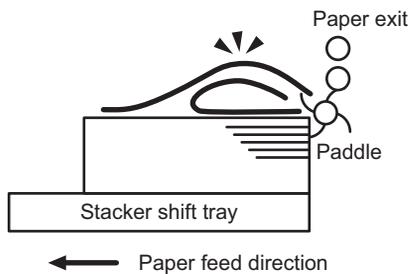
CEZ576

4. The next sheet to be delivered slips under the sheet still in the paper exit and bends back.

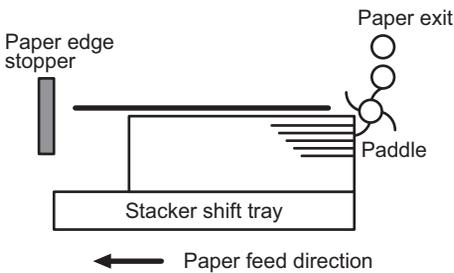
CEZ577

1. An uncurled sheet is delivered to the stacker shift tray.

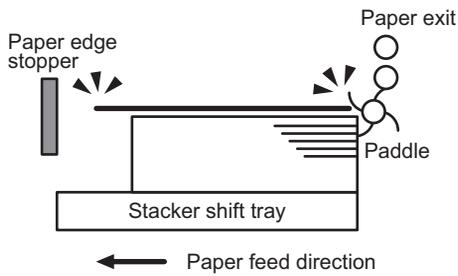
CEZ578

2. Strong friction occurs on the trailing edge so that the paddle cannot pull the sheet back and align the edges of the sheet with those of the stack.

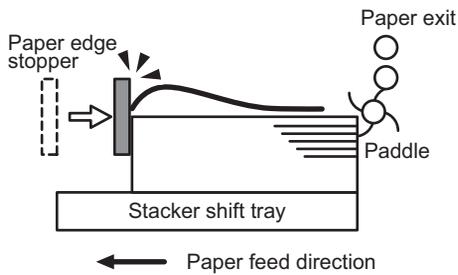
CEZ579

3. The paper edge stopper fails to push back the protruding leading edge and align the sheet as required.

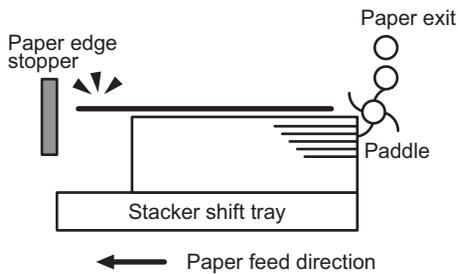
CEZ580

4. Stacked sheets are not aligned properly.

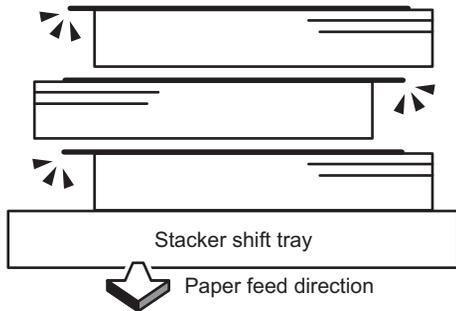
CEZ605

- The top sheet of each offset bundle of delivered sheets may protrude above the rest of the bundle by about 7 mm (0.2 inches).

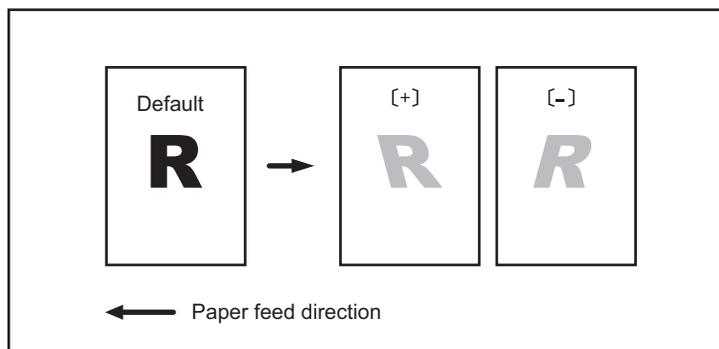
DFT310

(a) Adjust the image skew

Adjust the vertical position of the print image.

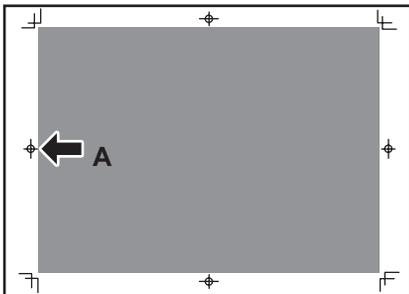
DFP492

(b) Adjust the image position (If custom paper is used)

Adjust the vertical and horizontal image position so that the center (A) of the leading edge of the image is aligned to the registration mark.

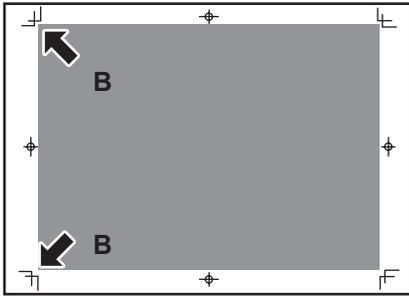
DFP320

(c) Adjust the magnification (Across feed direction)

Adjust the horizontal magnification to adjust the width between the front (B) and back corners (B) on the leading edge of the image.

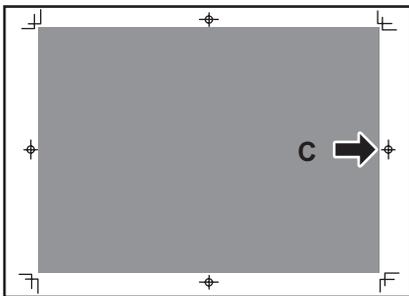
DFP321

(d) Adjust the magnification (With feed direction)

Adjust the vertical magnification to adjust the length (position of (C)) of the image.

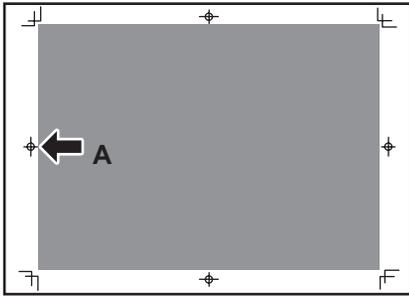
DFP492

(e) Adjust the image position (If custom paper is not used)

Adjust the vertical and horizontal image position so that the center (A) of the leading edge of the image is aligned to the registration mark.

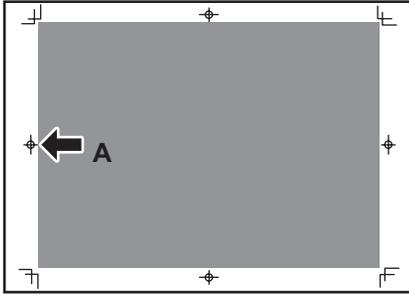
DFP492

(b) Adjust the image position (If custom paper is used)

Adjust the vertical and horizontal image position so that the center (A) of the leading edge of the image is aligned to the registration mark.

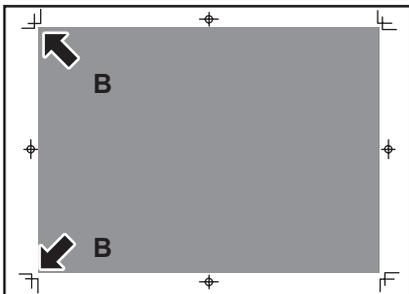
DFP320

(c) Adjust the magnification (Across feed direction)

Adjust the horizontal magnification to adjust the width between the front (B) and back corners (B) on the leading edge of the image.

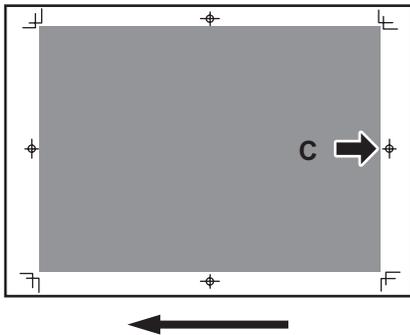
DFP321

(d) Adjust the magnification (With feed direction)

Adjust the vertical magnification to adjust the length (position of (C)) of the image.

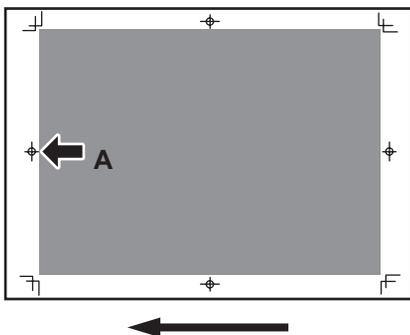
DFP492

(e) Adjust the image position (If custom paper is not used)

Adjust the vertical and horizontal image position so that the center (A) of the leading edge of the image is aligned to the registration mark.

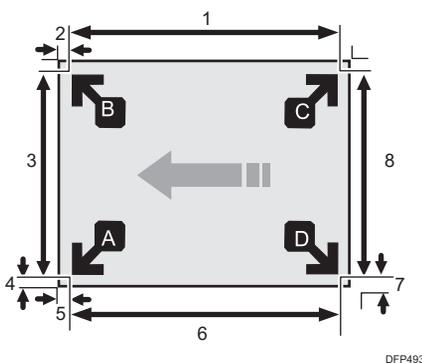
Using the ruler and magnifier, measure the length between each corner of the paper and the top of its adjoining arrow, and the length between the top of arrows with the scale in 0.1 mm.

1. Length between the top of each arrow
2. Length between each corner and the top of its adjoining arrow
3. Length between the top of each arrow
4. Length between each corner and the top of its adjoining arrow
5. Length between each corner and the top of its adjoining arrow
6. Length between the top of each arrow
7. Length between each corner and the top of its adjoining arrow
8. Length between the top of each arrow

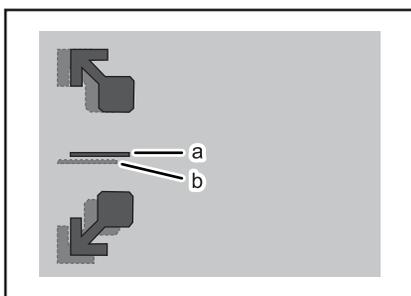
DFT314

Eg., Adjusting the center line of the leading edge on Side 2 (a) to match the center line (b) on Side 1

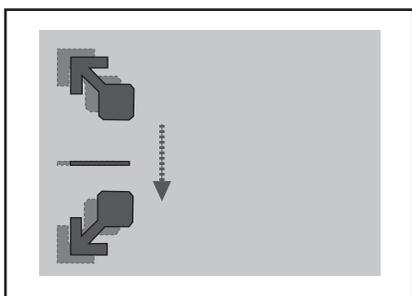
DFT315

Press [-] to shift the image to the bottom. (Press [+] to shift the image to the top.)

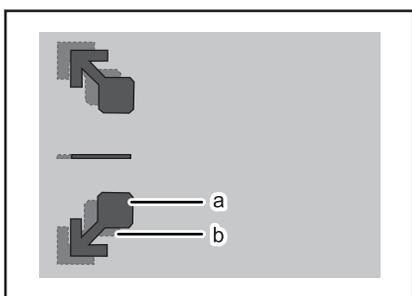
DFT316

Eg., Adjusting the image (a) on the leading edge of the paper on Side 2 to match the corresponding image (b) on Side 1

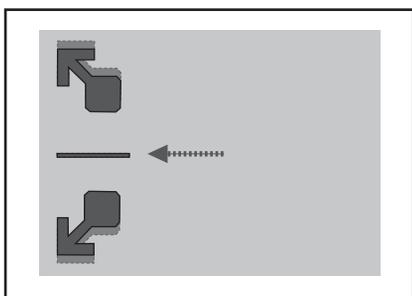
DFT317

Press [-] to shift the image to the left (leading edge). (Press [+] to shift the image to the right (trailing edge).)

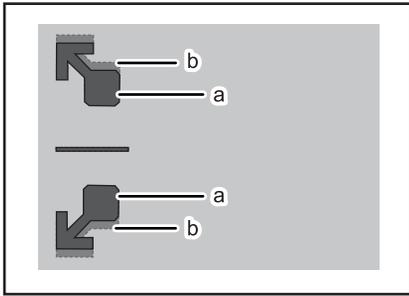
DFT318

Eg., Adjusting magnification to match the length between the arrows (a) on the leading edge of the paper on Side 2 to the length between the arrows (b) on Side 1

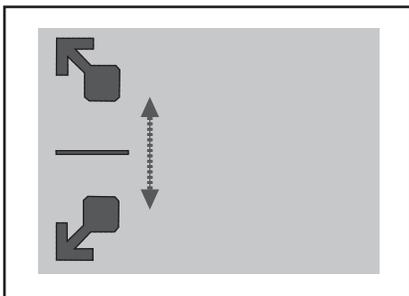
DFT319

Press [+] to increase the scaling. (Press [-] to reduce the scaling.)

The adjustment value is applied evenly both upward and downward.

To feed A3 paper with its short side parallel to the paper feed direction, increase the value by 0.025 percentage point to move the image by approximately 0.1 mm (0.004 inches).

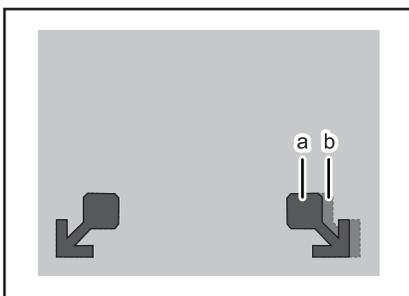
DFT320

Eg., Adjusting magnification to match the position of the arrow (a) on the trailing edge of the paper on Side 2 to the position of the arrow (b) on Side 1

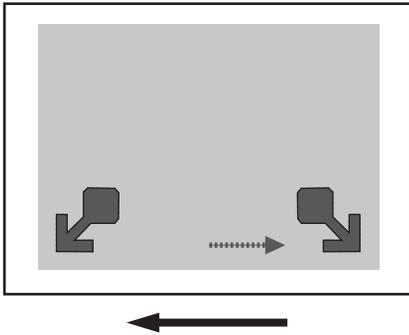
DFT321

Press [+] to increase the scaling. (Press [-] to reduce the scaling.)

To feed A3 paper with its long side parallel to the paper feed direction, increase the value by 0.025 percentage point to move the image by approximately 0.07 mm (0.0028 inches).

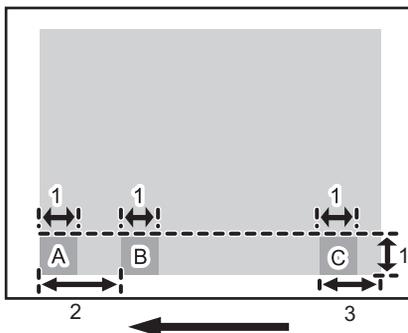
DFT073

When the punched holes are located at any of positions A to G in the following figure, depending on their locations, adjust the settings in [Advanced Settings] for the custom paper as follows;

When paper length between 269.9 mm to 297 mm (10.7 to 11.8 inches) is used.

1. 15 mm (0.6 inches)
2. 70 mm (0.8 inches)
3. 30 mm (1.2 inches)

Location of holes	Settings to adjust	What to do
A	1 18: [Registration Adjustment: Across Feed]	Set to [Activate].
	1 19: [Image Magnification Auto Adjustment]	Set to [Deactivate].
B	0 15: [Skew Detection]	Set to [Off].
C	0 15: [Skew Detection]	Set to [Off].
	1 19: [Image Magnification Auto Adjustment]	Set to [Deactivate].
D	1 18: [Registration Adjustment: Across Feed]	Set to [Activate].
	1 19: [Image Magnification Auto Adjustment]	Set to [Deactivate].
E	0 15: [Skew Detection]	Set to [Off].
F	0 15: [Skew Detection]	Set to [Off].
G	1 19: [Image Magnification Auto Adjustment]	Set to [Deactivate].

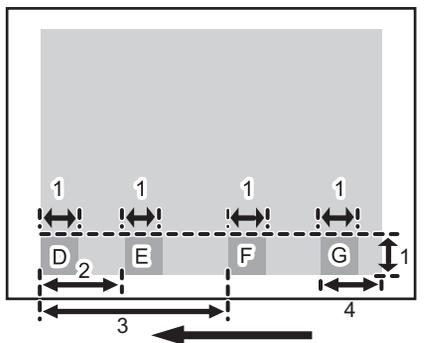
When paper length longer than 297 mm (11.8 inches) is used.

1. 15 mm (0.6 inches)
2. 70 mm (0.8 inches)
3. 270 mm (10.8 inches)
4. 30 mm (1.2 inches)

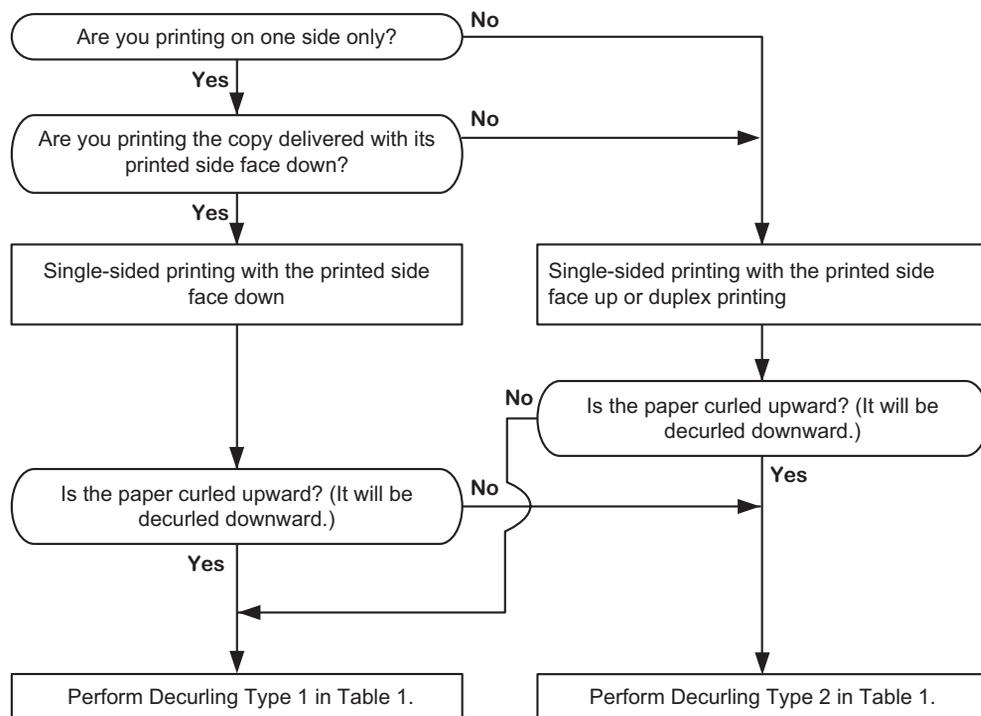
DF1071

Decurling Workflow

This shows how to select the type of decurling.

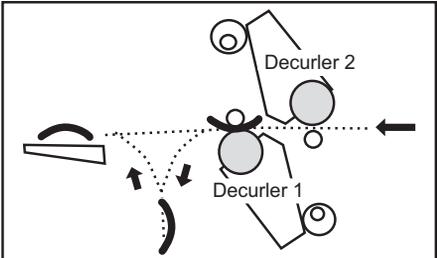
Type of decurling	Item to select in 0301: [Adjust Paper Curl]	Machine's operation
Decurling Type 1	[Adjust \curvearrowright Curl: Weak] [Adjust \curvearrowright Curl: Medium] [Adjust \curvearrowright Curl: Strong]	<p>- Single-sided printing: printed side face down</p> <p>- Duplex printing: printing on side 1</p> <p>The paper is decurled downward.</p>

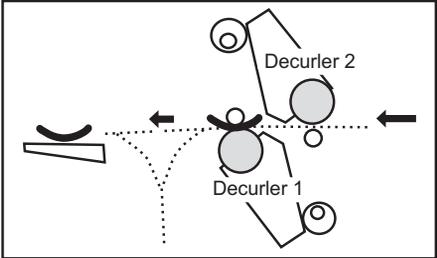
<p style="text-align: right; font-size: small;">DFT079</p>
		<p>- Single-sided printing: printed side face up</p> <p>- Duplex printing: printing on side 2</p> <p>The paper is decurled upward.</p>

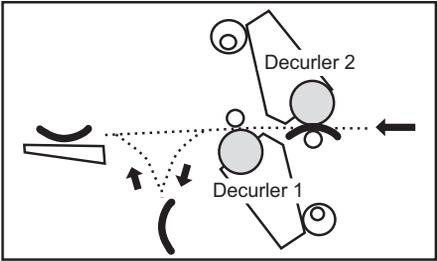
Type of decurling	Item to select in 0301: [Adjust Paper Curl]	Machine's operation
Decurling Type 2	[Adjust ^ Curl: Weak] [Adjust ^ Curl: Medium] [Adjust ^ Curl: Strong]	<p>- Single-sided printing: printed side face down</p> <p>- Duplex printing: printing on side 1</p> <p>The paper is decurled upward.</p>

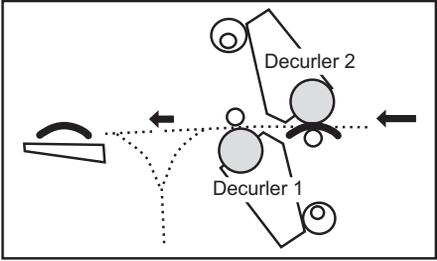
<p style="text-align: right; font-size: small;">DFT080</p>
		<p>- Single-sided printing: printed side face up</p> <p>- Duplex printing: printing on side 2</p> <p>The paper is decurled downward.</p>

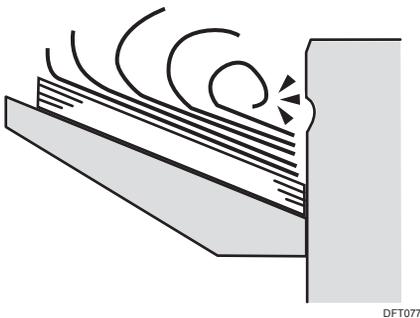
- The paper is curled at the finisher or stacker's output tray, allowing only a few sheets to be stacked.

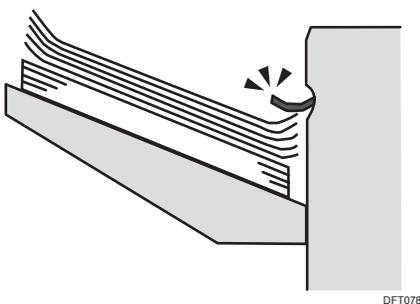
- The curling at the trailing edge of the paper is severe, so that only a few sheets can be stacked.
