Technical Bulletin

Model: VE-P1d	Date: 16-Nov-16	No.: RM136002a

Subject: Firmware Release Note: Network Support		Prepared by: J. Kitagawa		
From: 2nd Tech	Service Sect., MFP/Printe	r Tech Service Dept.		
Classification:	Troubleshooting	☐ Part information	☐ Action required	
	☐ Mechanical	☐ Electrical	☐ Service manual revision	
	☐ Paper path	☐ Transmit/receive	☐ Retrofit information	
	☐ Product Safety	Other (Firmware)	☐ Tier 2

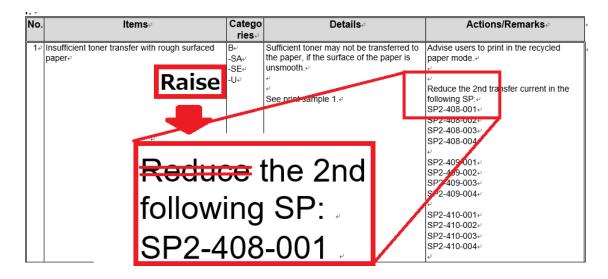
No. : 1

Items: "Insufficient toner transfer with rough surfaced paper"

Printing on unsupported media (not recommended) with rough surface results in a grainy looking image with white speckles.

- SP C342 These SPs adjust the electrical currents applied to the 2nd transfer, the lower the current for the 2nd transfer, the easier to occur this symptom.
- The SP number of the transfer current is different by Humidity.
