FAX 2500L/2600L/3500L

SERVICE MANUAL

Throughout this manual, the machines are referred to as follows: CRO: FAX2500L CS1: FAX3500L New CRO: FAX2600L

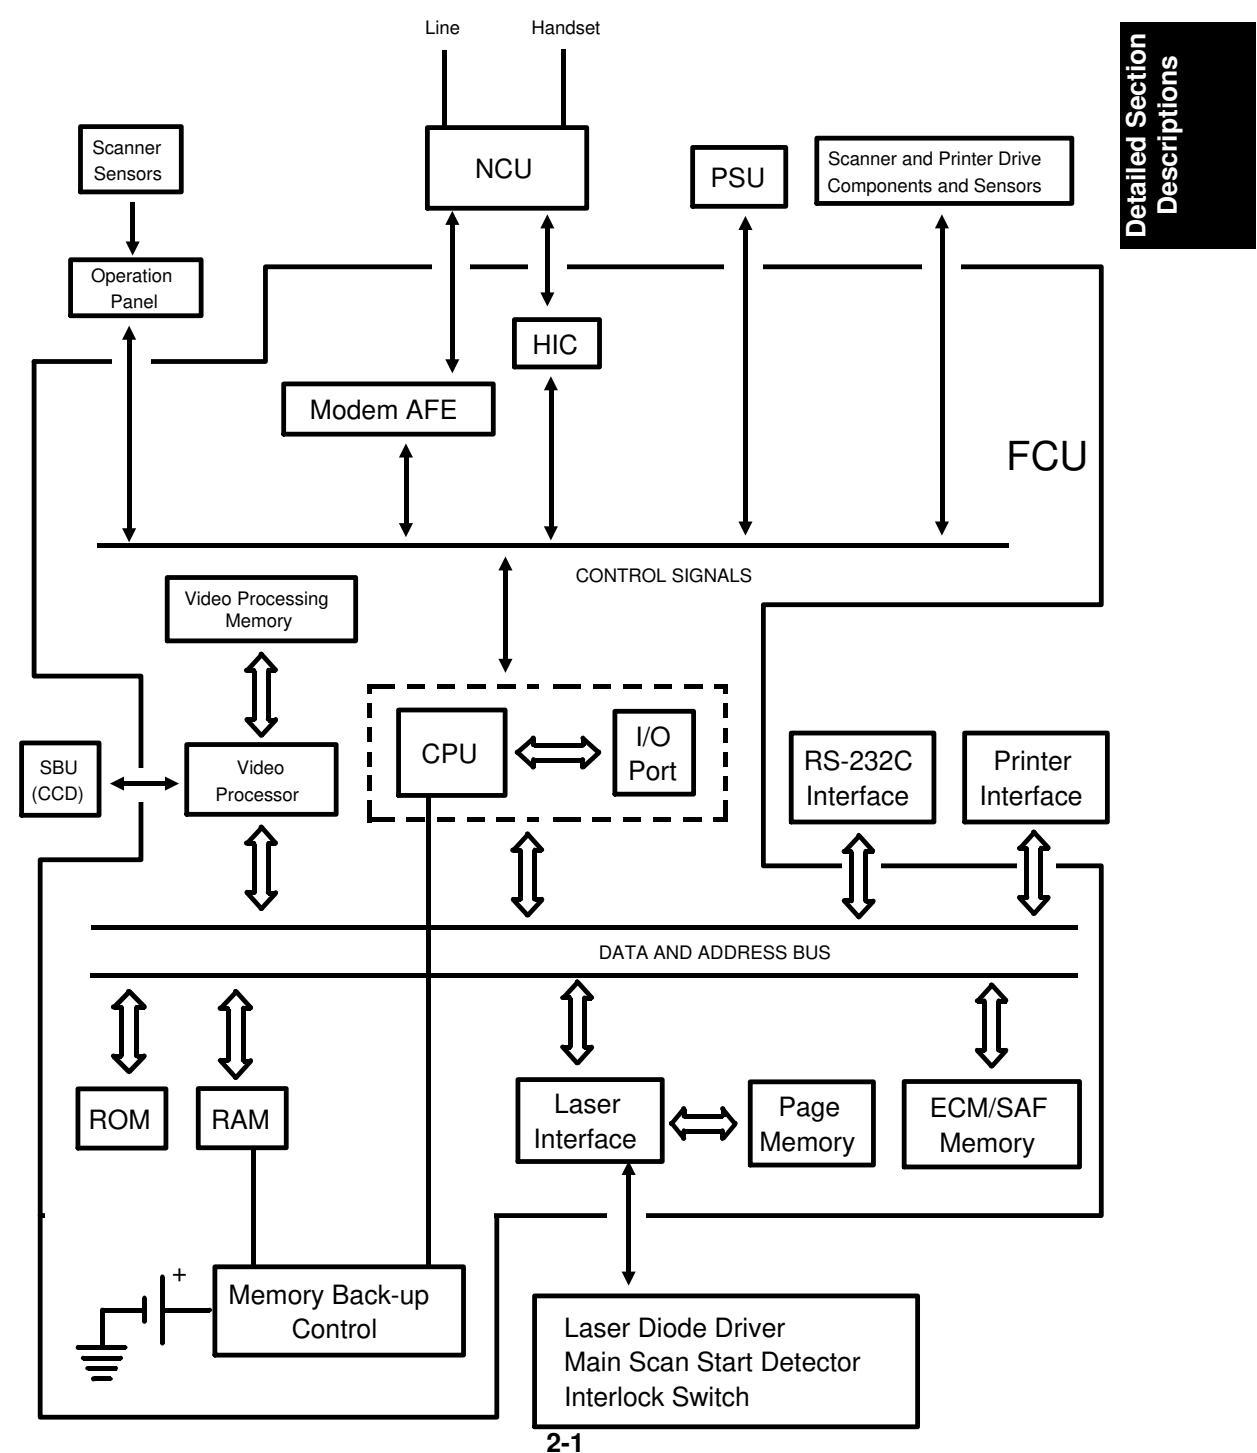
- 2.1.1. FCU
- 1. CRO

1. CPU (AFSP)

- 65C02 compatible microprocessor
- Interrupt and DMA control
- Data compression and reconstruction (high speed MH coding for 4.5second scanning)
- Modem (digital operations)
- Real time clock (battery backed-up)
- Memory control
- Control of all mechanisms (directly or through other chips)
- NCU control (through the I/O Port)

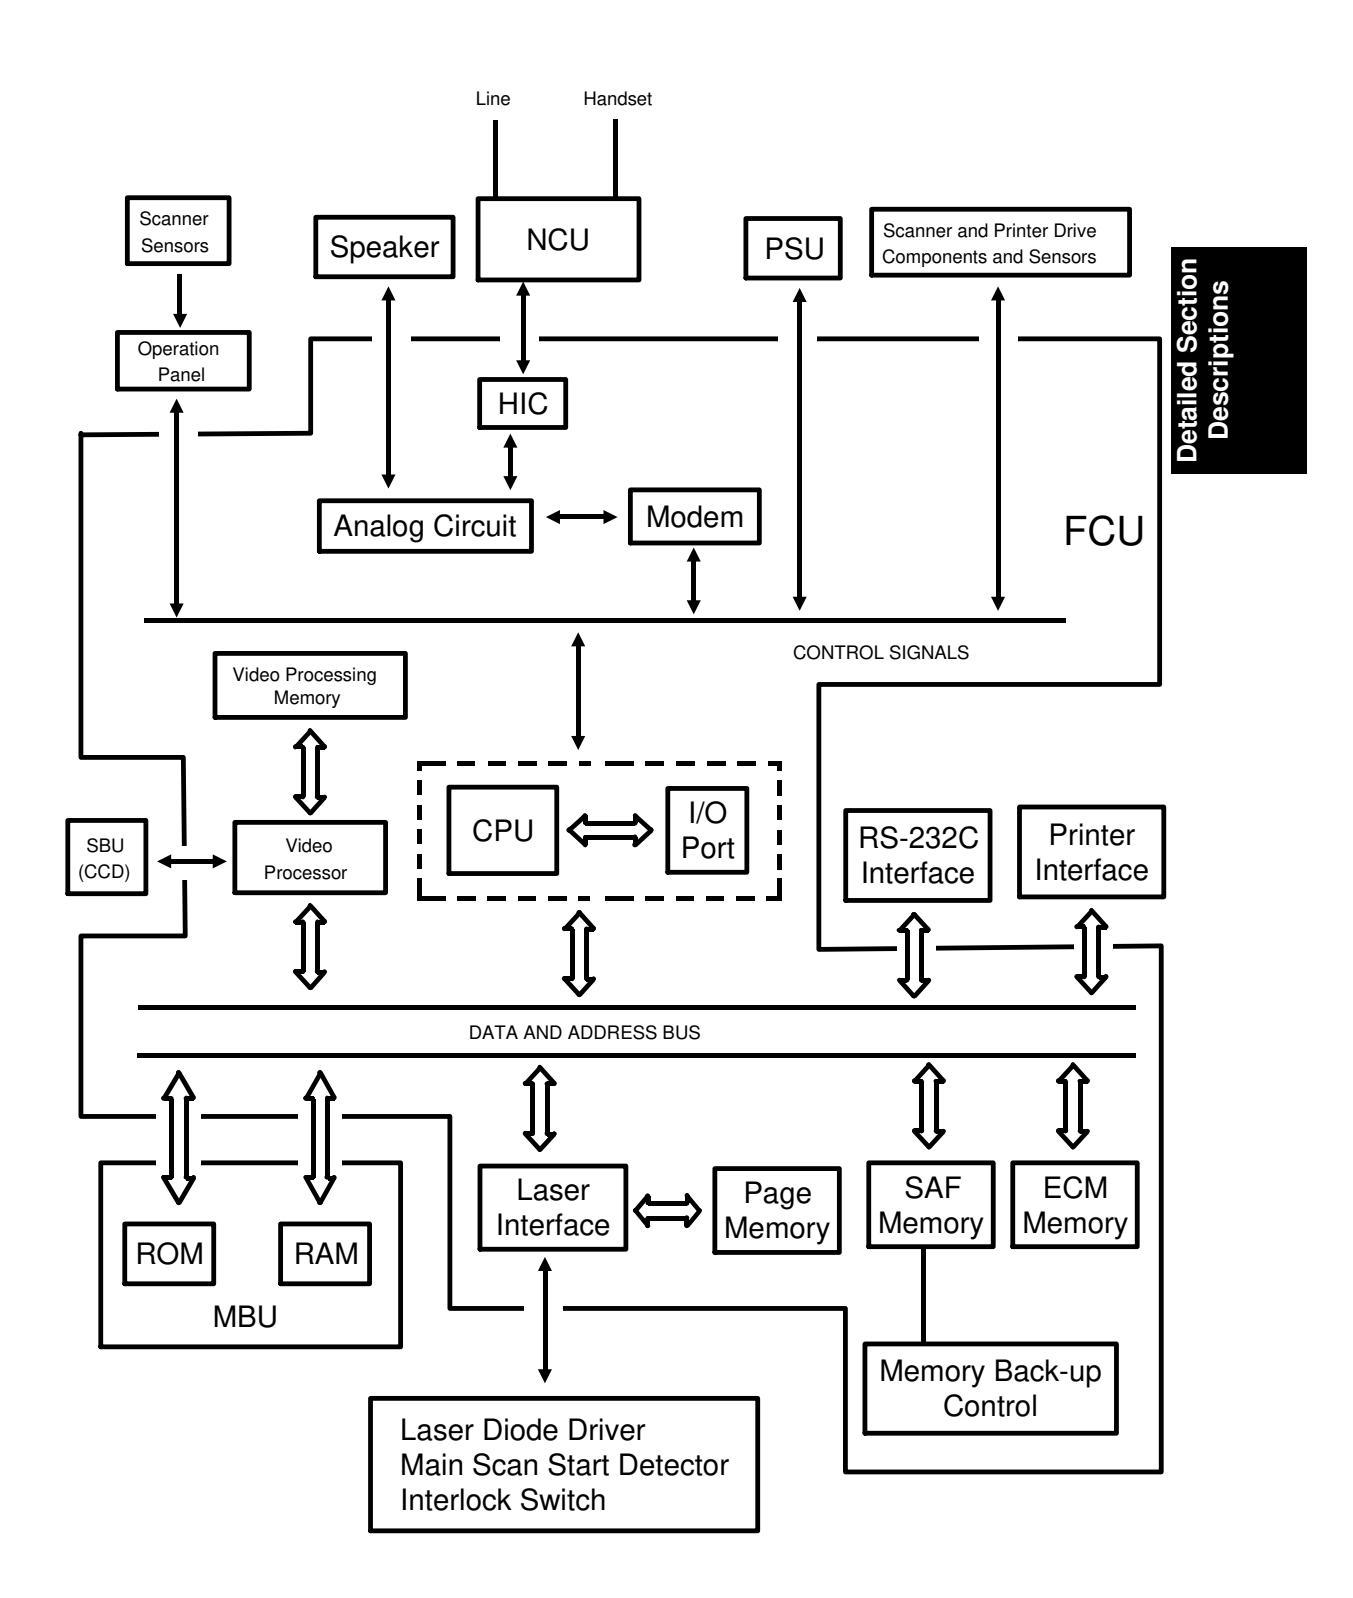
2. CS1

1. CPU (VFSP)

- 65C02 compatible microprocessor
- Interrupt and DMA control
- Data compression and reconstruction (high speed MH coding for 4.5second scanning)
- Real time clock (battery backed-up)
- Memory control
- Control of all mechanisms (directly or through other chips)
- NCU control (through the I/O Port)

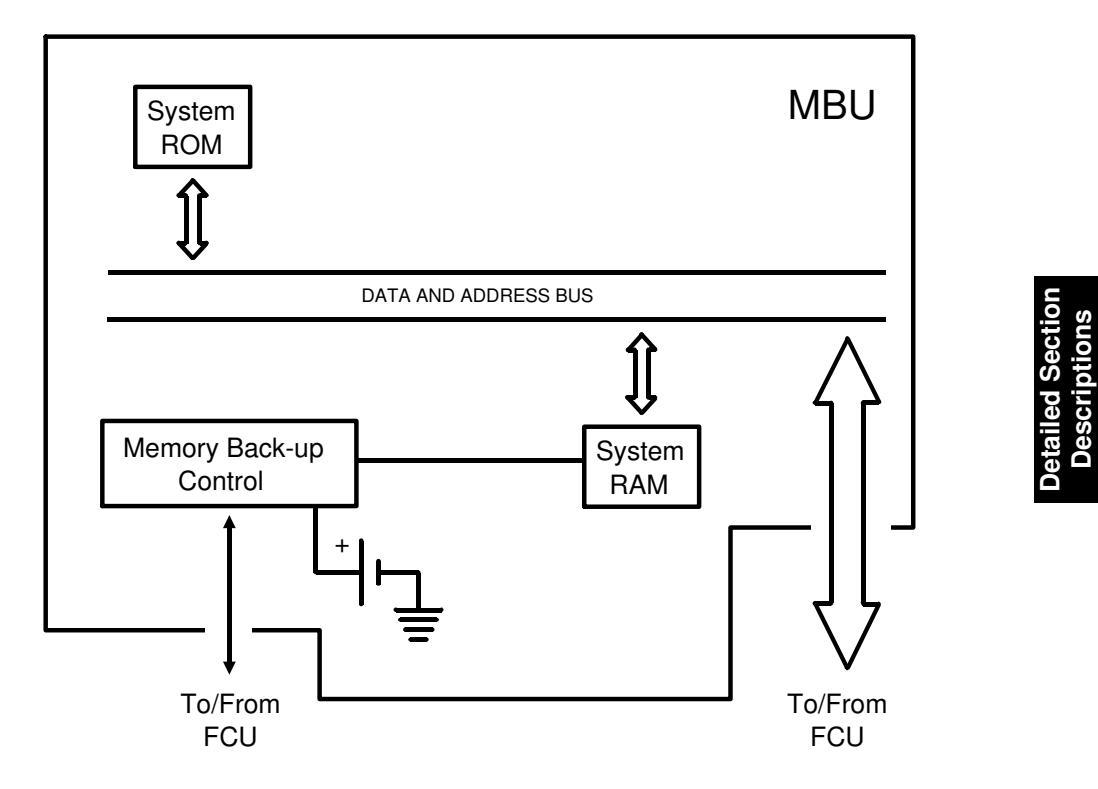
2.1.2. MBU (CS1 only)

1. System ROM

• 256k for the software to run the machine

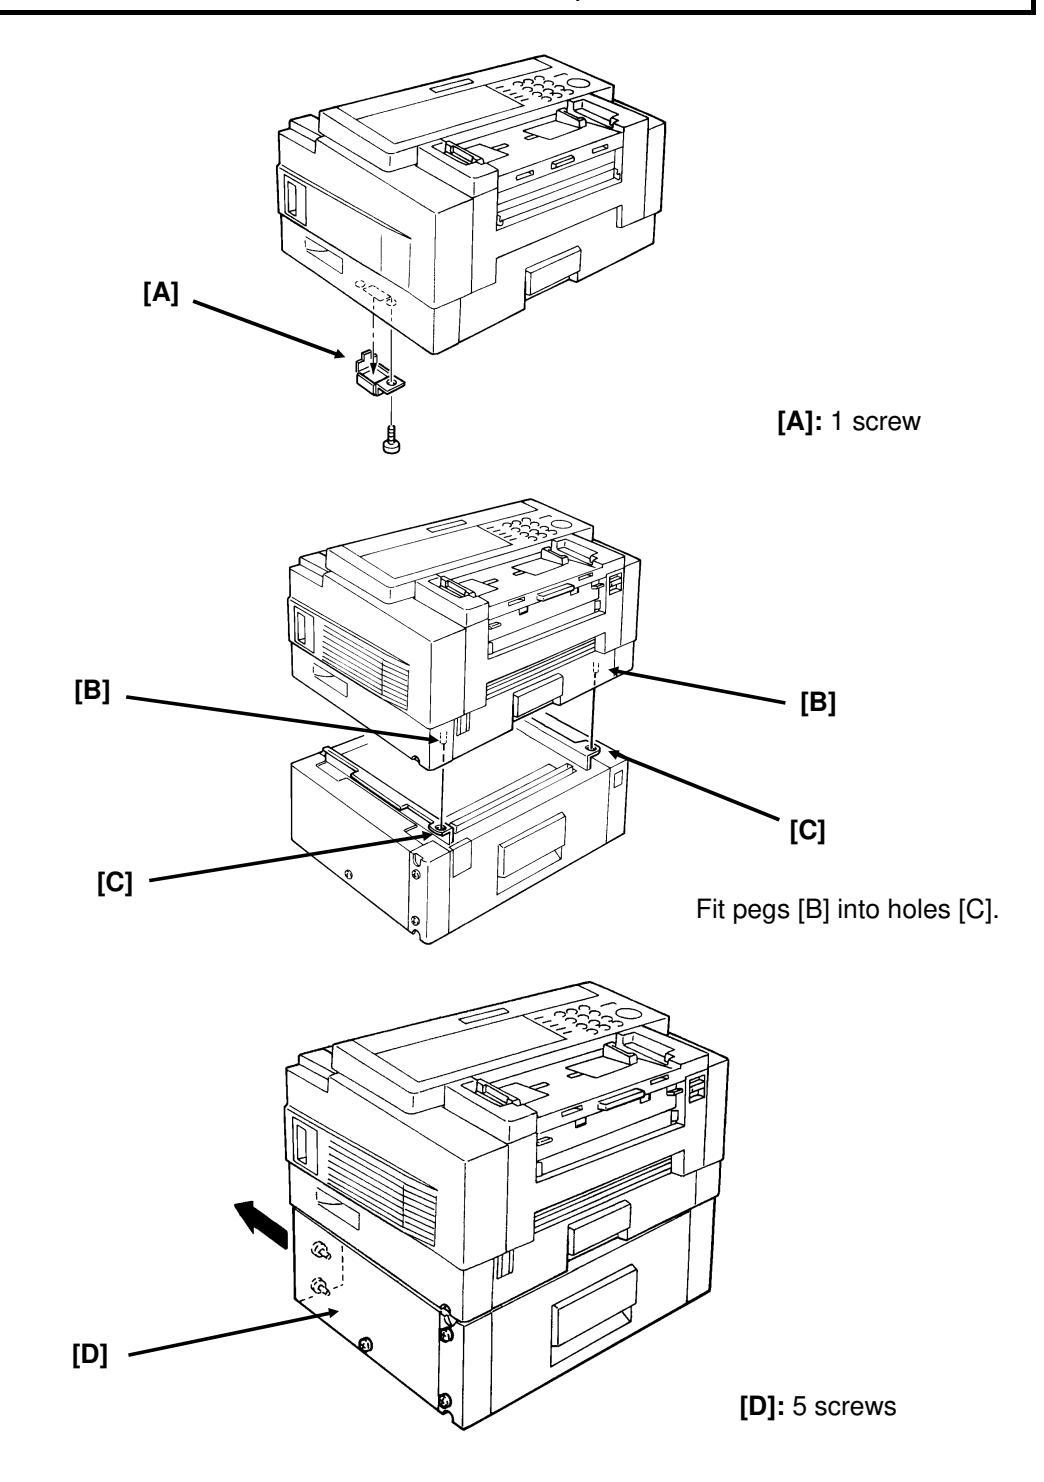
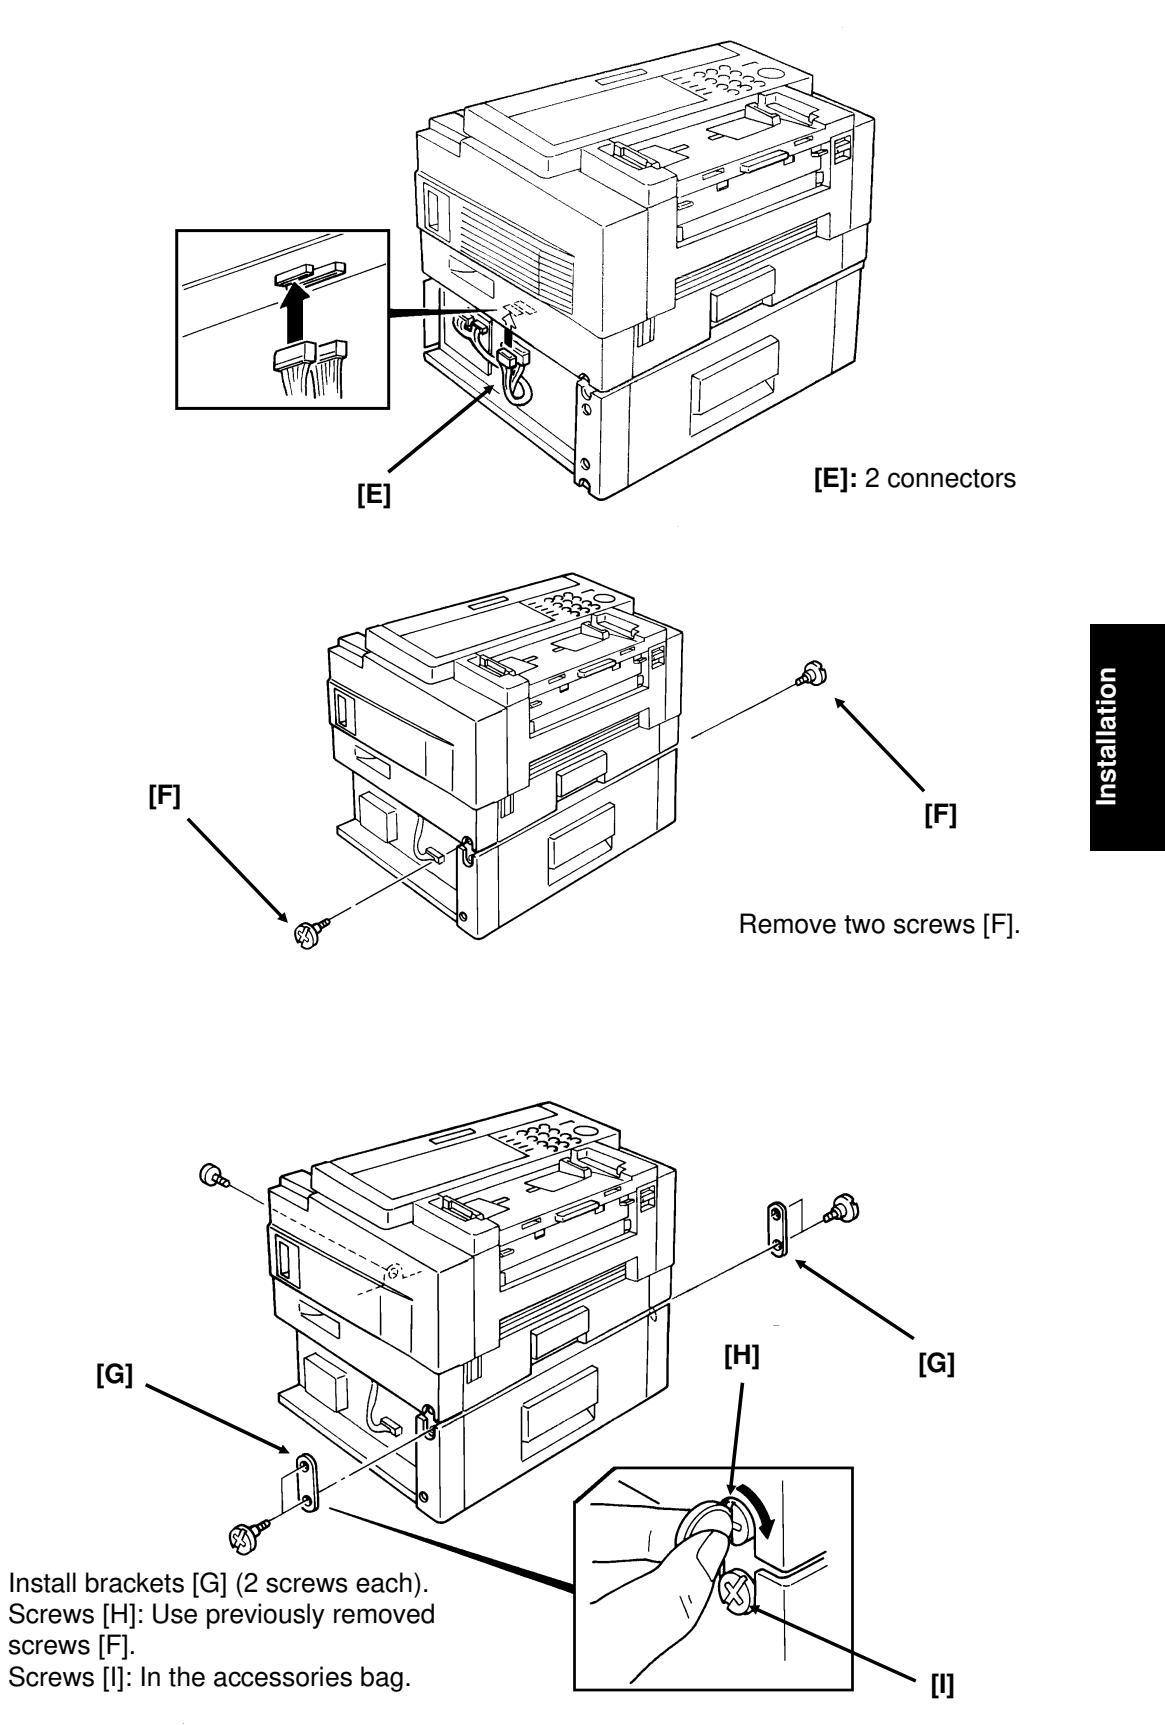
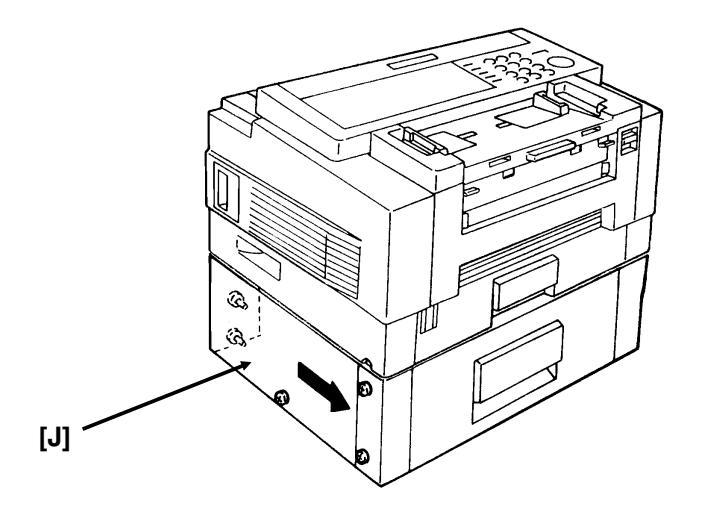
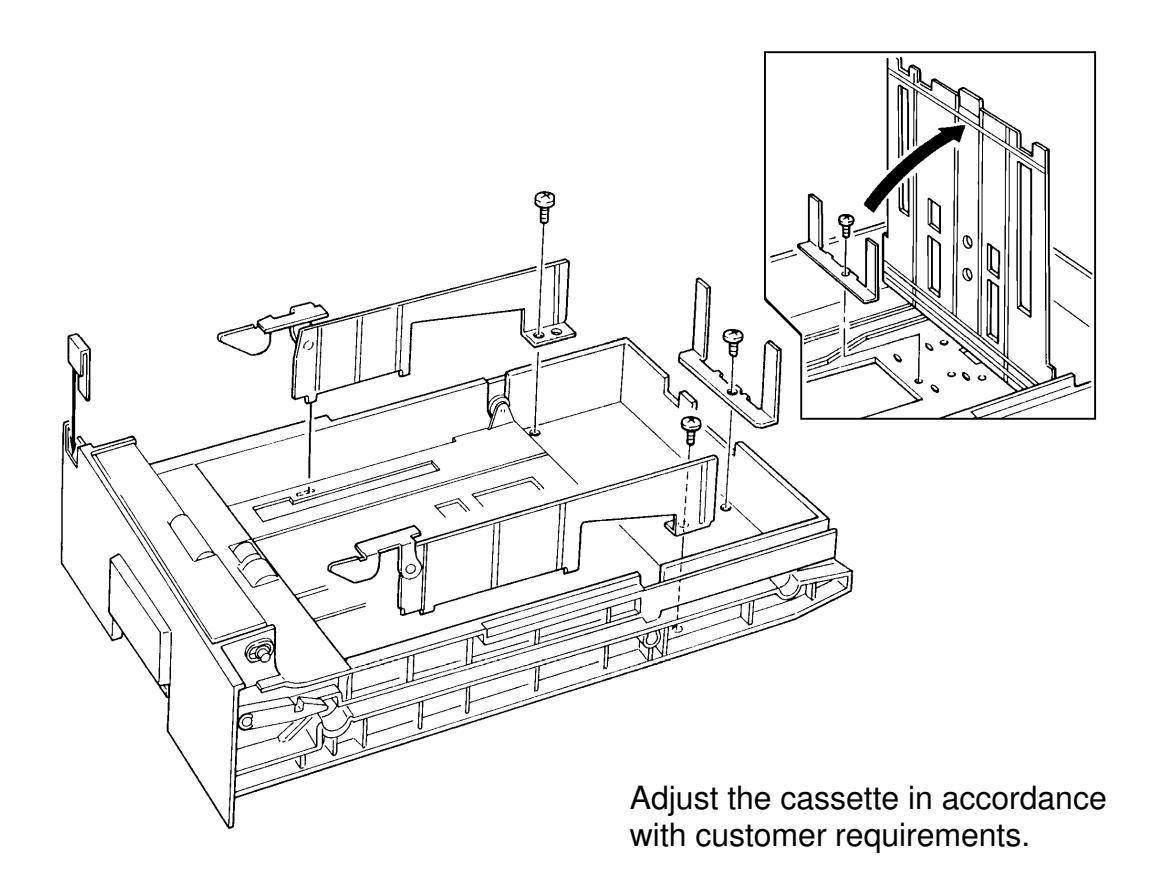
3.2.1. Lower Cassette (CS1 only)

Check whether there are any messages in the memory. If there are, you must install the lower cassette and turn the power back on within an hour.

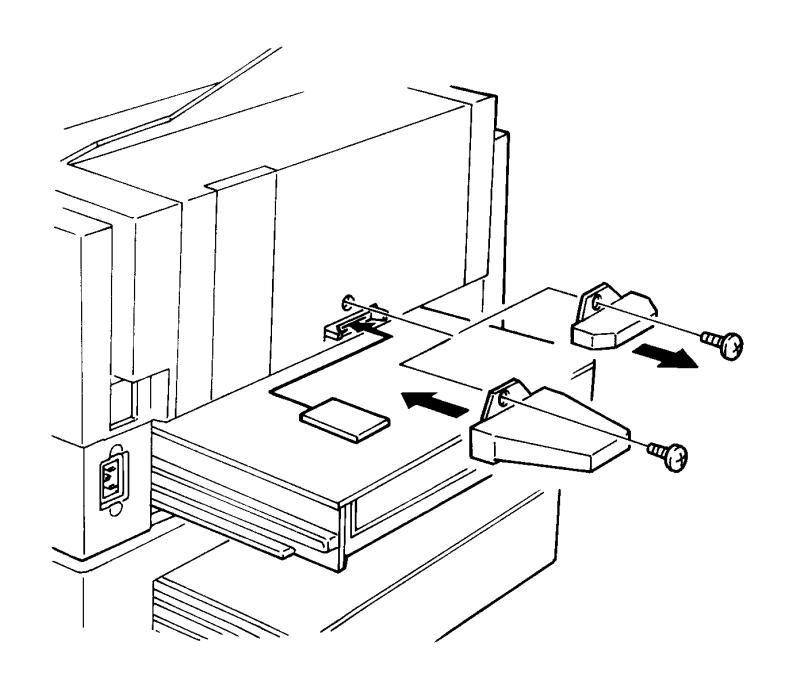
3.2.2. Memory Card

- Turn off the power before installing or removing a memory card.
- Make sure that 100% is displayed on the operation panel before installing or removing a memory card, or data will be lost.

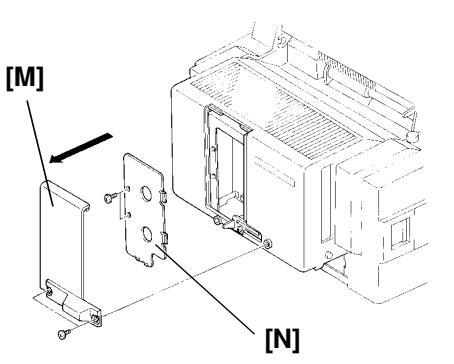
Installing the Memory Expansion Board

- 1. Print any messages still stored in the SAF.
- 2. Turn off the power and unplug the machine from the wall socket.
- 3. Remove the memory option cover [M] and the memory board cover [N].

4. Insert the memory expansion board [O].
5. Put back the memory board cover [P] and the memory option cover [Q].
6. Plug in the machine, then turn on the power.

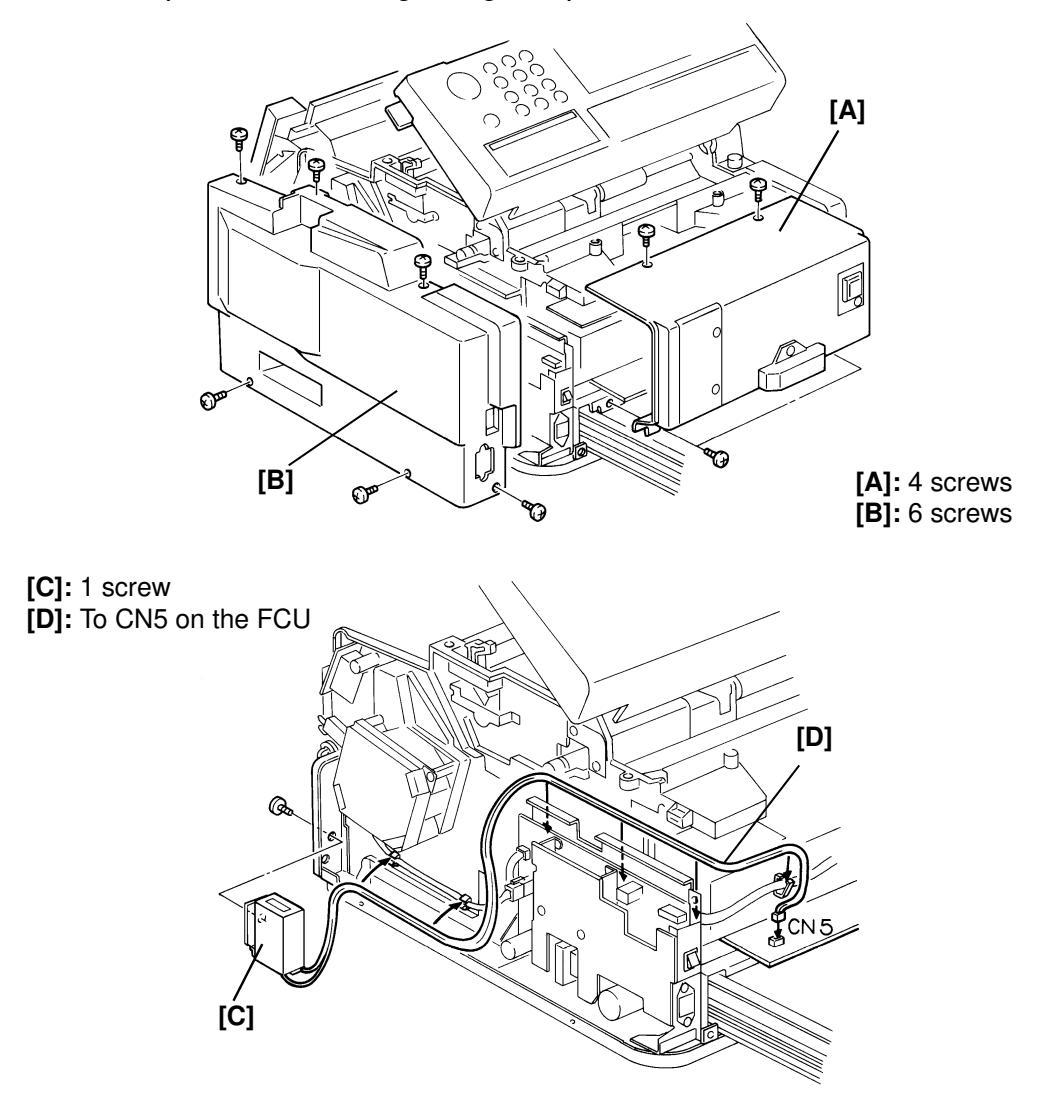
3.2.7. Counter

Turn off the power before beginning this procedure.

Make sure that the harness is fed through the machine without getting entangled around components.

Test the counter before reassembling the machine.

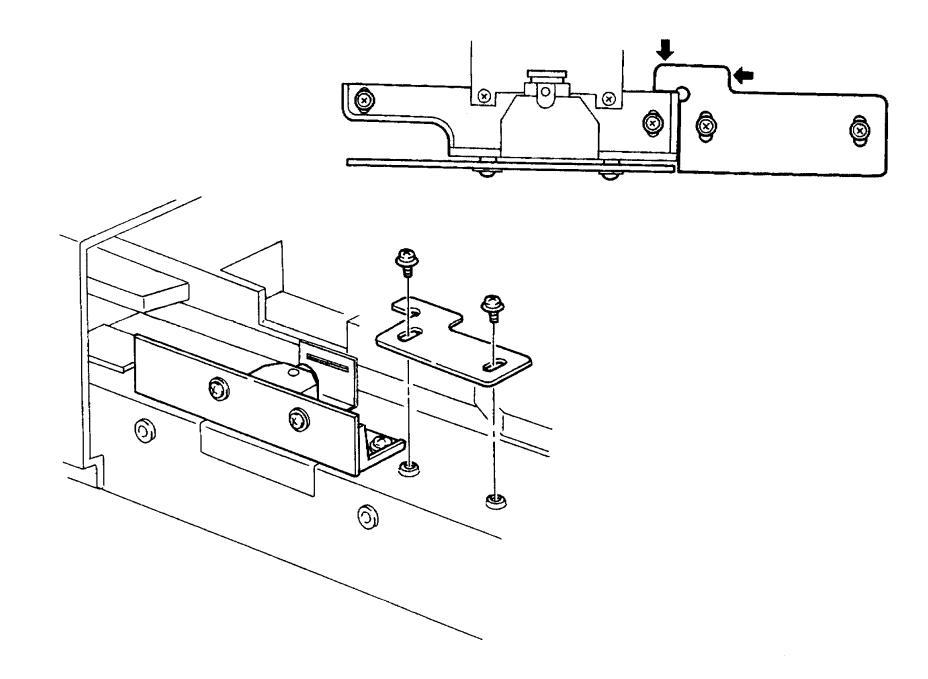
4.7. SPECIAL TOOLS AND LUBRICANTS

- Scan line test chart: P/N H0819502
- 8 line/mm test pattern: P/N H0419001
- Test lead: P/N H0419002
- SBU adjustment knobs: P/N H0129300
- Allen wrench
- Lens block positioning tool: P/N H0819503 For how to use, see the following diagram

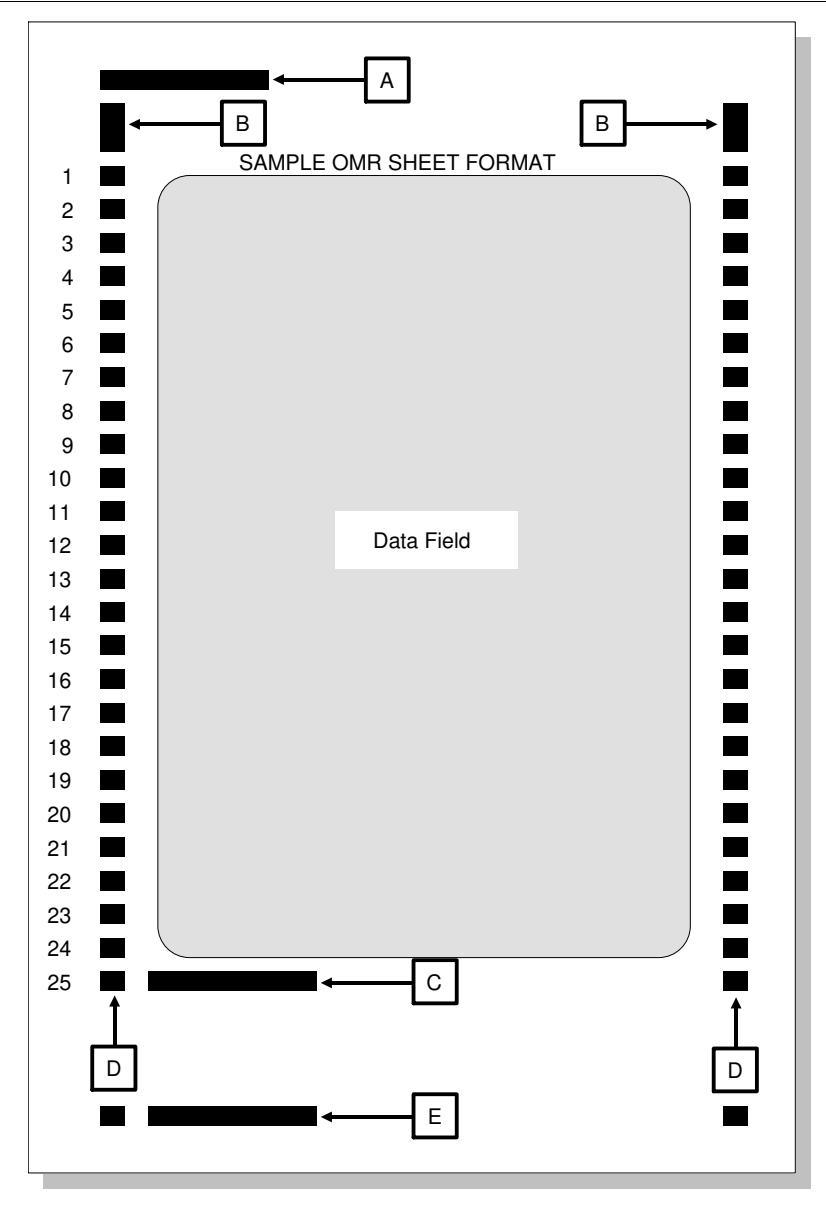
The following marks on the OMR sheet are used to detect errors. Refer to the next page for the locations of these marks.

Name	Usage
Α	Start mark	Used to detect the start of an OMR sheet.
В	Skew detection marks	Used to detect skew before scanning the data field.
С	End mark	Used to detect the end of the data field.
D	Guide marks	Used to detect lines in the data field, and to detect skew while scanning the data field.
E	Wrong way insertion detection mark	Used to detect wrong way insertion. On the transfer request program sheet, this mark is also used as the end mark.

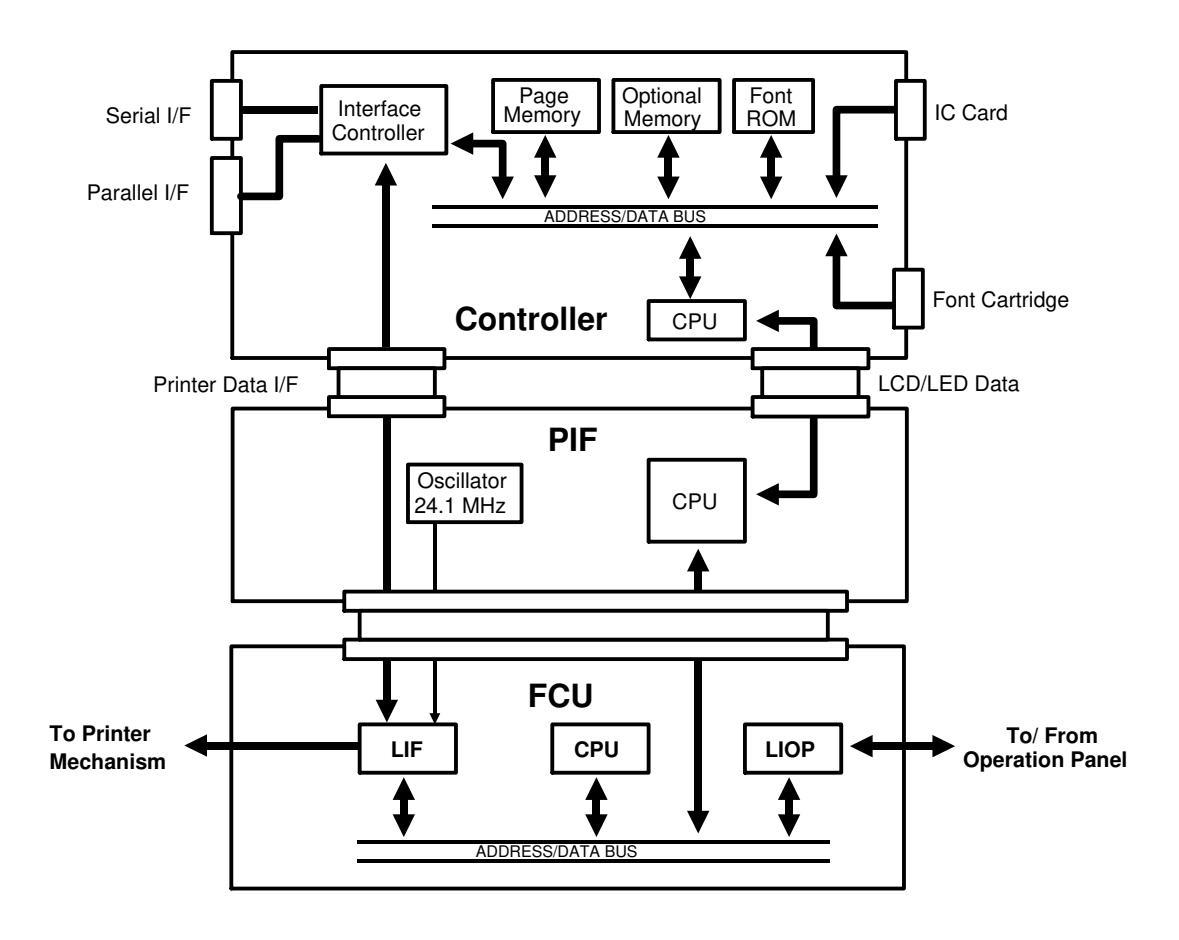
1.2. OVERALL SYSTEM CONTROL

The printer interface kit consists of two PCBs, the printer controller board (Controller) and the printer interface board (PIF).

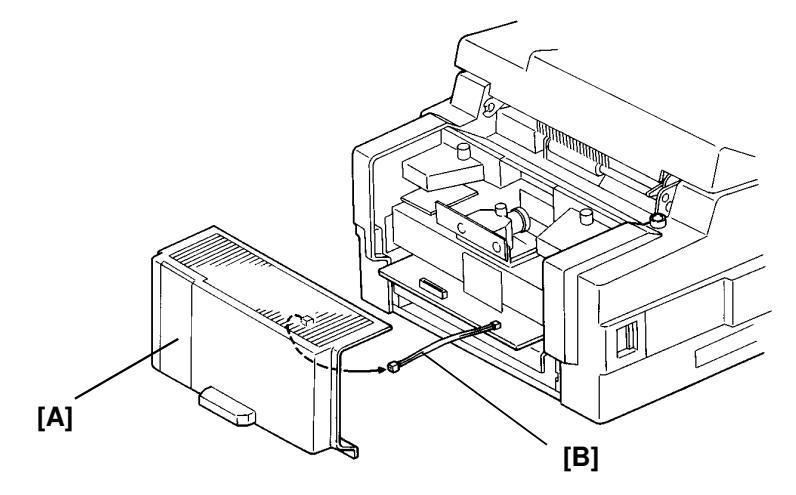
- 1. First, print any messages still stored in the SAF.
- 2. Turn off the power, and unplug the machine from the wall socket.
- 3. Slide out the cassettes.
- 4. Take off the rear cover [A] and disconnect the monitor speaker [B].

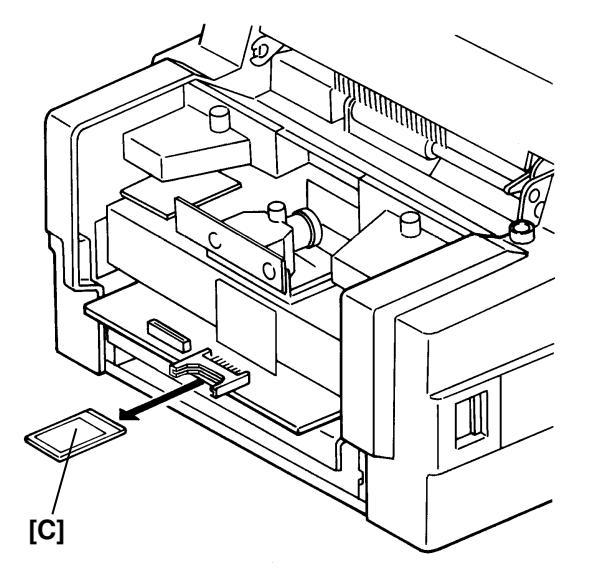
5. If a memory card [C] is installed, remove it.

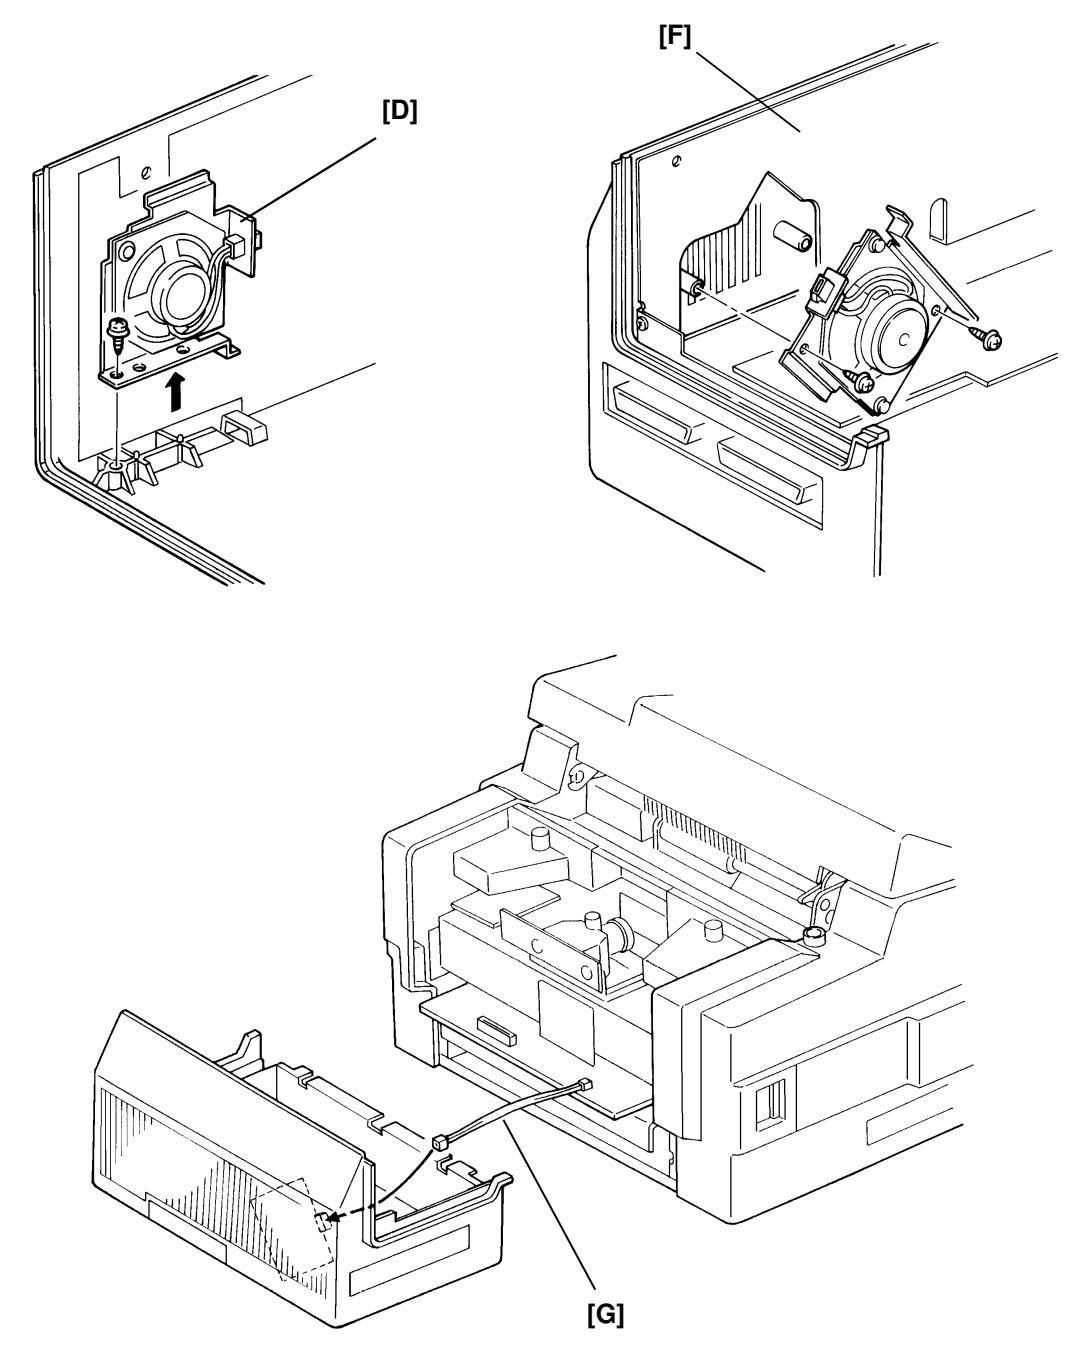
- 6. Take off the monitor speaker [D] from the rear cover.
- 7. Attach the monitor speaker [E] to the printer interface unit [F]. Then reconnect the monitor speaker [G].

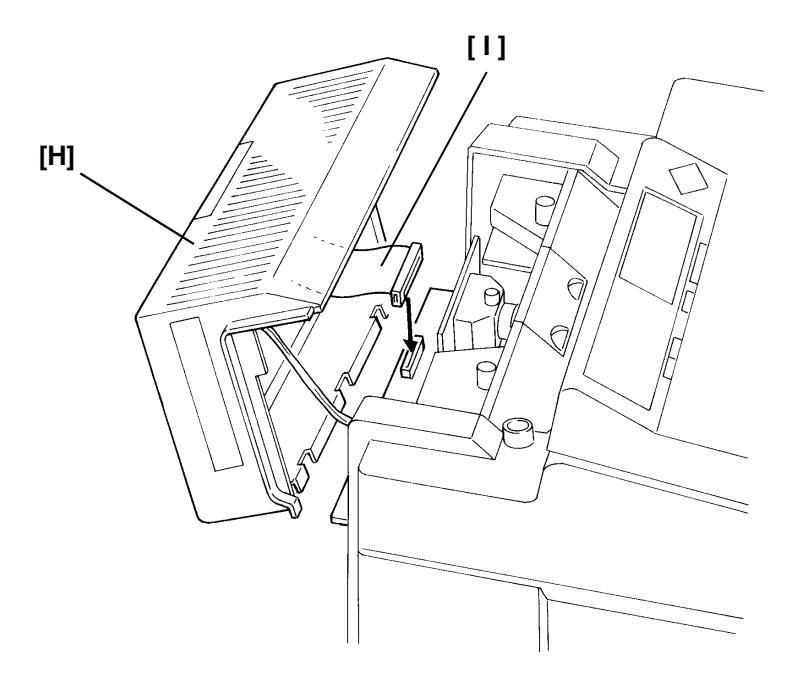
8. Hold the printer interface unit [H] near the machine with one hand, and plug the flat cable [I] into the connector on the FCU board.

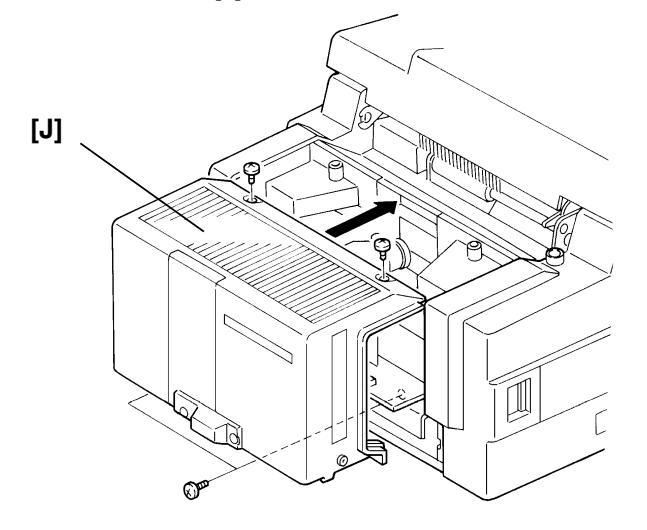
9. Attach the printer interface unit [J].

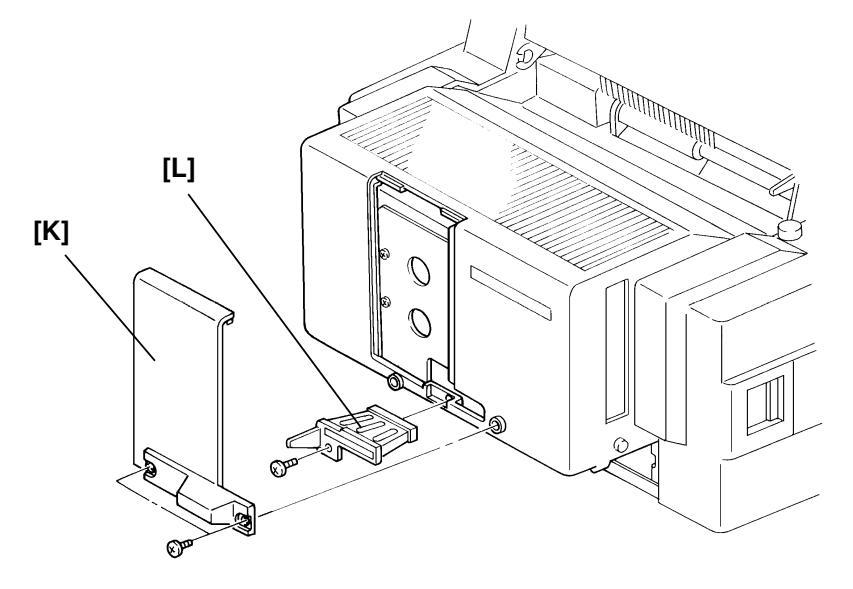
10. Remove the memory option cover [K].

11. Attach the memory card guide [L]. Then install the memory card if necessary.

Caution: To avoid damaging the memory card, always remove the memory card first before removing the printer interface unit.

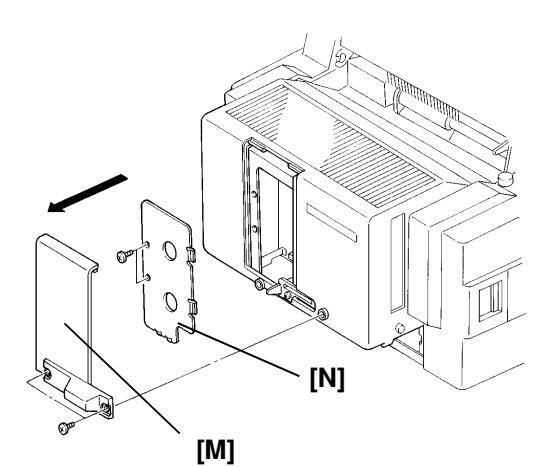
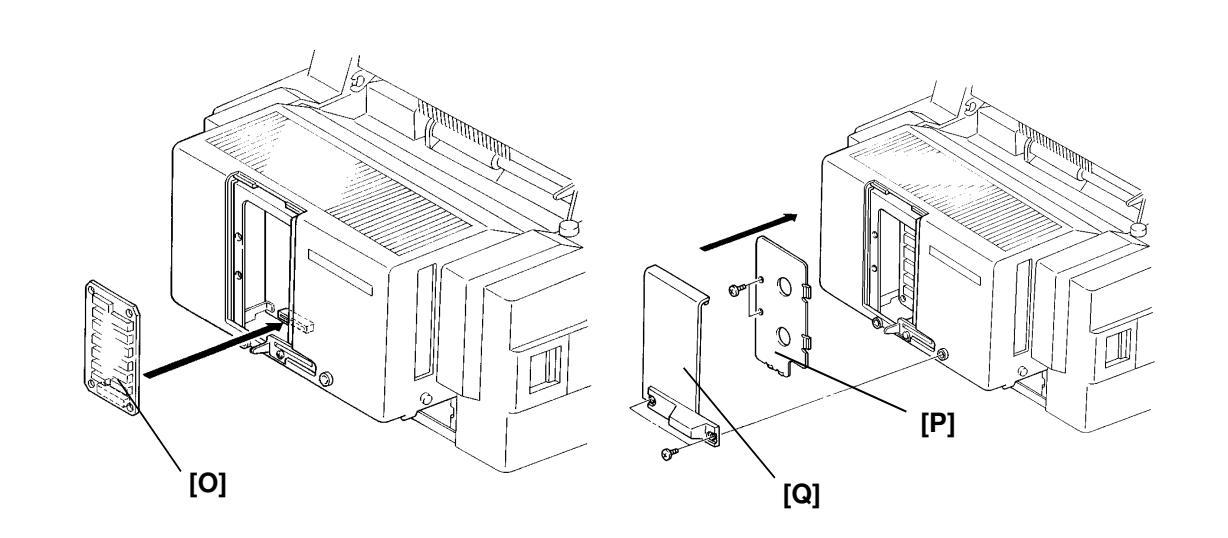
2.2. MEMORY EXPANSION BOARD (OPTIONAL)

- 1. Print any messages still stored in the SAF.
- 2. Turn off the power and unplug the machine from the wall socket.
- 3. Remove the memory option cover [M] and the memory board cover [N].
- 4. Insert the memory expansion board [O].
- 5. Put back the memory board cover [P] and the memory option cover [Q].
- 6. Plug in the machine, then turn on the power.

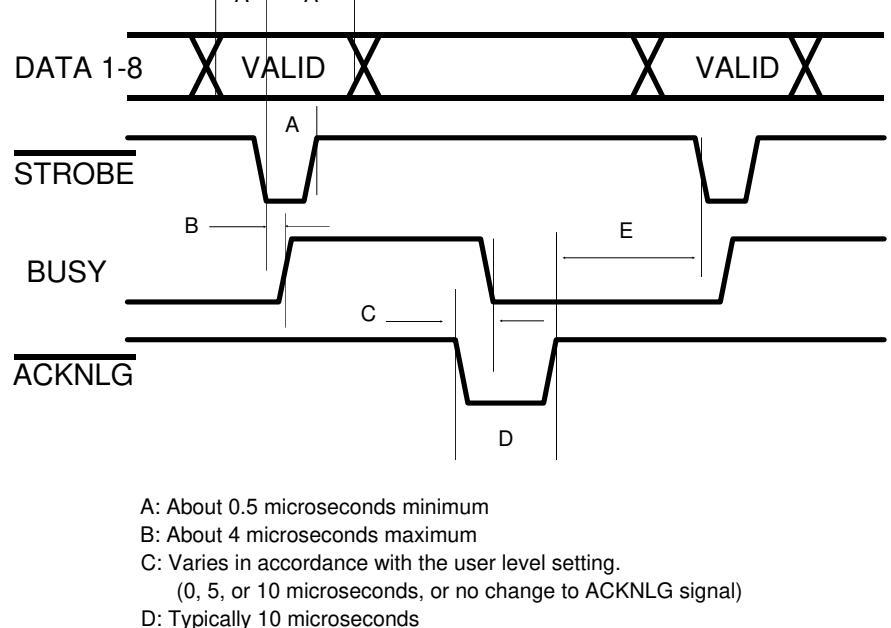
2. Interface Timing

The following diagram shows the timing for the parallel interface. $\begin{vmatrix} A & A \end{vmatrix}$

E: Always zero or greater

Signal Level: TTL Compatible
