Model: PR-C1(1-Bin Tray BN3020)	Date: 1-Apr-09	No.: RD010020a
---------------------------------	----------------	----------------

RTB Reissue

Subject: Guide: Tray: 1-Bin		Prepared by: M. Ishihara	
From: 1st Tech. Support Sec. Service Support Dept.			
Classification:	<input type="checkbox"/> Troubleshooting <input type="checkbox"/> Mechanical <input type="checkbox"/> Paper path <input type="checkbox"/> Product Safety	<input checked="" type="checkbox"/> Part information <input type="checkbox"/> Electrical <input type="checkbox"/> Transmit/receive <input type="checkbox"/> Other ()	<input type="checkbox"/> Action required <input type="checkbox"/> Service manual revision <input type="checkbox"/> Retrofit information <input type="checkbox"/> Tier 2

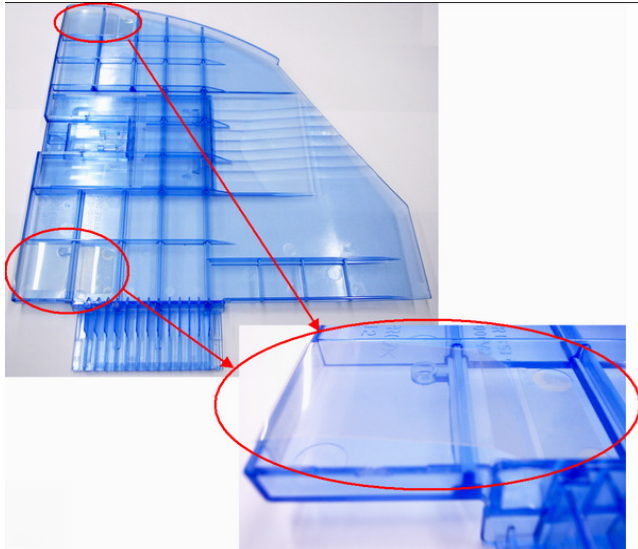
P/N D3394451

Note: *The two guides are attached to the underside of the exit tray using double-sided tape.*

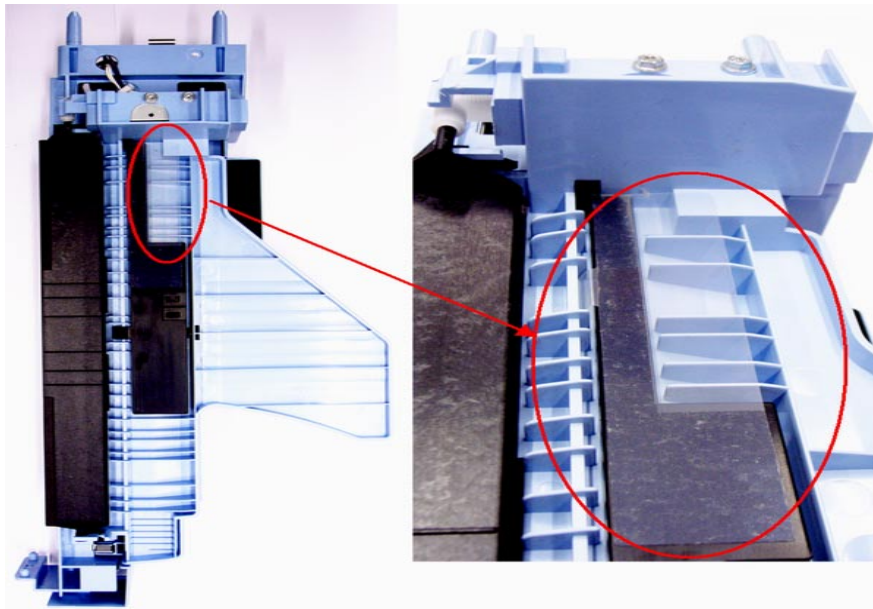
**P/N D3394452**

Note: *This guide is attached to the underside of the lower frame using double-sided tape.*
