Model: <b>ARDF (DF3060)</b>	Date: 12-Sep-11	No.: RD578001
-----------------------------	-----------------	---------------

Subject: Firmware Release Note: ARDF (DF3060)		Prepared by: T. Nihei	
From: 1st Overseas Tech Support Sec., 1st PQM Dept.			
Classification:	<input type="checkbox"/> Troubleshooting	<input type="checkbox"/> Part information	<input type="checkbox"/> Action required
	<input type="checkbox"/> Mechanical	<input type="checkbox"/> Electrical	<input type="checkbox"/> Service manual revision
	<input type="checkbox"/> Paper path	<input type="checkbox"/> Transmit/receive	<input type="checkbox"/> Retrofit information
	<input type="checkbox"/> Product Safety	<input checked="" type="checkbox"/> Other (Firmware)	<input checked="" type="checkbox"/> Tier 2

Model: ARDF (DF3060)		Date: 29-Mar-12	No.: RD578003
Subject: A small bend or tear on the original		Prepared by: T. Nihei	
From: 2nd Tech Service Sect., MFP/P Tech Service Dept.			
Classification:	<input checked="" type="checkbox"/> Troubleshooting <input type="checkbox"/> Mechanical <input type="checkbox"/> Paper path <input type="checkbox"/> Product Safety	<input type="checkbox"/> Part information <input type="checkbox"/>

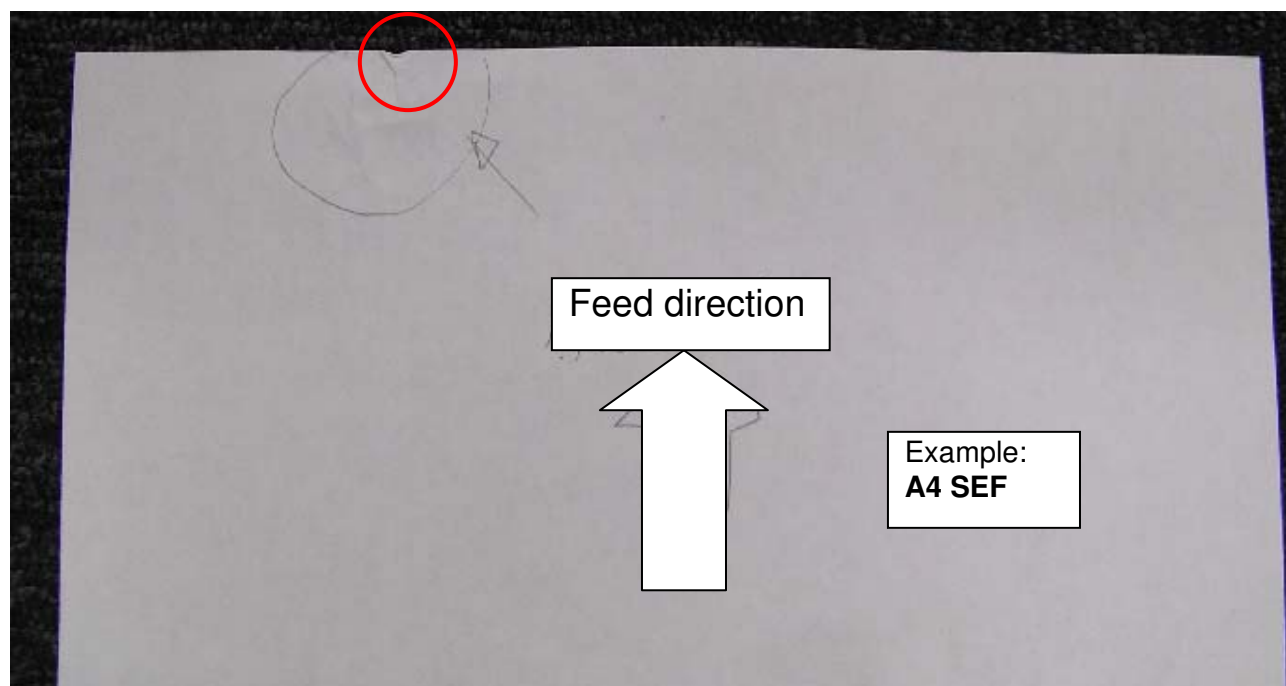
A small bend or tear may form on the leading edge of the original when using the ARDF.

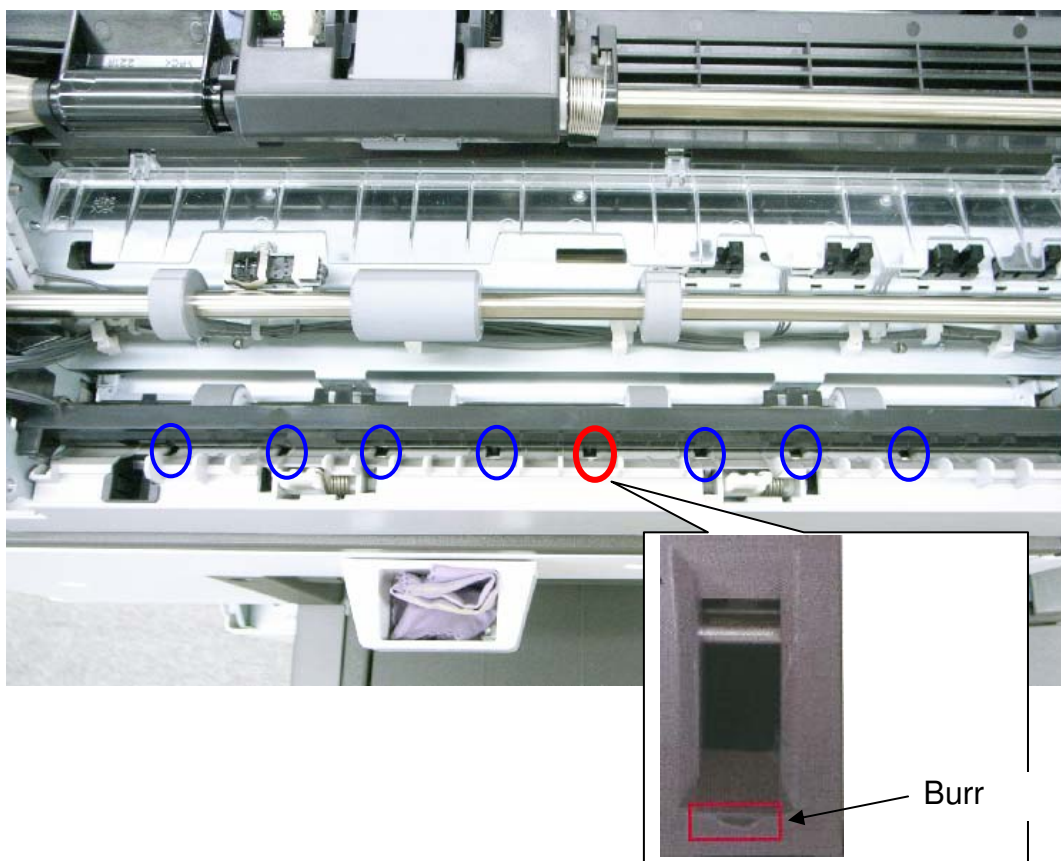
**Note:** After you remove the guide plate, you will see the eight holes circled in the photograph below (looking from the left side of the machine). The hole with the burr is the 4<sup>th</sup> from the right, circled in red below.

6. Remove the burr.
7. Reattach all the parts that you removed in the steps above.
8. Open the ARDF and clean the ARDF exposure glass.

**Note:** This is because some of the shavings from the burr may have dropped onto the exposure glass when you removed the burr in Step 6.

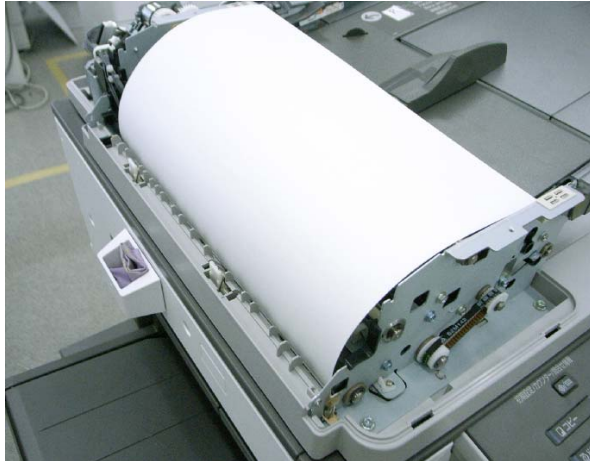
5. Insert a sheet of paper between the ARDF base frame and the entrance guide plate, as shown in the photograph below.

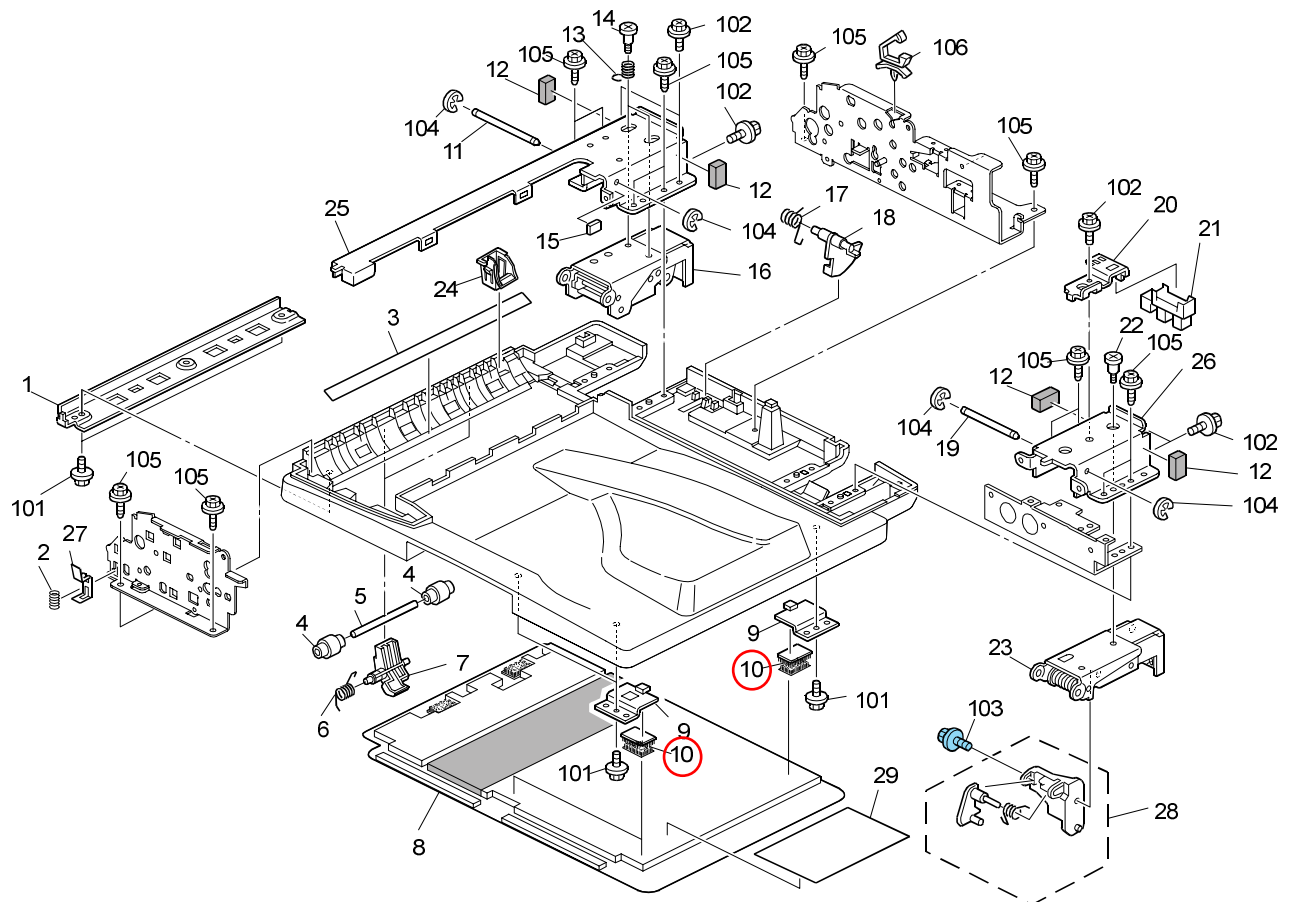
**Change/Reason:** The illustration was corrected.

- The Velcro (TAPE – PLATEN SHEET) is not included in the Pressure Plate Assembly service part (Index 8).

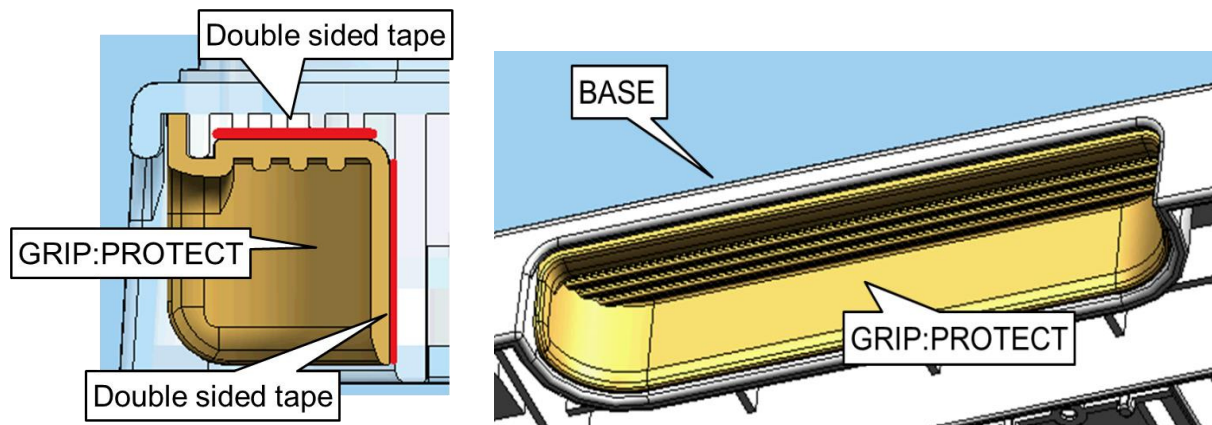
**Note:** The handgrip can be damaged when the DF is opened/closed repeatedly.

**Important:** Attach the grip to the base using double-sided tape.
