Model: PALM-B (D567, PB1030)		Date: 15-Jun-11	No.: RD567001
Subject: Plate: Heat Sink: 1		Prepared by: M. Ishihara	
From: 2 nd Overseas Tech Support Sec. 2 nd PQM Dept.			
Classification:	<input type="checkbox"/> Troubleshooting <input type="checkbox"/> Mechanical <input type="checkbox"/> Paper path <input type="checkbox"/> Product Safety	<input checked="" type="checkbox"/> Part information <input type="checkbox"/> Electrical <input type="checkbox"/> Transmit/receive <input type="checkbox"/> Other ()	<input type="checkbox"/> Action required <input type="checkbox"/> Service manual revision <input type="checkbox"/> Retrofit information <input type="checkbox"/> Tier 2

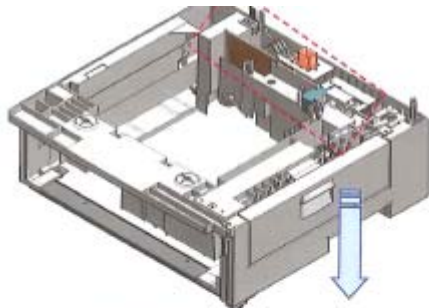
D5672744 (Plate: Heat Sink: 1)

Reason / Change: To prevent temperature increasing when the optional heater is installed, 2 plates were newly added as shown below.
