Model: Model PL-MF		Date: 2-Oct-06	No.: MG157001
Modified Article: Transfer Roller		Prepared by: H.K.	
From: Technical Service Dept., GTS Division			
Reason for Modification:	<input type="checkbox"/> Parts catalog correction <input type="checkbox"/> To facilitate assembly <input type="checkbox"/> Part standardization	<input checked="" type="checkbox"/> Vendor change <input type="checkbox"/> To improve reliability <input type="checkbox"/> Other	<input type="checkbox"/> To meet standards ()

Modified Article: Fusing Unit		Prepared by: H.K.	
From: Technical Service Dept., GTS Division			
Reason for Modification:	<input type="checkbox"/> Parts catalog correction <input type="checkbox"/> To facilitate assembly <input type="checkbox"/> Part standardization	<input type="checkbox"/> Vendor change <input type="checkbox"/> To improve reliability <input type="checkbox"/> Other	<input checked="" type="checkbox"/> To meet standards (RoHS)

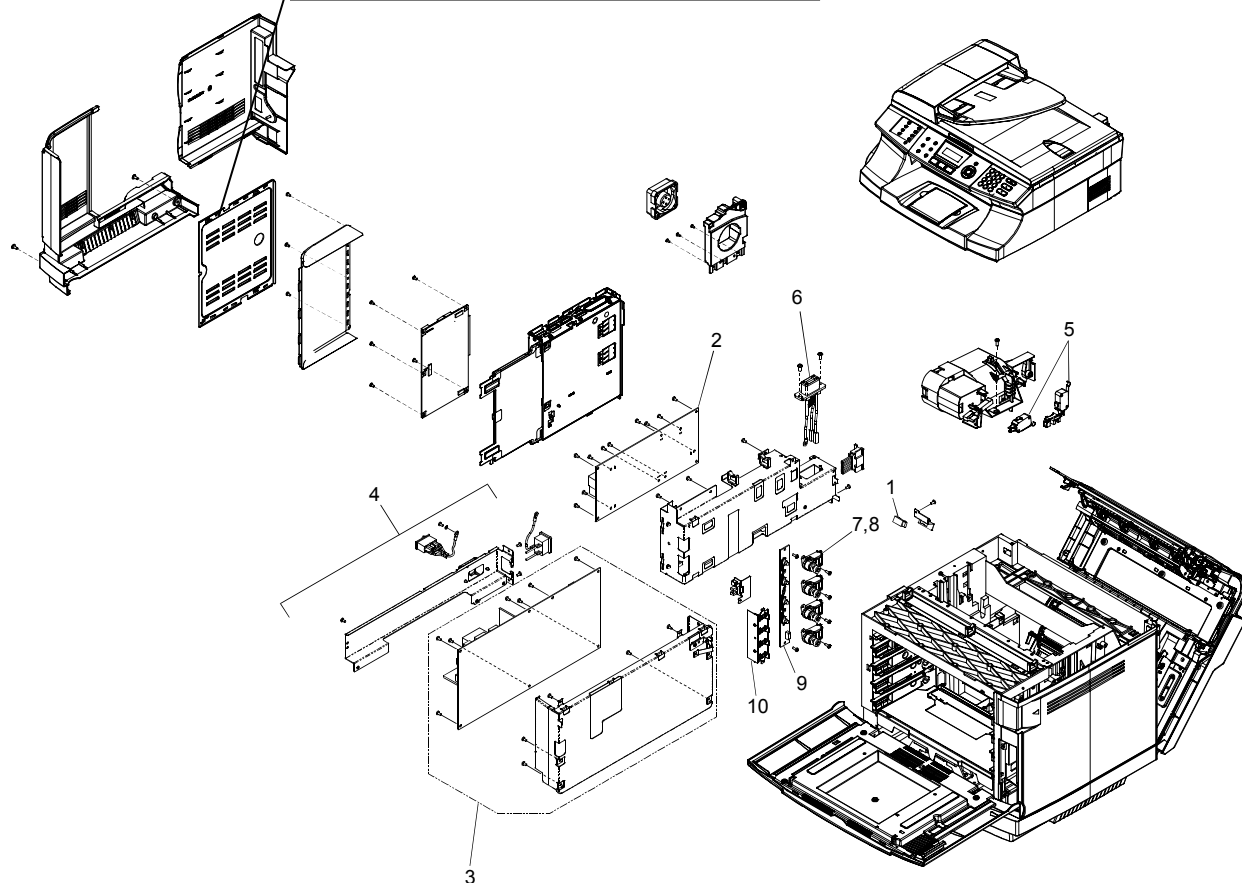
11: V121372: MSL1 SHIELD COVER A

Change: This part was added.

Reason: It was missing from the Parts Catalog.

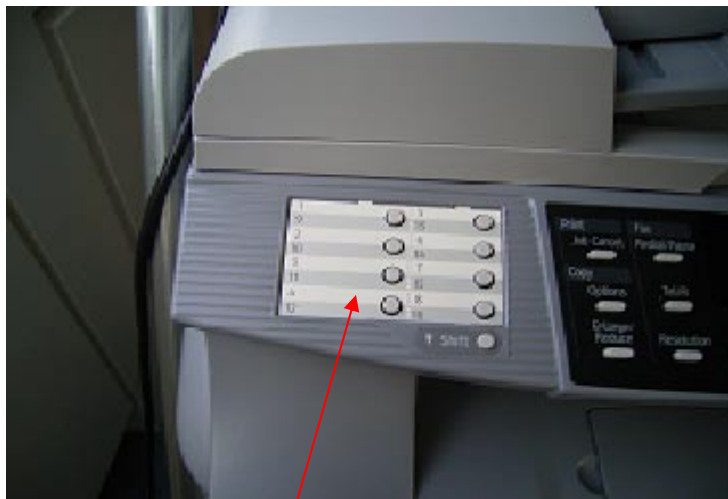
G1575011: OPERATION PANEL SHEET - SPEED DIAL

The operation panel sheet for speed dial has been registered as a spare part. Please add the part number to your parts catalog.

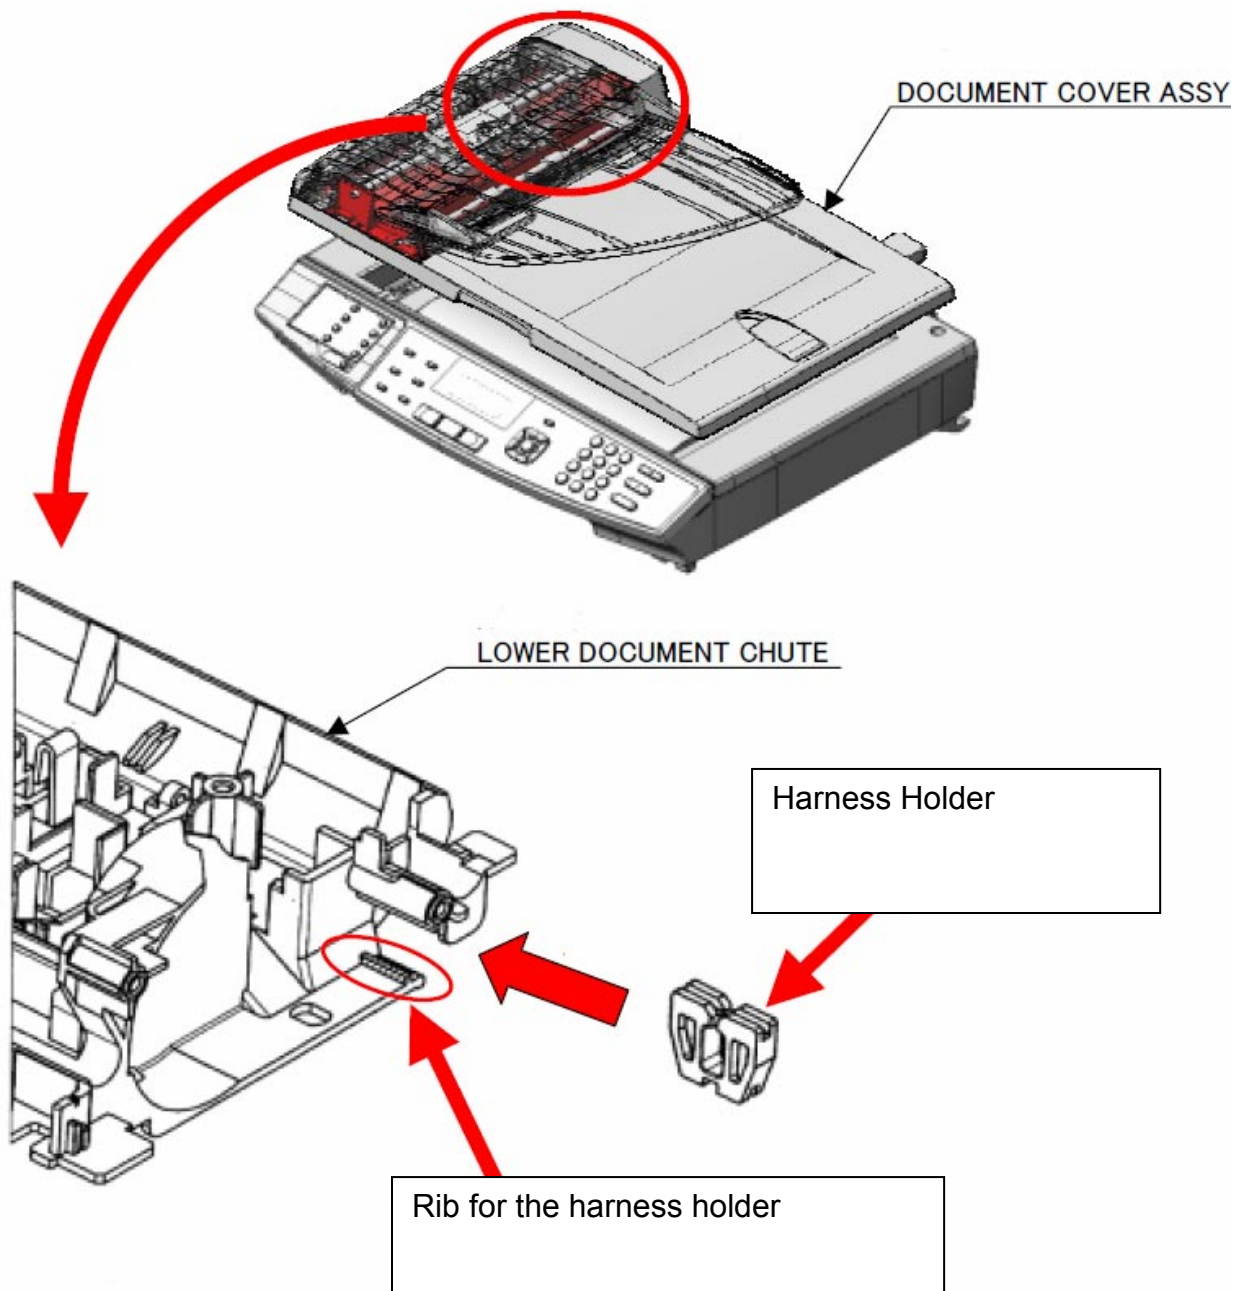
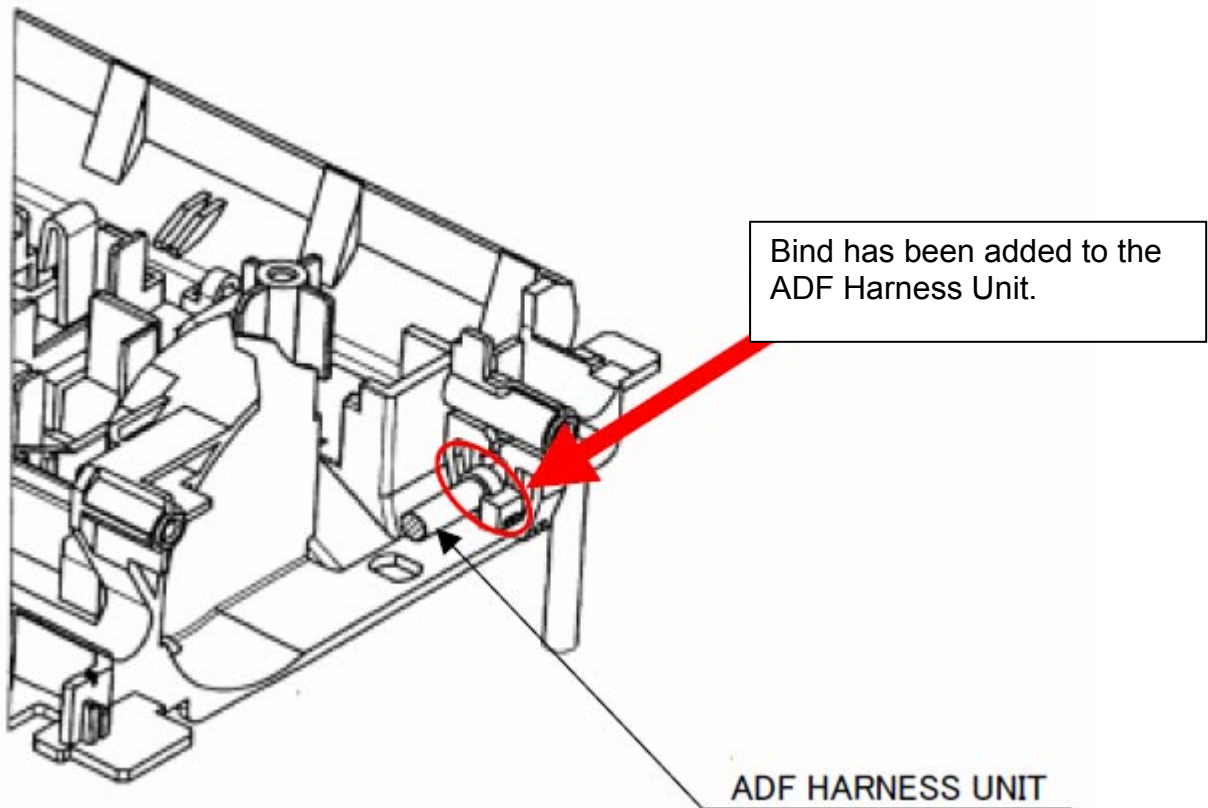
- 1) A harness holder was added to the Lower Document Chute.
- 2) A bind was added to the ADF Harness Unit Ass'y.

Reason: To further ensure the harnesses stay connected during factory assembly.

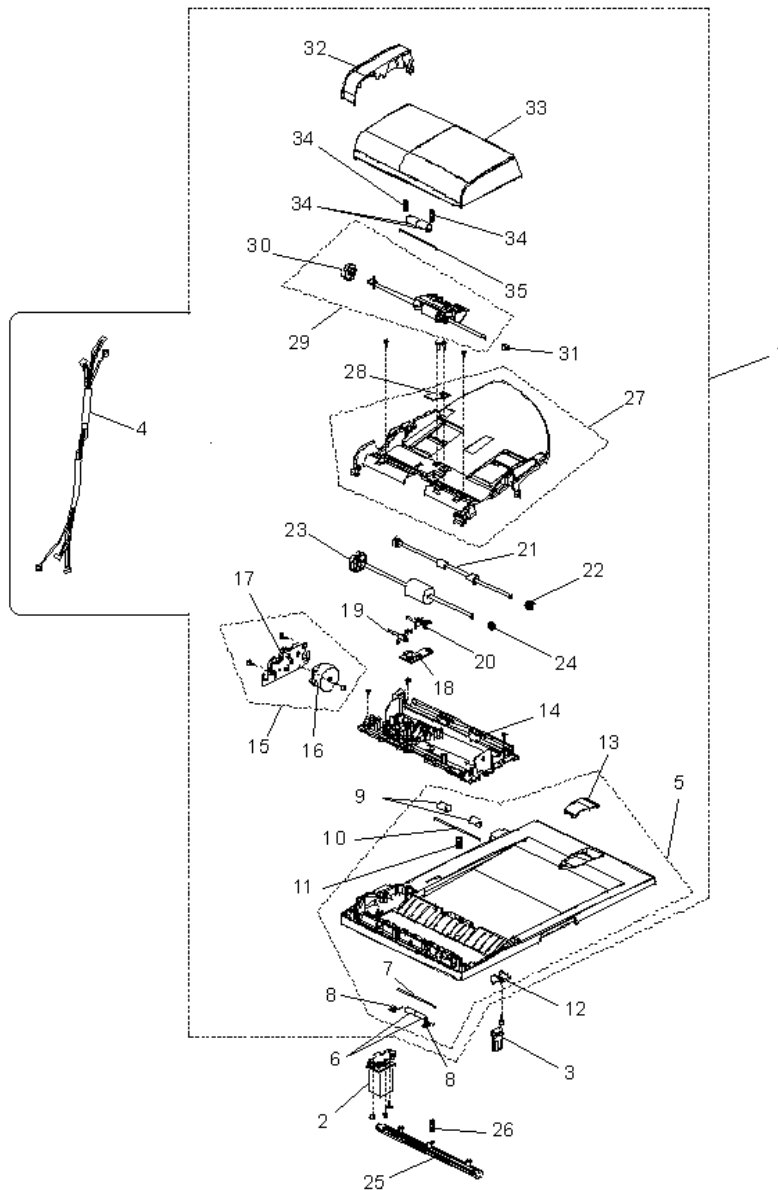
For illustration correction

ADF Harness Unit Ass'y (4) is included into DOCUMENT COVER ASS'Y (1).

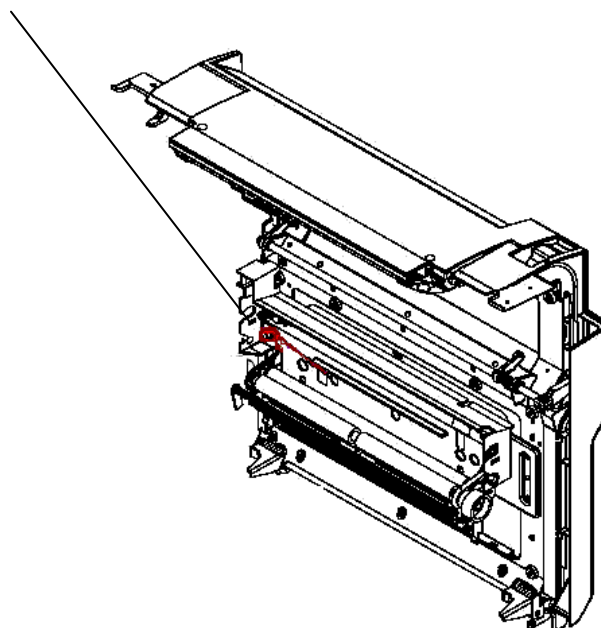
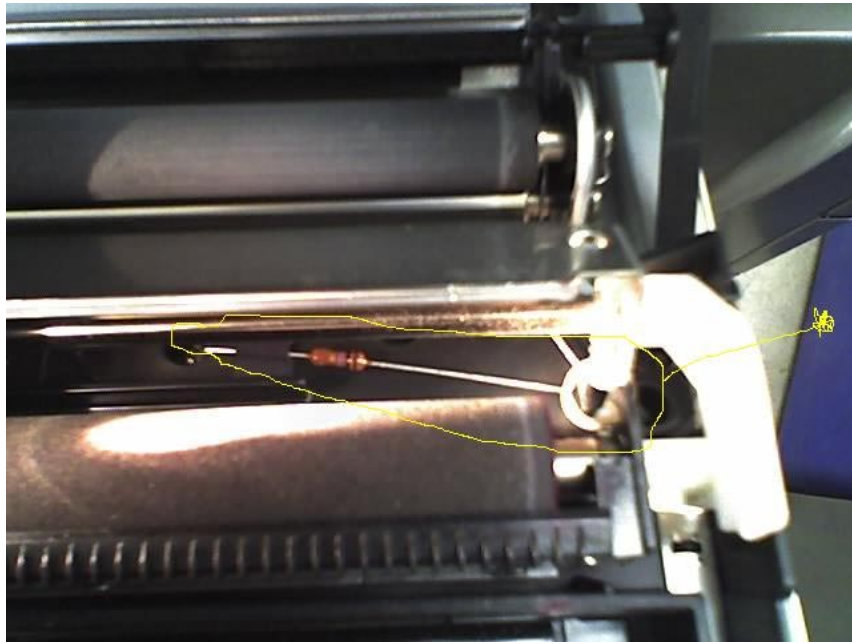
REGIST GROUND SRING

Change: The part in the table was added.

Important: Handle this spring carefully. Make sure not to deform or bend the spring, as this can cause jams, noise, or poor image transfer.

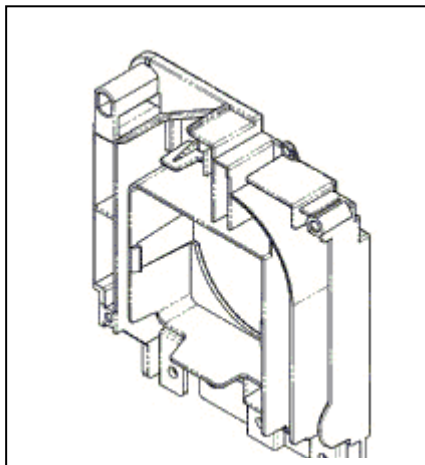
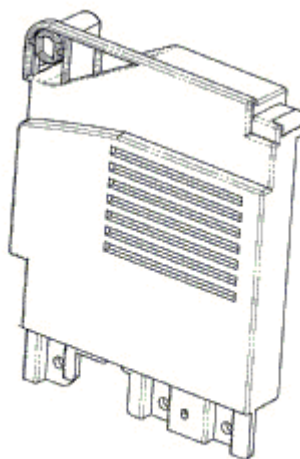
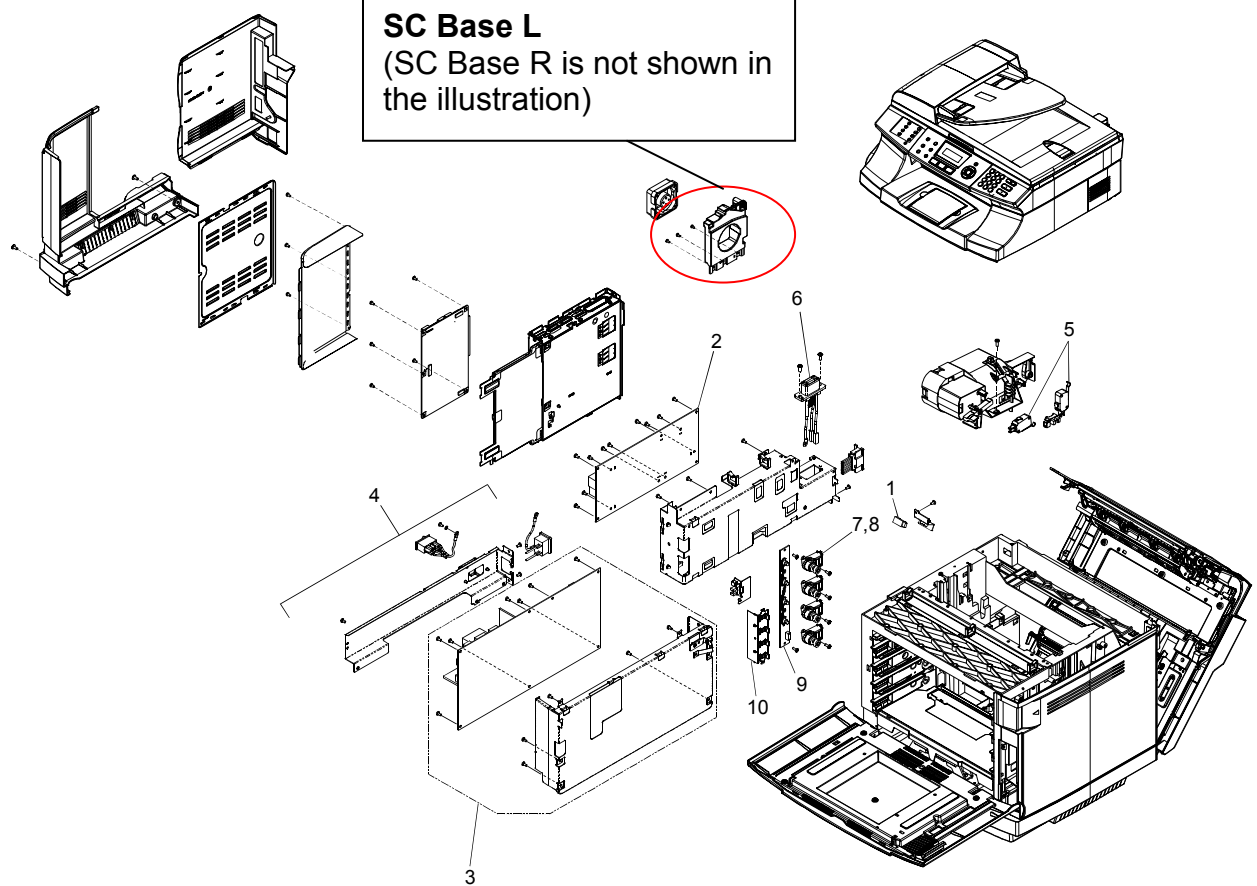
SC Base L/R KIT

Change: This part was added.

Reason: As per a request from the field.

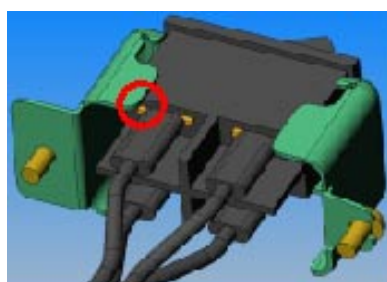
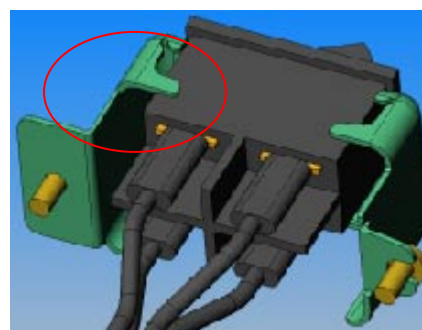
Change: The shape of the bracket was changed.

Reason: To meet European standards.

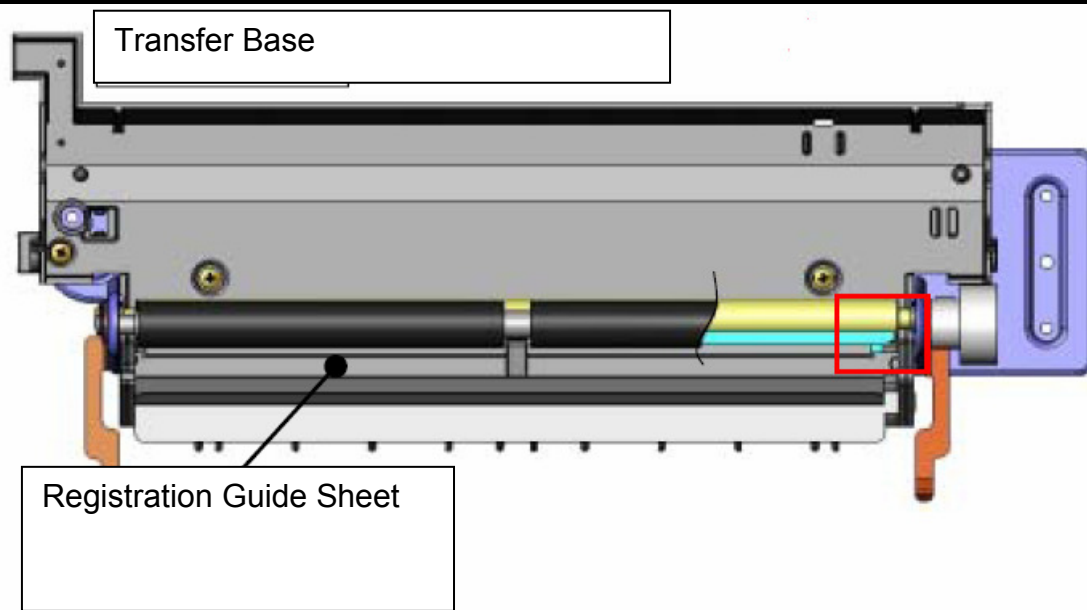
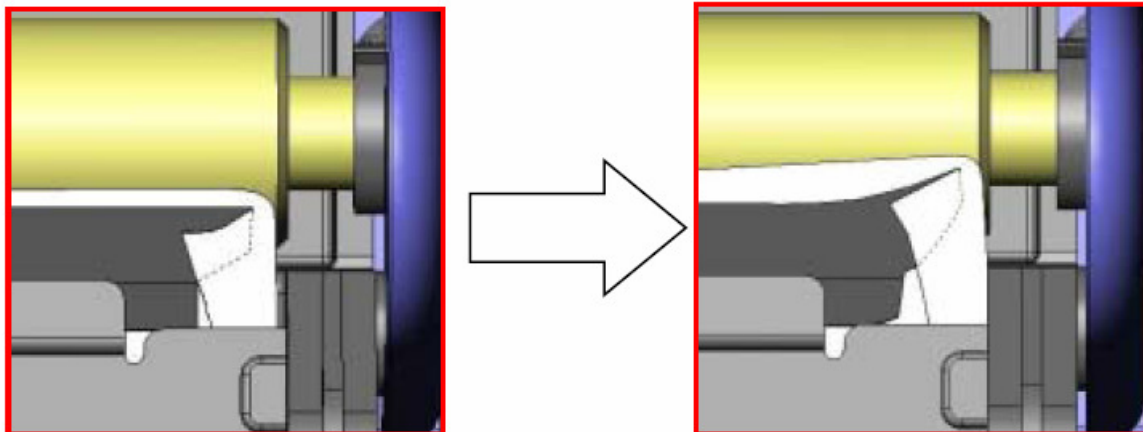
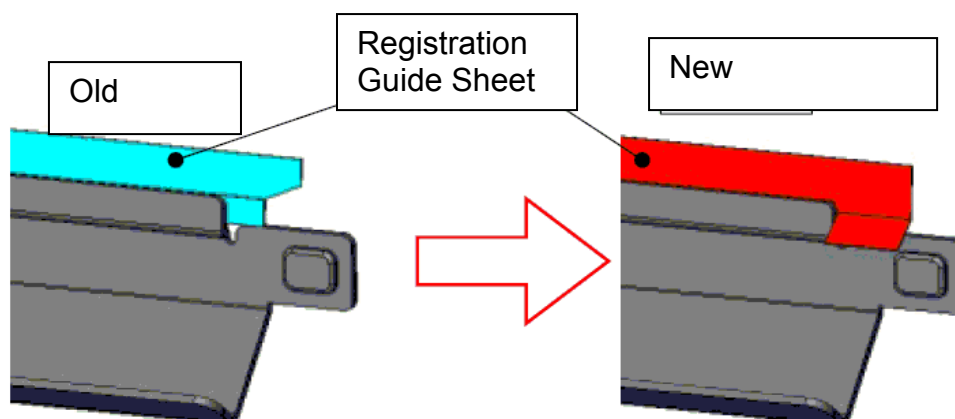
- 1) The shape of the registration guide sheet on the transfer base was changed.
- 2) The band of the transfer unit was deleted.

- 1) To ensure that the guide sheet is not bent by paper that is skewed during paper feed
- 2) To facilitate assembly on the production line.

Skewed paper may bend the old registration guide sheet.

Note: The band of the transfer unit was removed, but the existing spring and hinge mechanism will stop the rear cover halfway when it is opened.

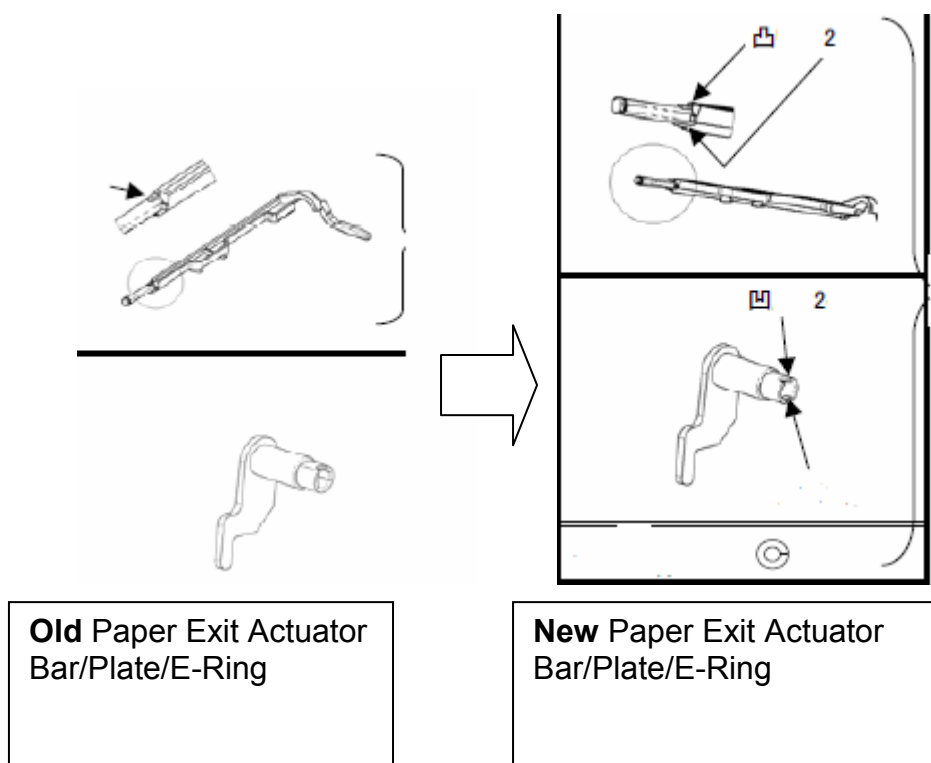
- 1) The shapes of the paper exit actuator (V128497) and bar (not a service part) were changed.
- 2) The new actuator and new bar were combined into one service part (V128720).

Reason: To facilitate assembly.

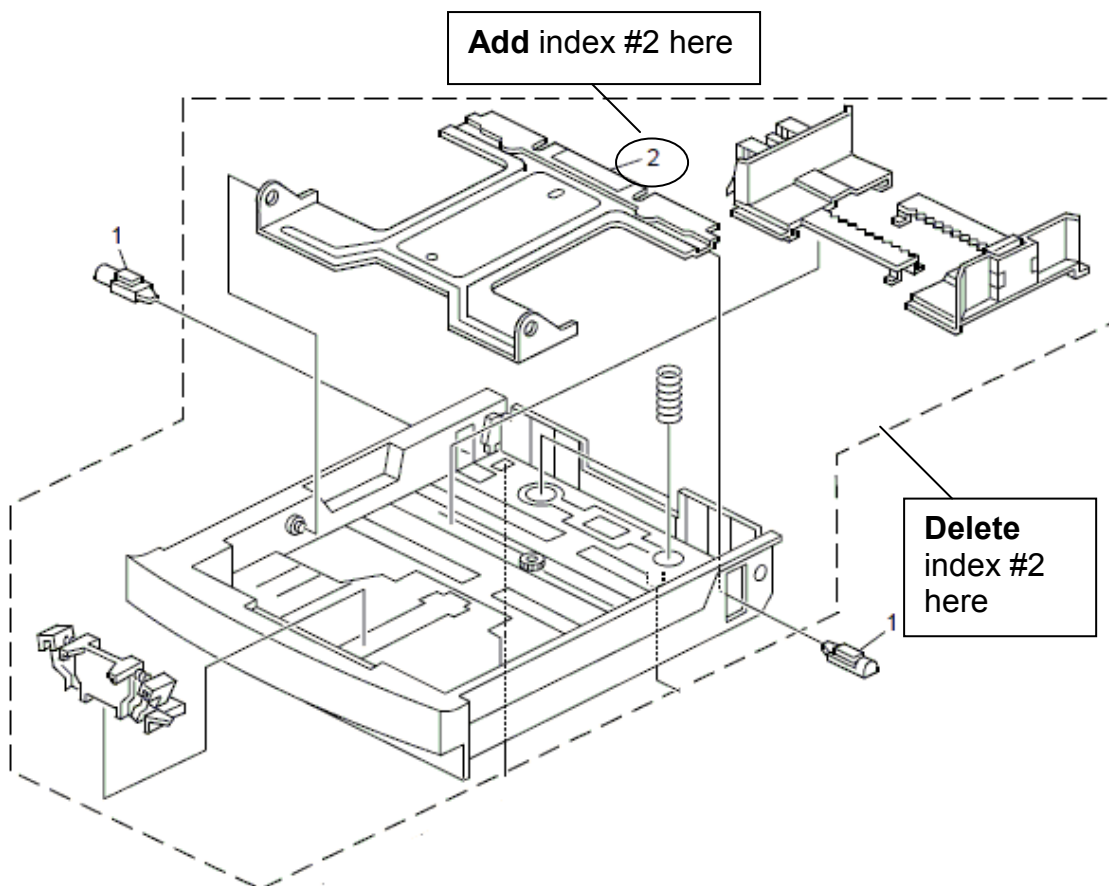
Parts Catalog, pg. 20

Change/Reason: The illustration was corrected as shown below.

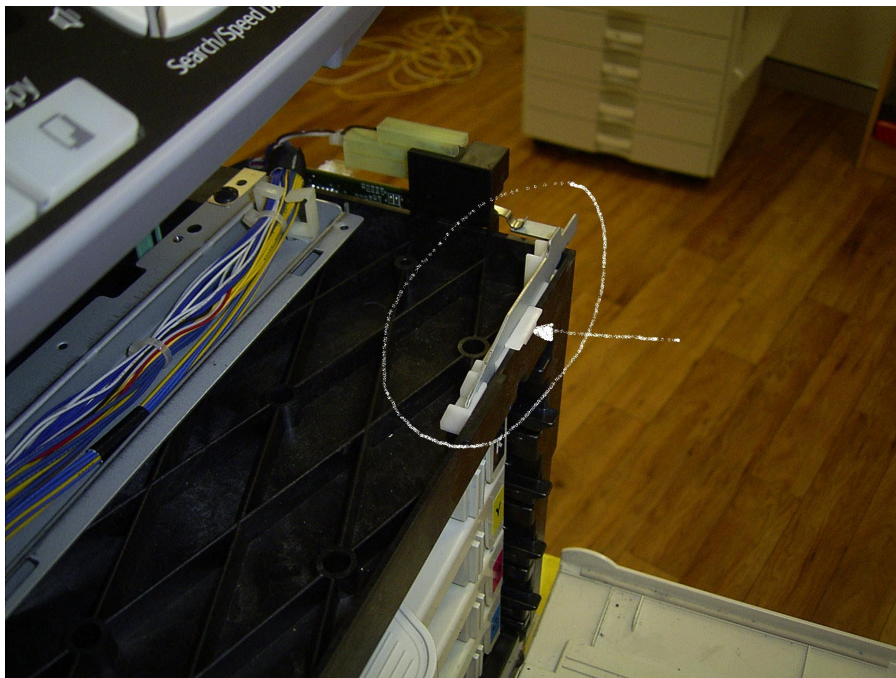
Index #30

Change/Reason: The part in the table was missing from the Parts Catalog.

P/N V128721 SL5F LOCK LEVER ASS'Y (Metal & Plastic parts)

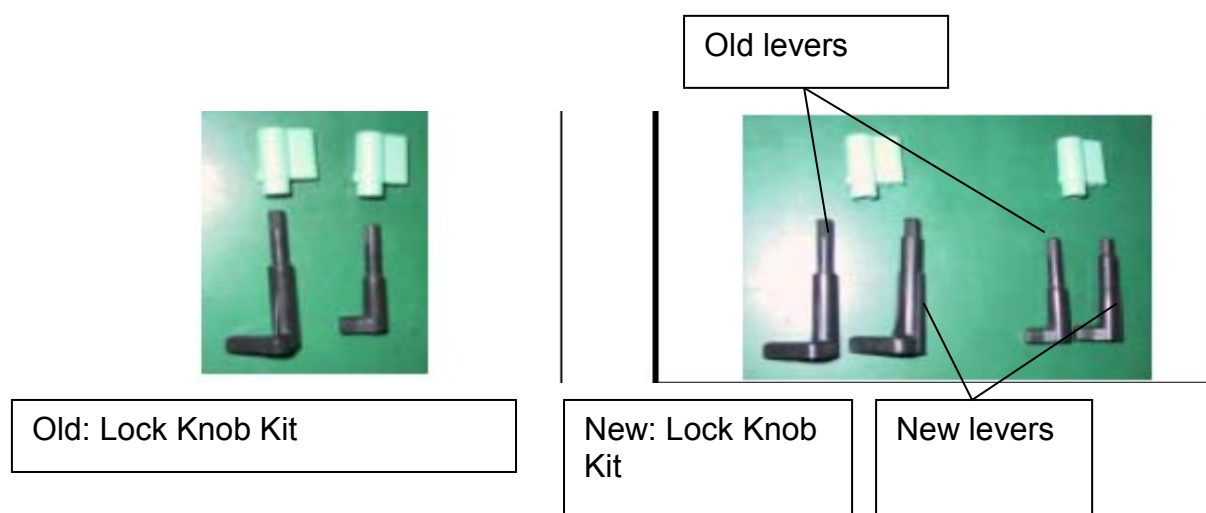
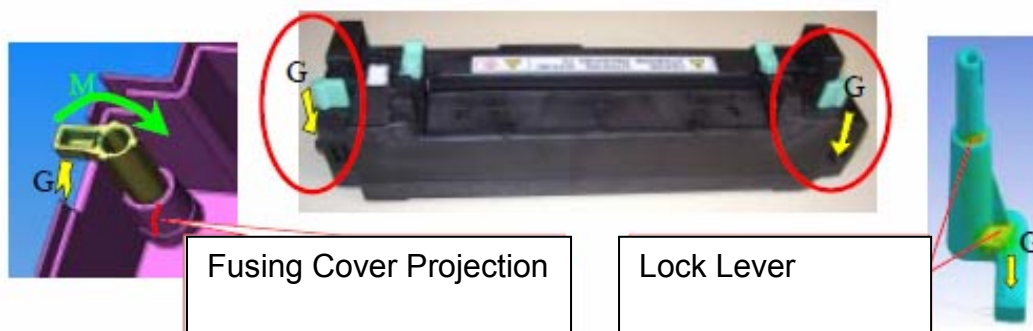
Change: The shapes of the fusing cover projection and lock lever were changed.

Reason: To increase the durability of these parts.

Ribs added

Shape changed A B C

A: Shape changed
B: Rib added
C: Rib extended

Important: If the old top fuser cover needs to be replaced, install the new top fuser cover **together with** the new lock levers in the new lock knob kit.

Note: The new lock knob kit contains both the old and new lock levers, so that you can replace the lock knob.
