Model: Cattleya 2		Date: 26-Feb-01	No.: RB023001
Subject: Main ROM upgrade for Cattleya2		Prepared by: H. Matsui	
From: Technical Services Dept., GTS Division			
Classification:	<input type="checkbox"/> Troubleshooting	<input type="checkbox"/> Part information	<input checked="" type="checkbox"/> Action required
	<input type="checkbox"/> Mechanical	<input type="checkbox"/> Electrical	<input type="checkbox"/> Service manual revision
	<input type="checkbox"/> Paper path	<input type="checkbox"/> Transmit/receive	<input type="checkbox"/> Retrofit information
	<input type="checkbox"/> Other ()

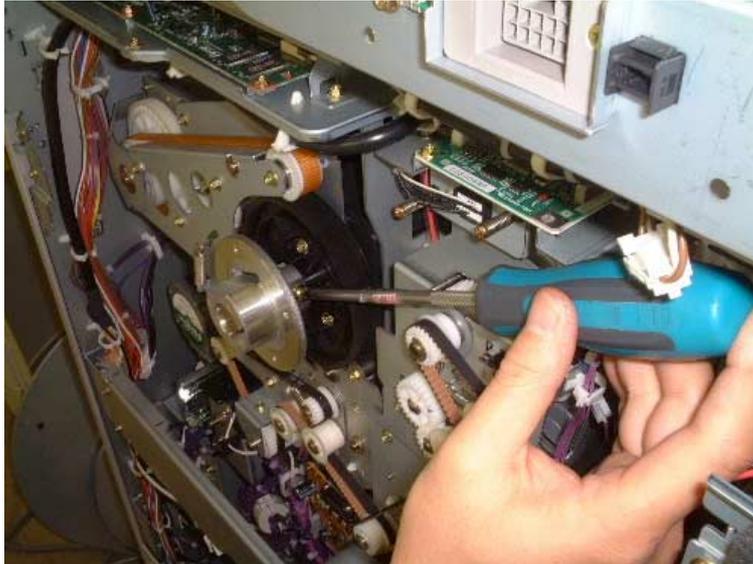
Fig-4

1. The screwdriver must be perpendicular to the screw, or the threading inside the drum shaft screw hole will be damaged.
2. Be sure to tighten the screw enough so that the underside of the screw head [F] is tightly flush against the surface of the Flywheel Supporter (Fig-5).

4. Insert and tighten the first new Flywheel Supporter screw as shown in Fig-4.

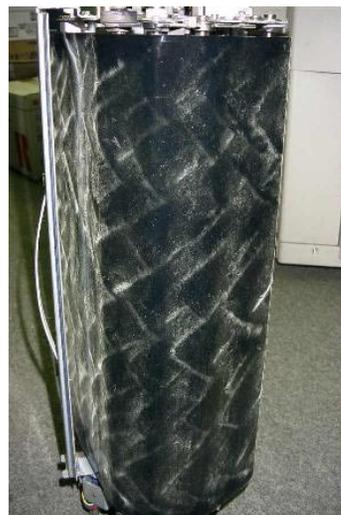
Following ITB replacement, the rubber positioning seals around the inside edge of the belt peel off at about 1-2 kD, causing SC326 or SC452.

1. Please be sure to apply ***a sufficient amount*** of setting powder to the entire surface of the belt at replacement. As a reference, the picture below shows the belt after a sufficient amount has been applied.

Note: When in doubt, it is better to apply slightly more powder than less.
